SAFETY RECALL NOTICE

McLaren Voluntary Safety Recall – NVH Insulation Removal and Potential Fuel Tank Replacement

Bulletin type: Aftersales
Reference number: AFT.023.2020

Affected vehicles: McLaren 570GT, McLaren GT, McLaren 720S (Coupe and Spider), McLaren Senna

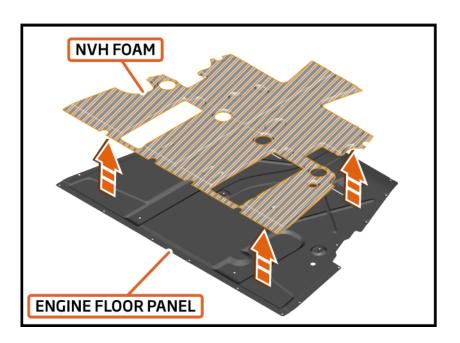
The forthcoming voluntary recall relates to the fact that the Noise, Vibration and Harshness (NVH) foam padding positioned on the underside of the fuel tank can, in some instances, trap corrosive moisture, which can over time cause corrosion of the fuel tank. If not addressed, the corrosion may cause fuel vapour or liquid fuel to leak from the fuel tank, which could increase the risk of a fire.

- Remove the engine floor panel
- Inspect the fuel tank for signs of corrosion and / or leakage Refer to the Care Point below
- Remove all the NVH foam padding on the engine floor panel
- Clean off any residual adhesive
- Re-install the engine floor panel

CARE POINT: In the unlikely event that signs of corrosion are present on the fuel tank, please submit a Technical Request (TR) including pictures of the concerned area to the Technical Support team for further guidance. Where appropriate, the Technical Support team will authorise a replacement of the fuel tank In instances where a replacement fuel tank is or may be required and not available, a loan vehicle is to be offered to the customer. If a loan vehicle is not available within the Retailer, contact the Client Services team for further support.
