# McLaren Voluntary Safety Recall Removal of Engine Floor Panel NVH Foam Padding (and Potential Fuel Tank Replacement)

<b>Bulletin type:</b>	Safety Recall Campaign
<b>Reference number:</b>	AFT.027.2020
<b>Affected vehicles:</b>	McLaren 570GT, McLaren GT, McLaren 720S (Coupe and Spider), McLaren Senna
<b>Attention:</b>	All Retailer Staff
<b>Situation:</b>	Voluntary Safety Recall - Potential for corrosion of the fuel tank
<b>Procedure:</b>	Action affected vehicles on next Retailer visit. Please refer to the information outlined in this document to remove the NVH foam padding on the engine floor panel and inspect the fuel tank for possible corrosion
<b>Date:</b>	17 <sup>th</sup> June 2020

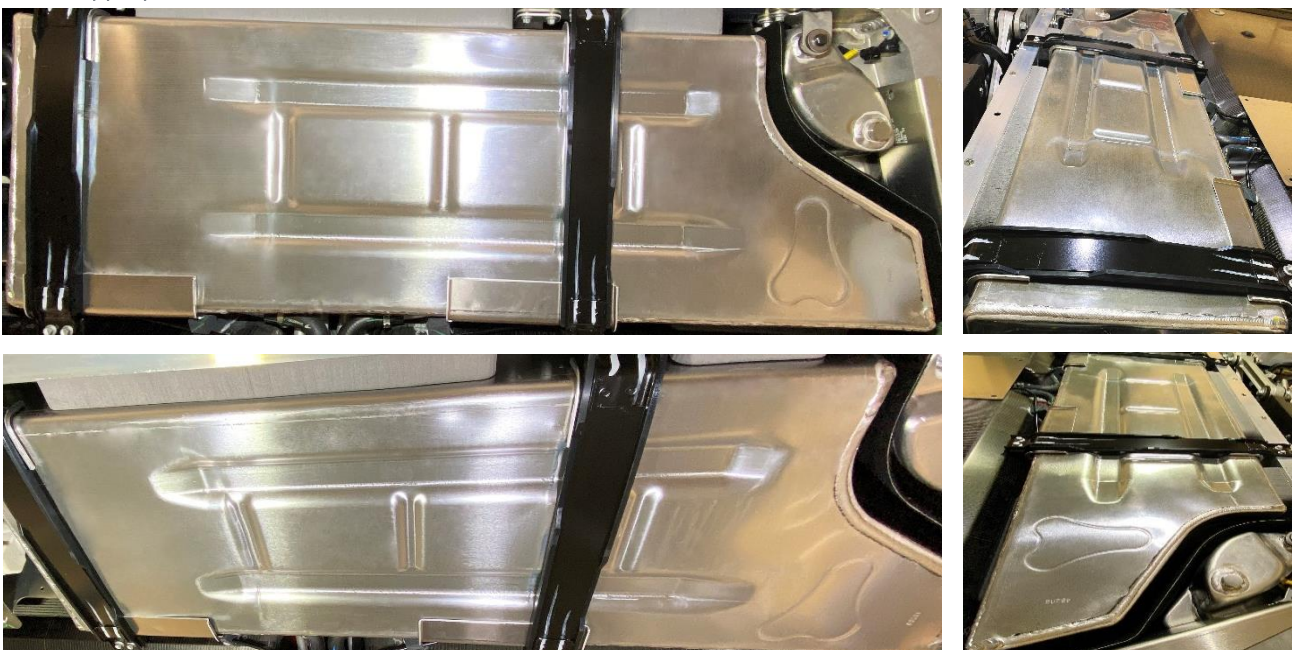
If signs of corrosion and / or leakage are found, raise a TR and attach pictures of the fuel tank to show the overall condition (from angles similar to the below example pictures) and also additional pictures focusing on any signs of localised corrosion and / or pitting.

If signs of localised corrosion and / or pitting is evident, carry out the following steps where possible and provide the recorded values when submitting the TR:

- Carefully remove any oxidised material and note the amount of excess removed
- Measure the diameter of the concerned area(s) using a suitable tool i.e. vernier gauge
- Measure the depth of the concerned area(s) using a suitable tool i.e. depth gauge

The Technical Support team will then review the data provided and will authorise a replacement of the fuel tank where appropriate.
