TO: Mercedes-Benz Dealer Principals, General Managers, Sales Managers, Service Managers, Parts Managers	FROM: Gregory Gunther, Department Manager, Vehicle Compliance and Analysis, Engineering Services
RE: Recall Campaign Launch Notification Check Vehicle Body Sealing for Water Intrusion MY20 247 (GLB-Class)	DATE: July 25, 2020

Campaign No. 2020070009, July 2020

SUBJECT: **Model GLB-Class vehicles (247 platform)**
Model Year 2020
Vehicle Body Sealing

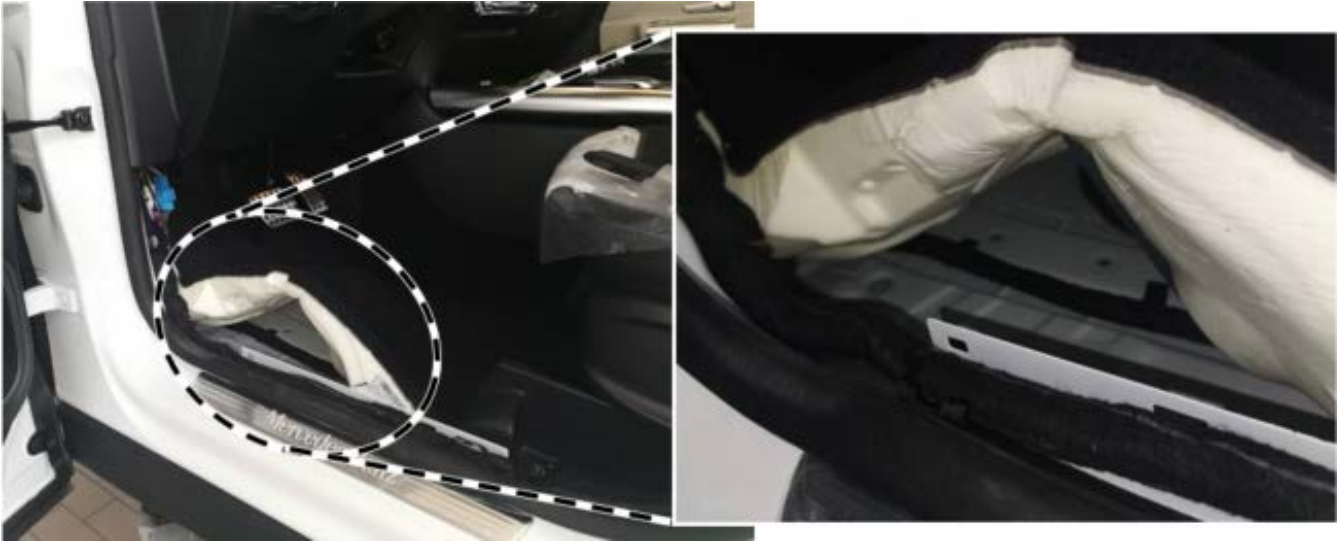
**Figure 1**

1. Remove right and left front door sills (**AR 68.30-P-4101MFA**).
2. Lift floor covering in footwell on driver's side and front passenger side and check for moisture (**Figure 1**).
i There may be no ingress of water under the floor covering in the footwell on the driver's side and front passenger side.

- a. **No** ingress of water in footwell on driver's side and/or front passenger side: Carry out **work procedure A**.
- b. Ingress of water in footwell on driver's side and/or front passenger side: Carry out **work procedures A and B**.

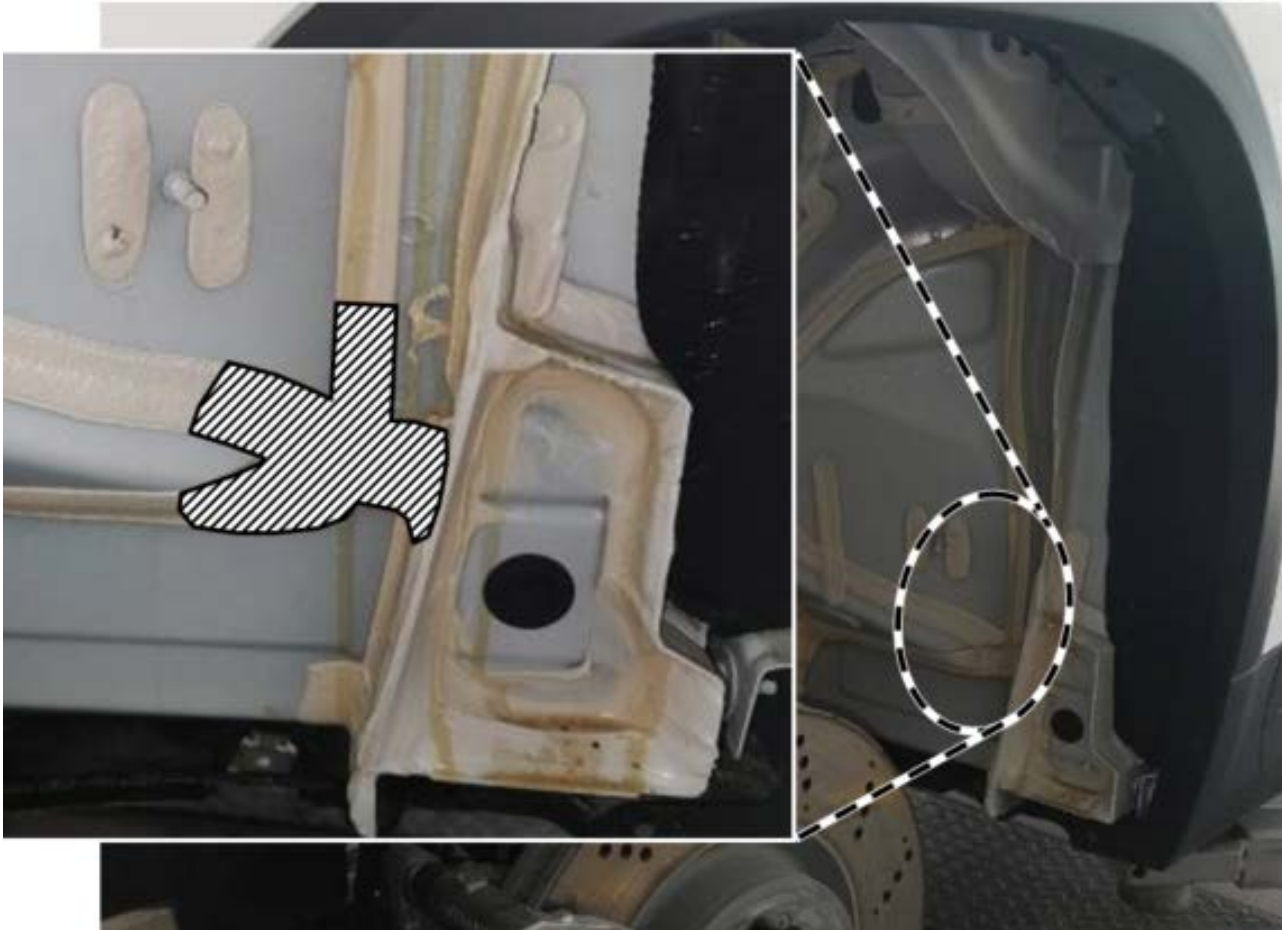
Figure 2

Mercedes-Benz AG (“MBAG”), the manufacturer of Mercedes-Benz vehicles, has determined that on certain Model Year (“MY”) 2020 GLB-Class vehicles (247 platform), the vehicle body might not be sealed in the area of the front wheel wells according to current production specifications. Under certain conditions, it is possible for water to enter from the wheel wells into the front occupant foot wells. This might impair the functionality of the control units and other electrical components installed in these areas (e.g., the instrument cluster might malfunction and not show any information). Additionally, the engine might stall during driving or might not start, increasing the risk of a crash. Occupants might observe wet carpets in the front foot wells and/or fogged windows as an indication of the condition. An authorized Mercedes-Benz dealer will seal the vehicle body in the subject area and check the front foot wells for water intrusion. In the event that water intrusion is confirmed, the necessary repair will be carried out.

1. Remove rear section of right and left front fender liners.
i For basic data, see **AR88.10-P-1301MFA**.
2. Clean/prime seam seal on right and left of firewall (marked area) and rework with transparent seam seal (**Figure 2**).
