Bentley Bulletin

20-059

Subject: Safety Recall – Fuel Line Quick Connector (RE20/14)

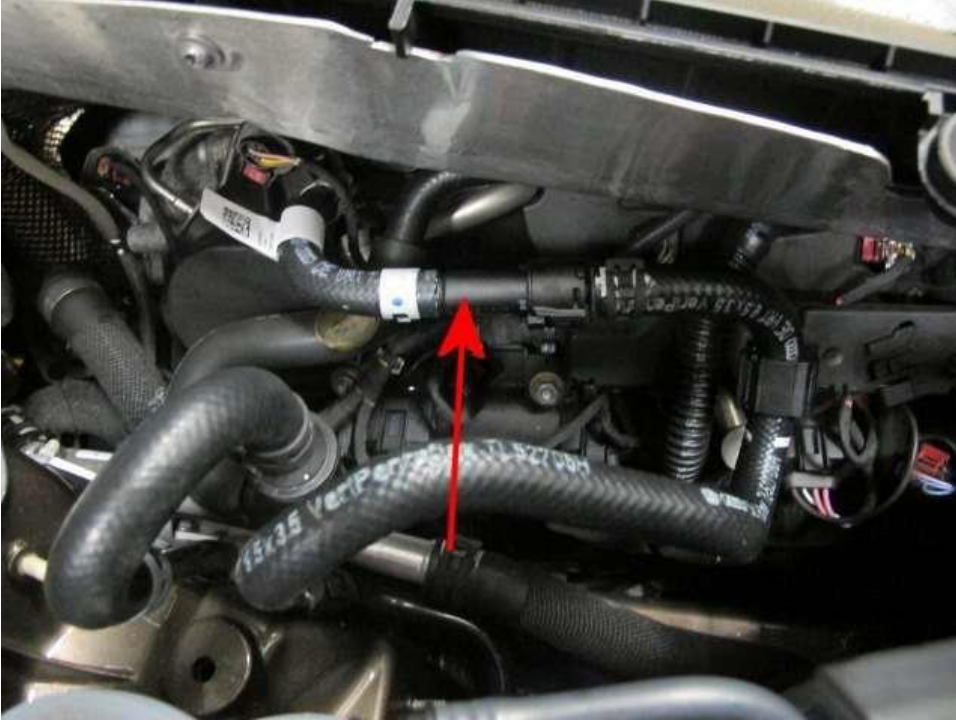
Figure 1

1) Remove the Air cleaner element top cover – Refer to Repair manual Rep.Gr24 - Air-cleaner element - To remove and fit - Identify the fuel feed hose which is located at the rear of Bank 1 (Figure 1)

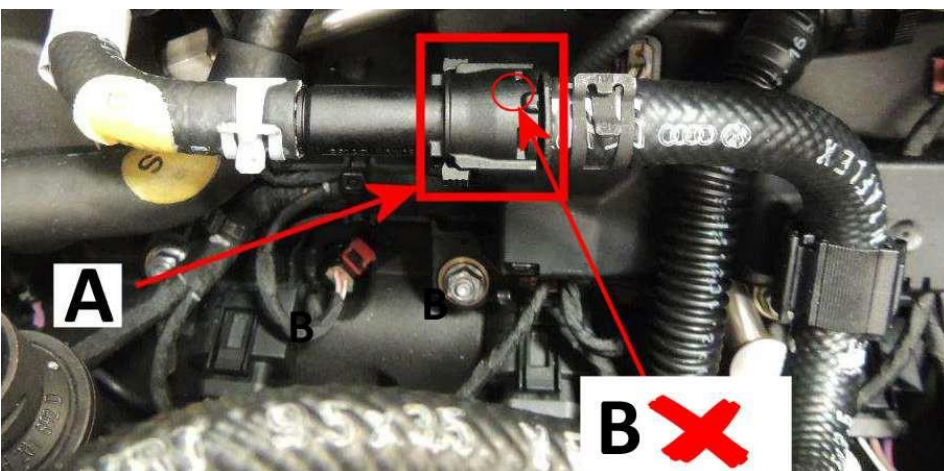
2) Referring to Figure 2 (Incorrect orientation) - Locate the connection at (Point A)

Visually check the connection shown at (Point B) should no hole or dimple be evident (facing upwards) this shows an incorrectly orientated hose and MUST be replaced

- **VERY IMPORTANT:** In the event the hose orientation is confirmed as incorrect the hose **MUST BE REPLACED DO NOT ATTEMPT** to rotate the hose/quick connect – Refer to the fuel hose replacement instructions within the onward instructions

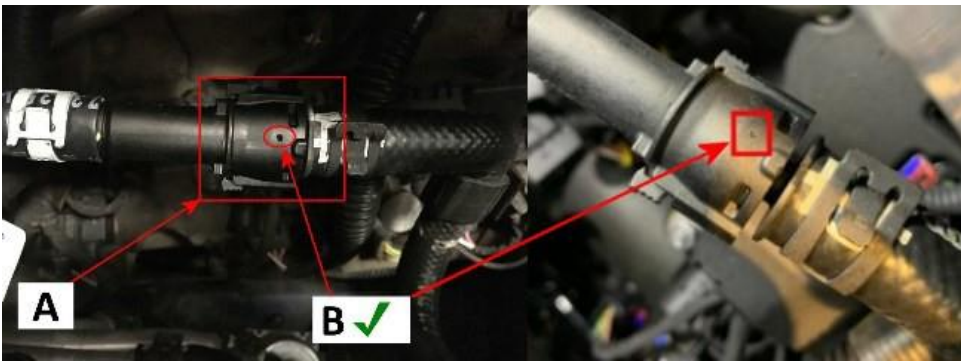
Figure 3

3) Referring to the example shown in Figures 3 (Correct orientation) - Locate the connection at (Point A)

• Visually check the connection shown at (Point B) should the hole/dimple be evident (MUST be facing upwards) this shows a correctly orientated hose

IMPORTANT NOTE: The holes/dimples can vary in depth/size as can be seen in the two examples shown at (Point B)

VERY IMPORTANT: Although correctly orientated, the hose MUST be replaced if the software update is required to be updated

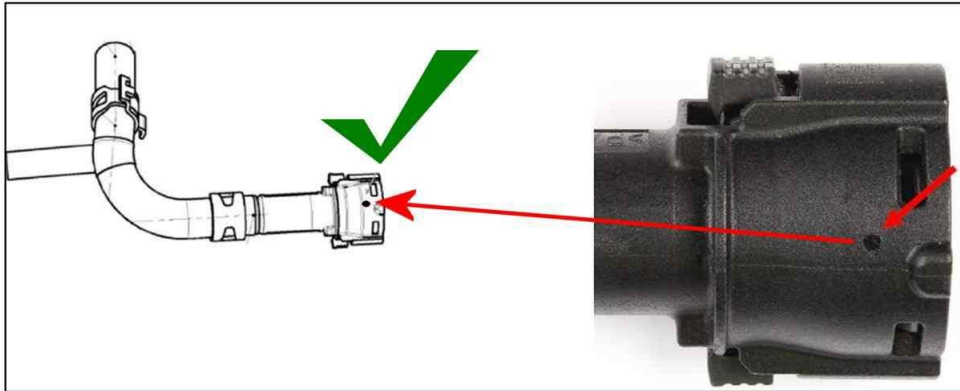
- Figure 4 also shows a close up example of a correctly orientated hose (see hole/dimple which is facing upwards)

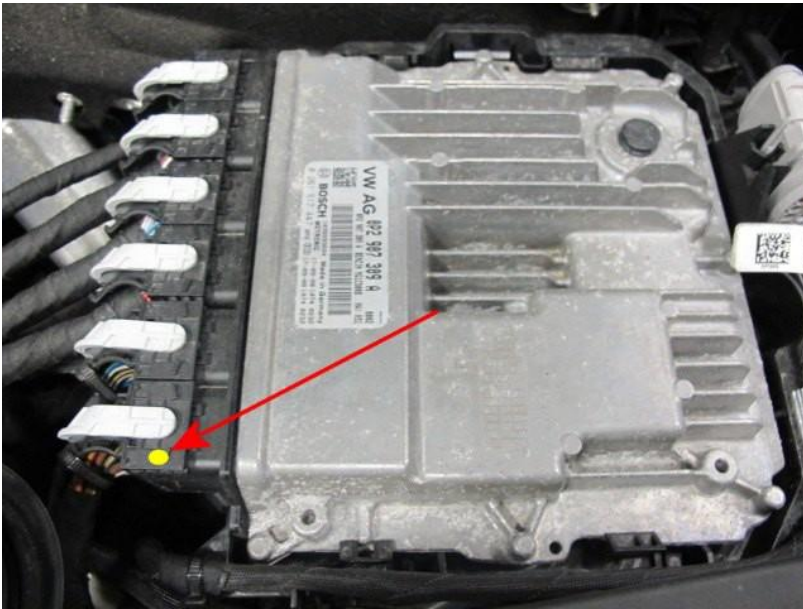
Yellow paint completion mark on the front engine control module plug confirms the fuel hose was successfully replaced

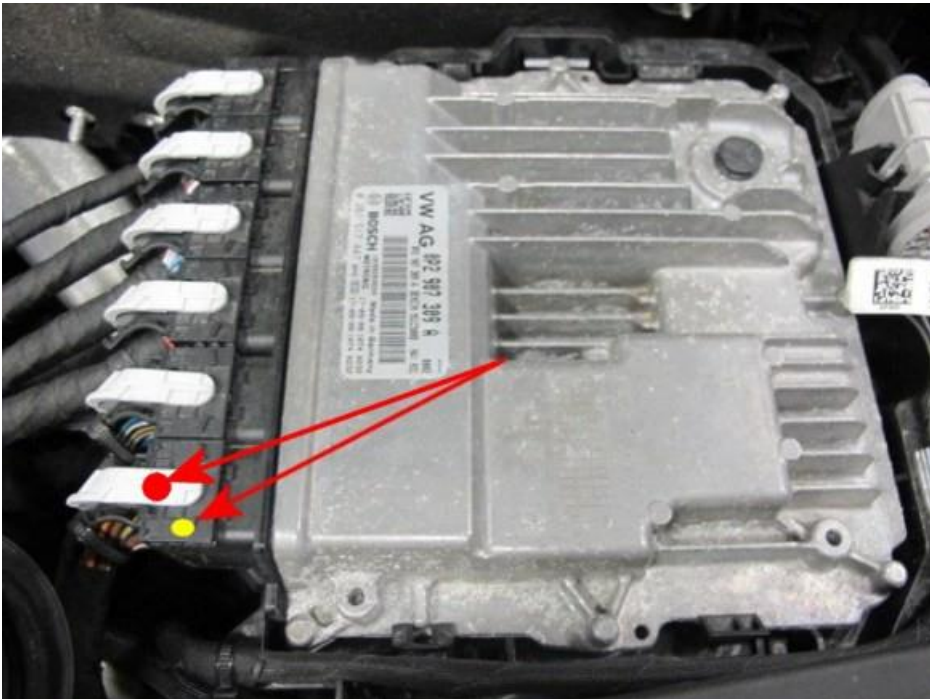
Yellow and red paint marks on the engine control module plug confirms the fuel hose was successfully replaced and software update was successfully applied
