David J. Johnson  
Director  
Service Engineering Operations  
Ford Customer Service Division

July 20, 2020

**SUBJECT: NEW VEHICLE DEMONSTRATION / DELIVERY HOLD -  
Safety Recall 20S37**

Certain 2016-2018 Model Year MKX and 2019-2020 Model Year Nautilus Vehicles  
Equipped with 16-Way Power Front Seats - Wire Abrasion to Seat Frame

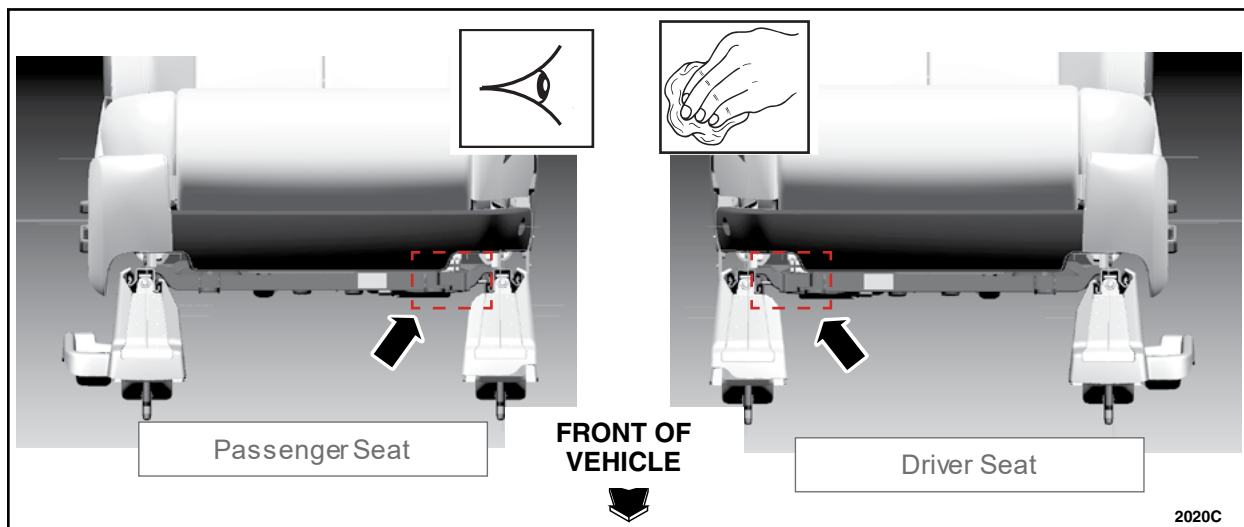
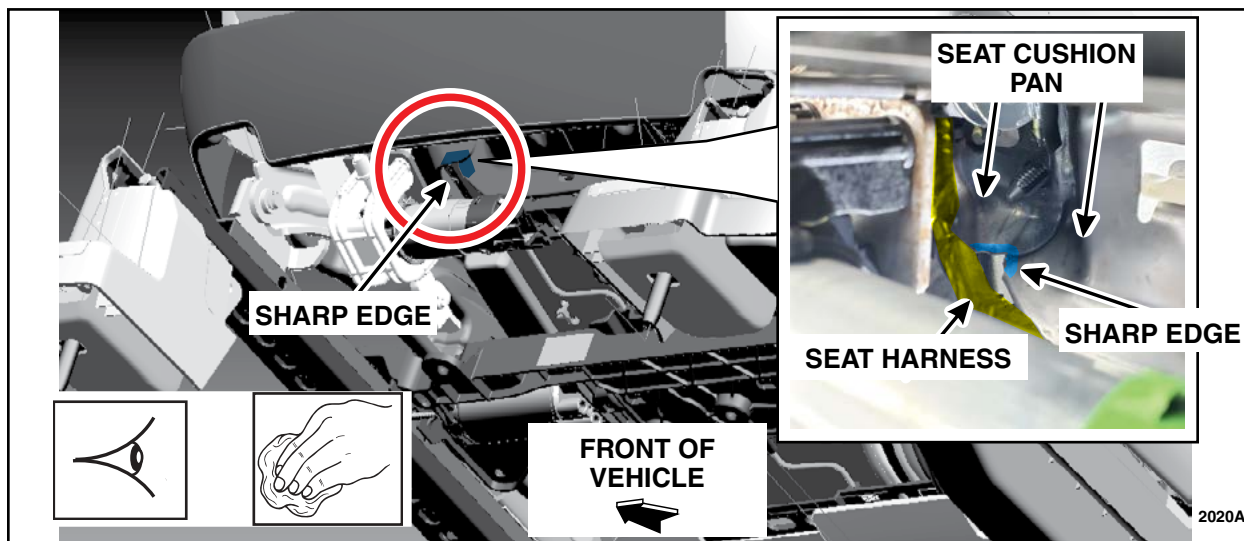
**FIGURE 2A**

3. Locate and inspect the seat harness in the specified location. See Figure 2A and 2B.

- Are any of the wires in the wire harness bundle damaged?

No - If no wire chafe is present or if some minor chafing is visible, with no wire damage, proceed to Step 4.

Yes - If chafing is present, with wire(s) damage, proceed to remove the seat from the vehicle following the Workshop Manual (WSM) procedures in Section 501-10. Please refer to the Wiring Diagrams Cell 005 for Connector Repair Procedures and repair any damaged circuits as necessary. After repair is complete, proceed to Step 4.

4. Scuff the highlighted area of inboard side of the seat cushion frame using a Scotch-Brite® pad or equivalent then, using isopropyl alcohol and a clean shop towel, clean the highlighted area to remove any oil or residue. See Figure 2A and 2B.
