David J. Johnson
Director
Service Engineering Operations
Ford Customer Service Division

October 14, 2020

SUBJECT: NEW VEHICLE DEMONSTRATION / DELIVERY HOLD
Safety Recall 20S41 – Supplement #1
Certain 2020 Model Year Corsair
Rear Coil Spring Inspection

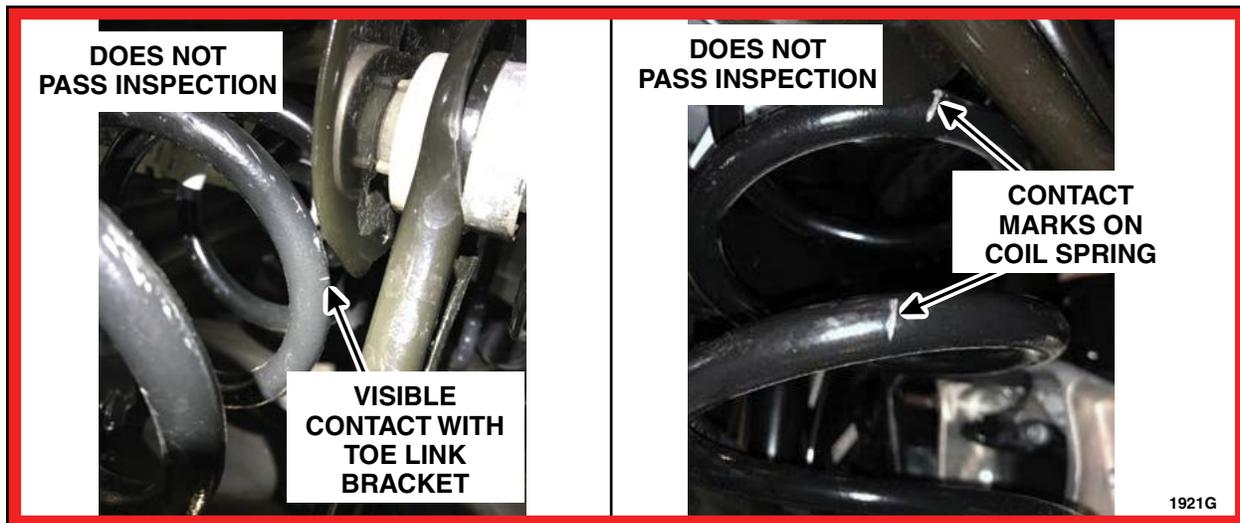
FIGURE 1

1. Position the vehicle on a hoist. Please follow the Workshop Manual (WSM) procedures in Section 100-02.
2. Inspect both rear coil springs on side of toe link bracket for any signs of contact with the toe link bracket. See Figure 1.

3. Are there any signs of contact on rear coil spring?

Yes - Does Not Pass inspection, proceed to Step 6.

No - Additional inspection required, proceed to Step 4.

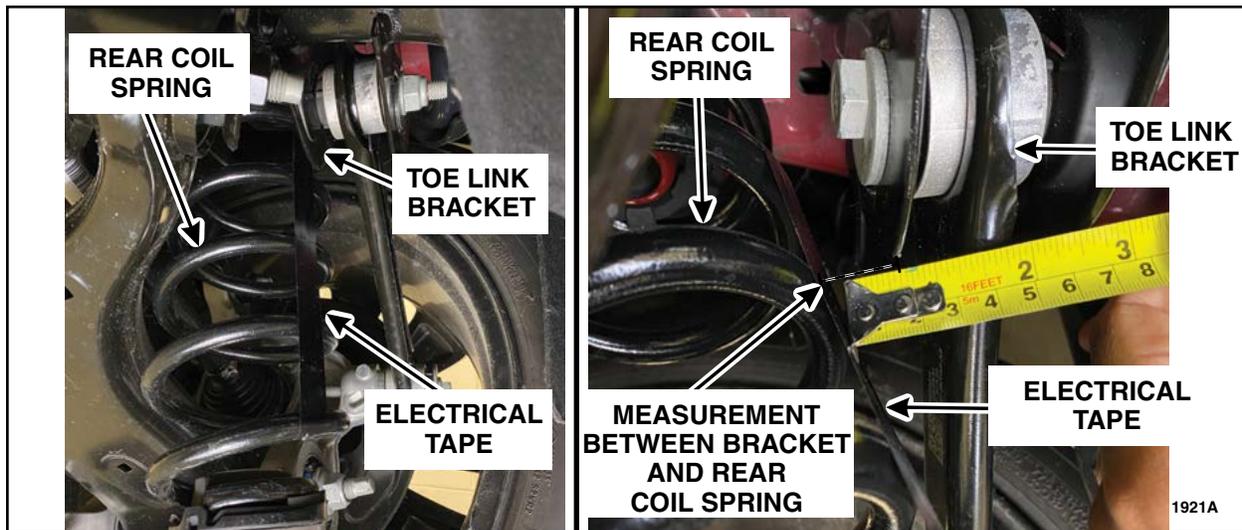
FIGURE 2

4. Measure the gap between the rear coil spring and toe link bracket, to aid in getting a flat surface you can use electrical tape stretched across the coils. See Figure 2.

5. Was the measurement of the gap between the rear coil spring and toe link bracket 6 mm (1/4" inch) or greater?

Yes - Passes inspection, gap is greater than 6mm (1/4" inch) between coil spring and toe link bracket. Procedure is complete.

No - Does Not Pass inspection, proceed to step 6.

NOTE: If gap is less than 6mm (1/4" inch) there may or may not be signs of toe link bracket contacting spring. Regardless of signs of damage if gap is below specification a new spring along with cutting of toe link bracket needs to be performed following technical instructions. This procedure only needs to be done on the side with gap under specification. In some cases that is just one side, in others can be both driver and passenger sides.
