Recall Campaign Launch Notification			October 16, 2020
Campaign No. :	NHTSA ID	Campaign Desc. :	Check Rear Spoiler
2020090006	20V480	20P7792002	
<p>This is to notify you of the Recall Campaign Launch to check the rear spoiler on 10,644 Model Year (“MY”) 2020 GLB-Class (247 platform) vehicles. The recall campaign will be visible on the www.safercar.gov website and may generate questions from customers. Affected VINs will be flagged in VMI as “OPEN” on October 16, 2020.</p>			
Background			
Issue	<p>Mercedes-Benz AG (“MBAG”), the manufacturer of Mercedes-Benz vehicles, has determined that on certain Model Year (“MY”) 2020 GLB-Class vehicles (247 platform), the rear spoiler located above the tailgate might have been manufactured outside specifications. The upper surface of the rear spoiler might not have been welded correctly, or not welded at all to the base part. In the event of missing welds, it is possible that the upper surface might not be sufficiently connected to the base part. Should the rear spoiler be incorrectly welded, parts of the rear spoiler could detach while driving which could increase the risk of a crash for other road users. In the event of insufficient welds on t

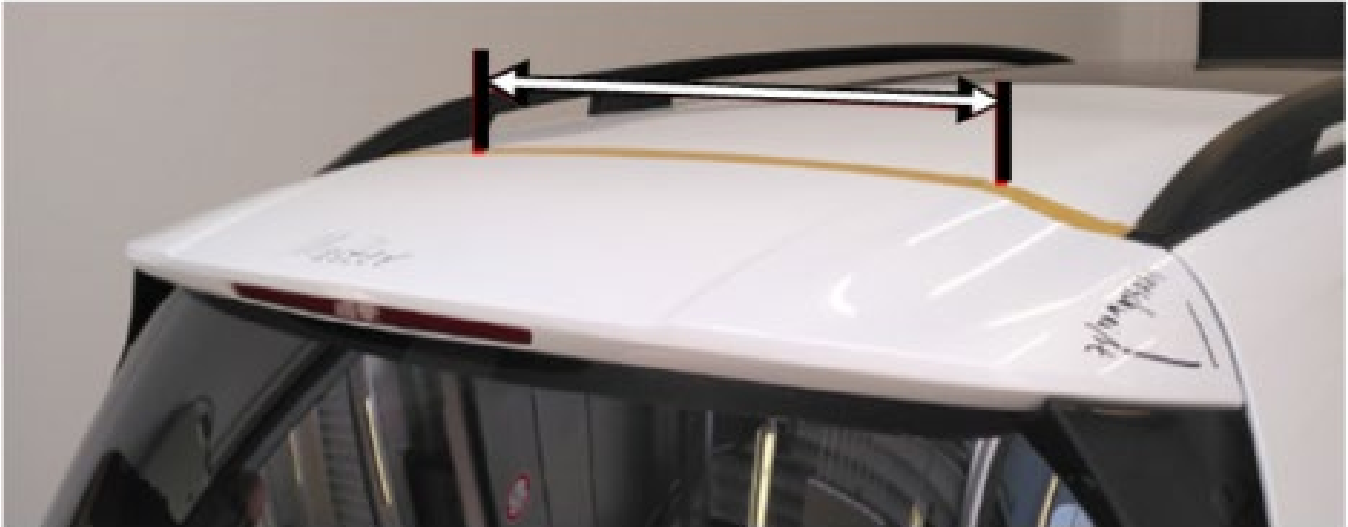
Figure 1

1. Open tailgate and apply masking tape to roof edge between left and right roof railings. **(Figure 1)**

i The masking tape is applied to protect the paintwork.

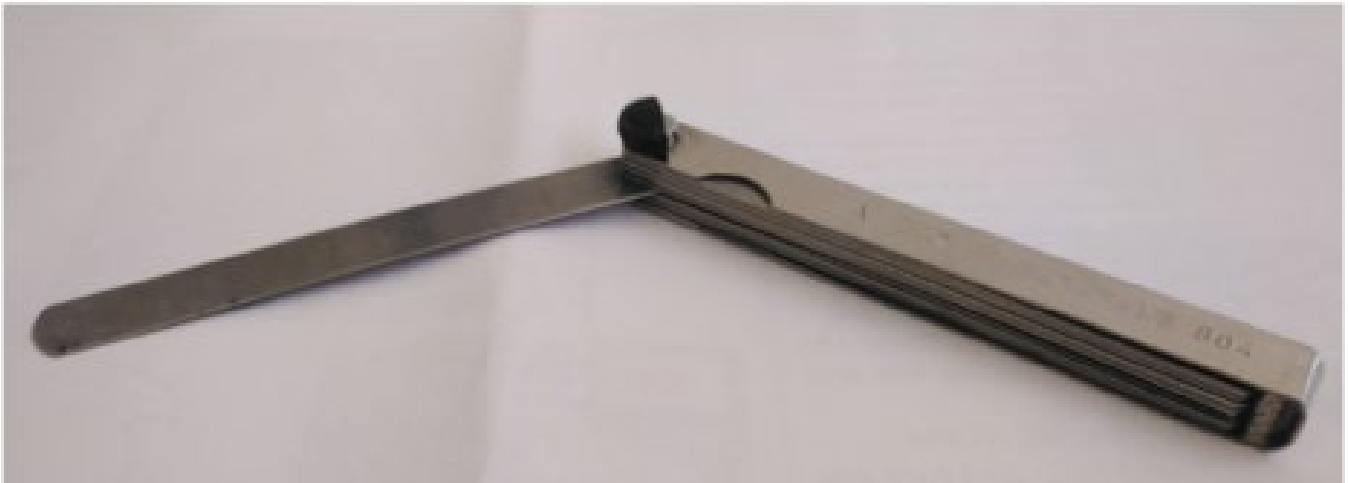
Figure 2

2. Lay out gauge with **0.5 mm**.

i E.g. feeler gauge **(Figure 2)**

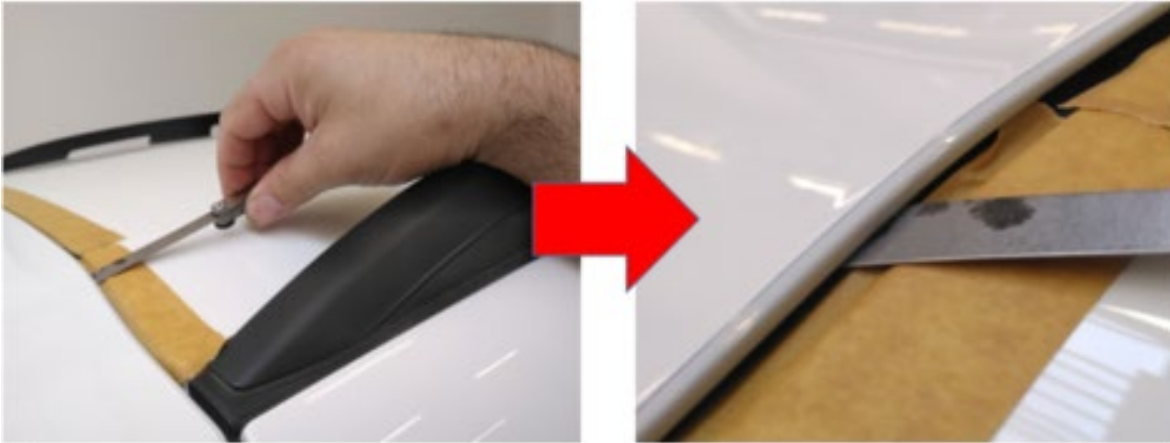
Figure 3 (OK)

3. Carefully attempt to slide the gauge between the outer shell and the spoiler lip.

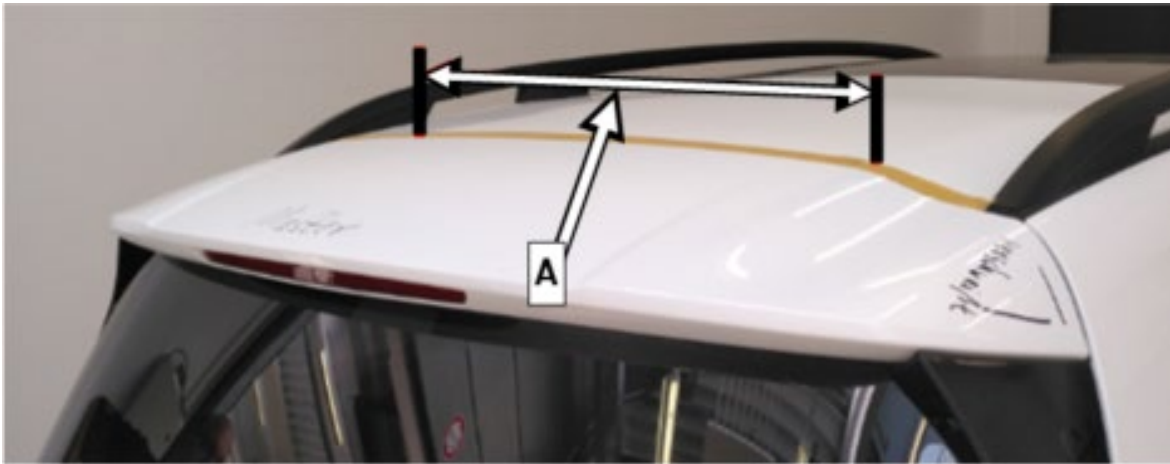
Figure 4

i The test must be performed along the length shown (A, Figure 4), starting from the roof center and extending approx. 100 mm to the left and right roof railings.

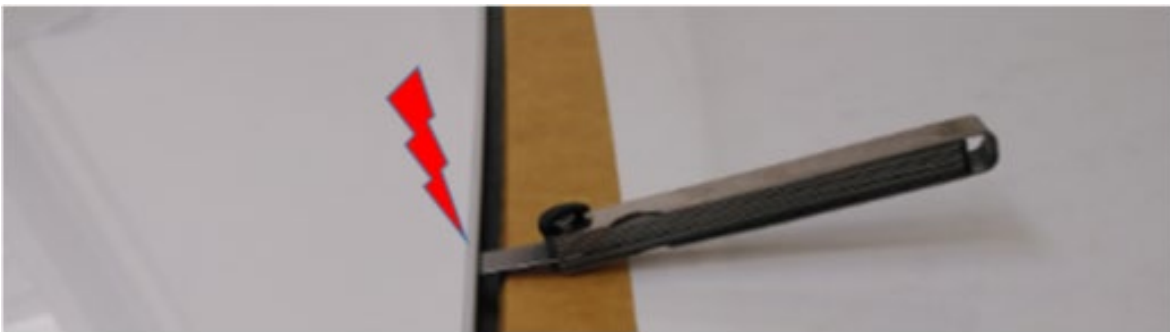
Figure 5 (not OK)

i It **must not be possible** to slide the gauge between the spoiler lip and the outer shell of the center rear

spoiler. (Figure 5, not OK)

1. Replace center rear spoiler (**AR72.20-P-4000MFD**).

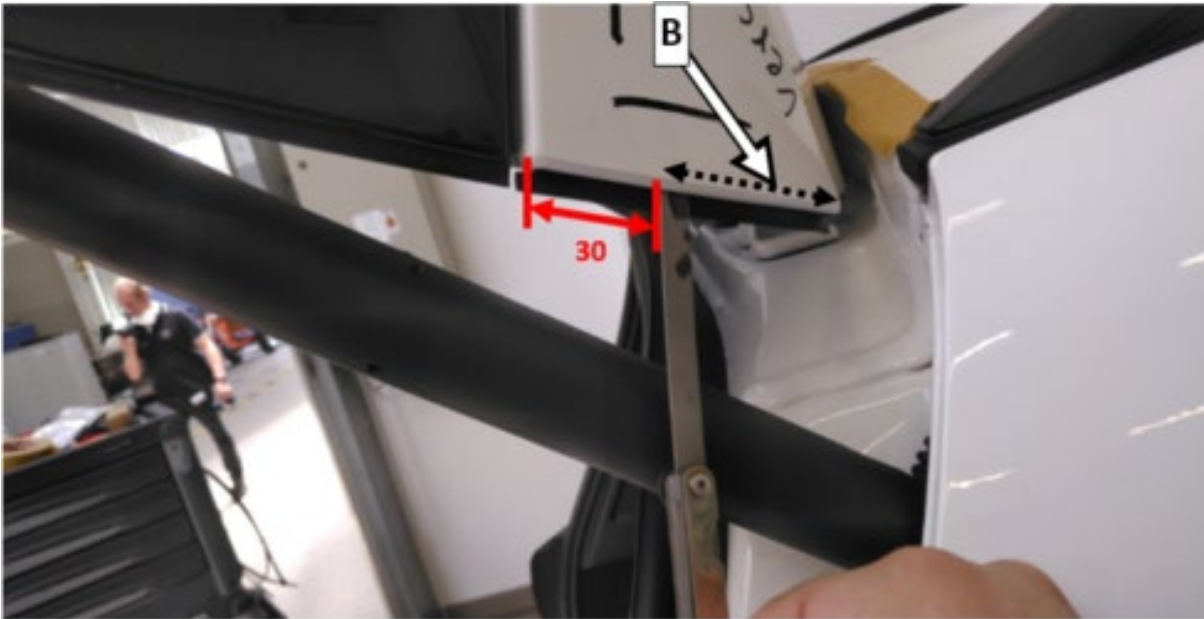
Figure 6

4. Open tailgate and carefully check at a distance of **30 mm** to the left and right of the edge in the test area (B, Figure 6) whether the gauge can be slid between the outer skin and the spoiler lip.

i It **must not be possible** to slide the gauge between the spoiler lip and the outer shell of the center rear

spoiler.

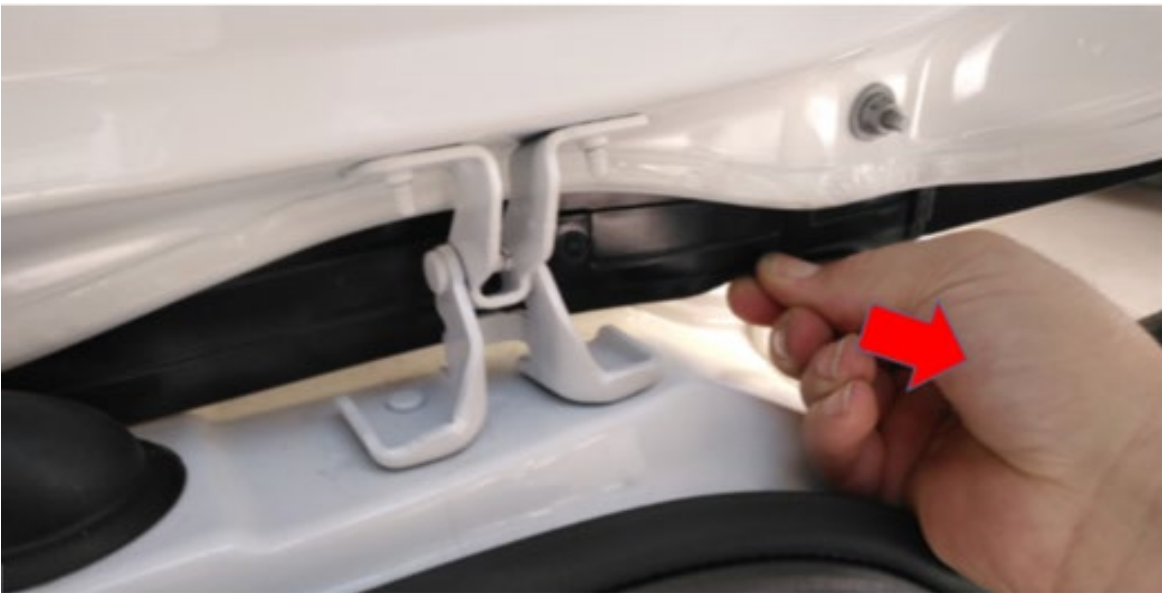
Figure 7

5. Carefully pull on the spoiler lip in the area of the hinges on the left and right of the tailgate.
i The spoiler lip **must not** detach from the outer shell of the center rear spoiler.

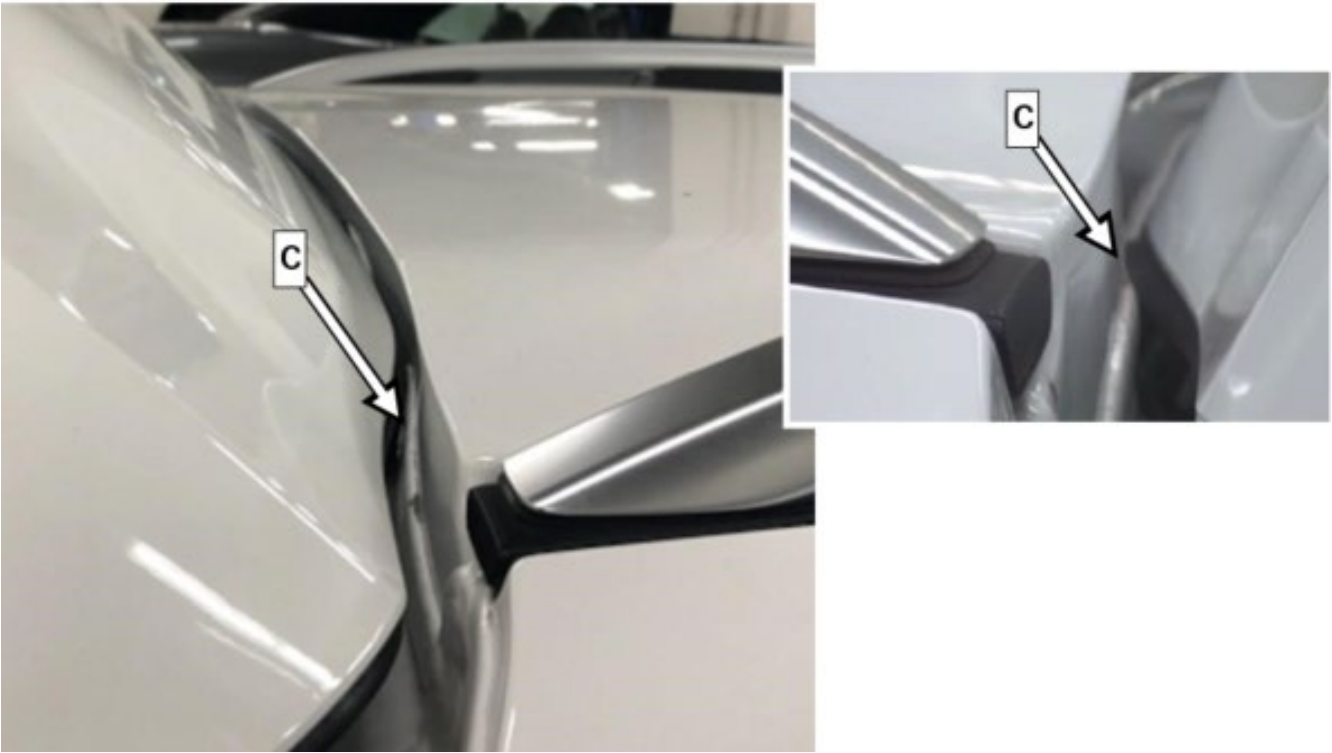
Figure 8

6. Open and close tailgate and check whether the spoiler lip brushes against the seam seal in the area of the roof edge (C, Figure 8).
i Minimal brushing without the spoiler lip snapping is acceptable.
i The test must be performed along the entire length of the seam seal.

i Should the spoiler lip have been damaged by the collision the complete center rear spoiler must be replaced.

1. Remove tailgate (AR72.20-P-1020MFX).
 2. Rework or replace seam seal on roof edge.
 - i** Prior to painting, ensure that there is no longer any contact between the spoiler lip and the seam seal.
 3. Apply the paintwork structure in the working area in accordance with the Mercedes-Benz specifications.
 4. Install tailgate.
-

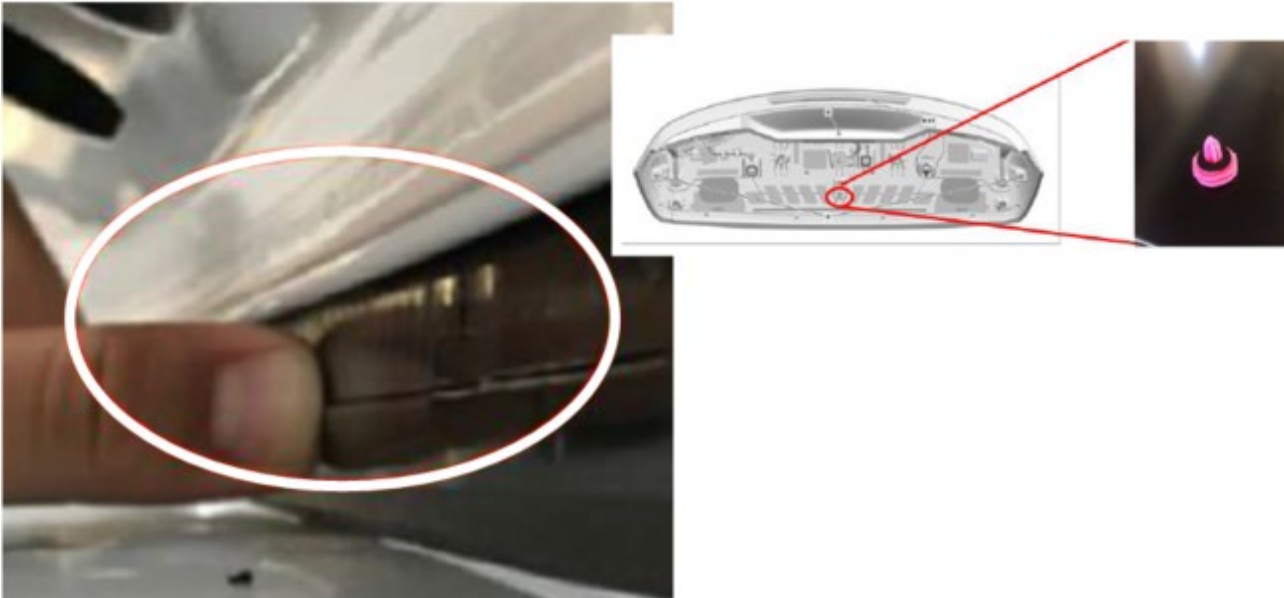
Figure 9

7. Check whether the retaining clip in the center of the center rear spoiler is engaged.

i To do so, fully open the tailgate and then lower it by **approx. 25 cm**. The test is meaningful only in this position.

i While the tailgate is open, press against the center rear spoiler from the inside with your thumbs (force applied: approx. 10 lbs.).

i If the center rear spoiler can easily be pressed against the roof edge the center retaining clip is not engaged and possibly damaged.

1. Remove center rear spoiler and replace all retaining clips, screws, and adhesive strips.
 - i** For basic data, see **AR72.20-P-4000MFD**.
 - i** Check whether the retaining clips of the center rear spoiler are engaged correctly after the repair.
-
