April 2021  
FL860AB  
NHTSA #20V-527  
Transport Canada #2020-408  
REVISED NOTICE

## **Subject: Freightliner Engine Harness Clearance**

**Models Affected: Specific Model Year 2018-2021 Freightliner 108SD, 114SD, and Business Class M2 vehicles manufactured May 24, 2017, through August 26, 2020, and equipped with a Detroit Diesel DD8 engine.**

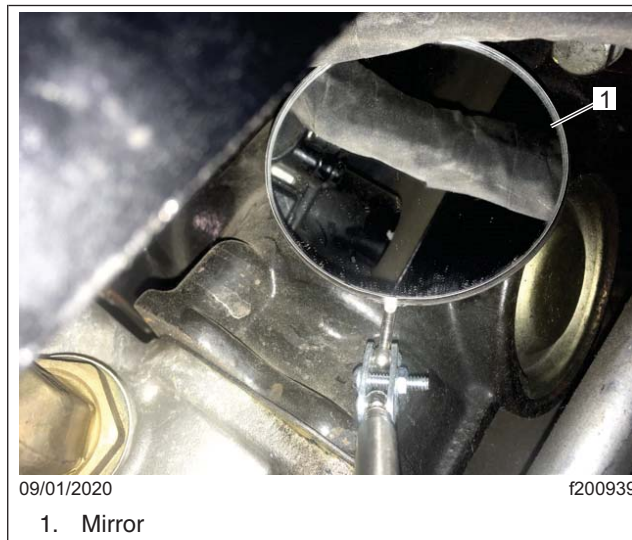
**Fig. 3, Inspection by Mirror**

NOTE: Wiring harnesses are considered damaged when chaffing has worn through the fiber wrap and wire insulation to expose strands of wire copper.

8. If necessary to access the engine harness for inspection, remove the transmission dipstick tube brackets, fuel line brackets, and clipping points for the airline bundle.
9. Inspect the engine harness for damage at the key chaffing points. Pull the harness away from the brackets to make a complete inspection, using a mirror as needed. See [Fig. 3](#).

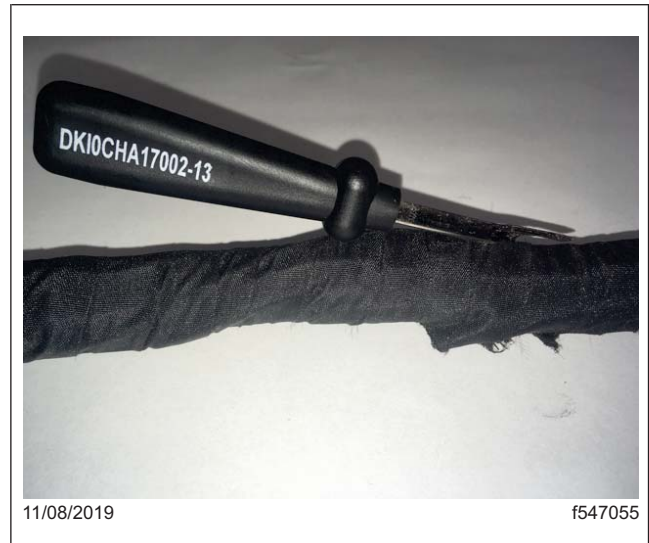
**Fig. 5, Cutting the Fiber Wrap Using the Blunt End of the Seam Ripper**

- If five or fewer wires (approximately 30% or less) in the harness are damaged, the harness can be repaired.
- If more than five wires in the harness are damaged, the harness must be replaced.

10. If damage to the wiring is found, cut and unwrap the harness wrap in the damaged area to determine the extent of damage. See [Fig. 5](#).

- 11.1 Locate the damaged area and carefully cut open the fiber wrap using a sewing seam ripper tool. See [Fig. 4](#).
- 11.2 Flip the seam ripper tool over so that the blunt end is facing the wiring, then cut enough length to allow the fiber wrap to be unwrapped. See [Fig. 5](#).

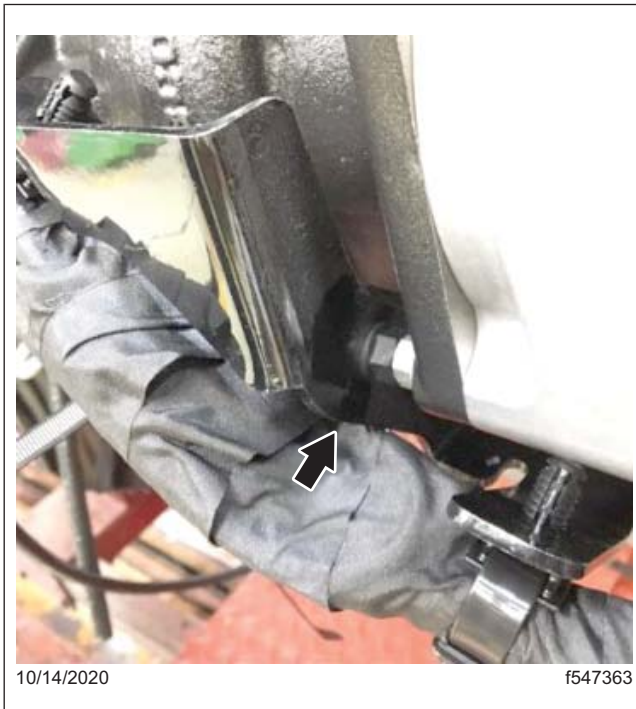
On affected vehicles, DD8 engine harnesses are chafing against several locations: at and around the air compressor, the edges of the engine harness bracket, and at the engine power steering pump and frame rail. This chafing results in circuits shorting out. Depending on which wires are chafed, the symptoms can include: dash lights flashing, gauges dropping in and out, and/or sweeping intermittently, the check engine light coming on, loss of power, transmission shifting issues, and engine shutdown/stall with no restart.

**Fig. 13, Current Air Compressor Mounted Bracket Showing Area of Possible Harness Rub**

1. Replace the existing air compressor-mounted bracket (see [Fig. 13](#)) with the one supplied in the kit (part number 66-13326-000). See [Fig. 14](#).
  - 1.1 Remove the two fasteners securing the old bracket to the air compressor and remove the bracket.
  - 1.2 Install the new bracket (part number 66-13326-000) then torque the fasteners 27 to 32 lbf-ft (36 to 43 N-m).
