**SUBJECT: NEW VEHICLE DEMONSTRATION / DELIVERY HOLD  
Safety Recall 20S50**

Certain 2020 Model Year Explorer Vehicles  
Second Row Center Seat Belt Buckle Bolt Not Properly Secured to Seat

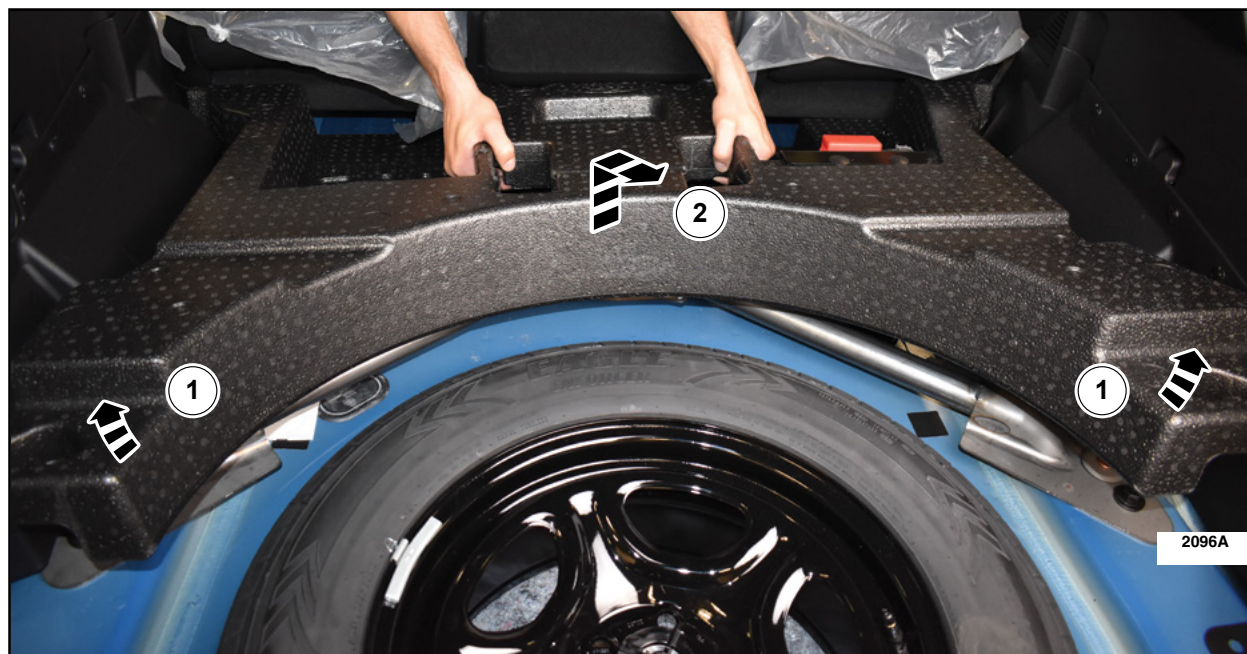
FIGURE 1

**NOTE:** To aid in the removal and prevention of damage of the loadspace floor rear trim panel, use the lifting locations shown. See Figure 1.

1. Using the lifting locations shown, raise the two ends of the loadspace floor rear trim panel.
2. Using the lifting locations shown, lift upwards and towards the rear of the vehicle to remove the loadspace floor rear trim panel.

**NOTE:** To aid in the installation and prevention of damage of the loadspace floor rear trim panel, reverse the removal procedure. See Figure 1.
