FL863AB

Creation Date:	June 2022
Revised Date:	July 2025
NHTSA #	20V-567
Transport Canada #	2020-444

Subject: Freightliner Cascadia Brake Light Illumination

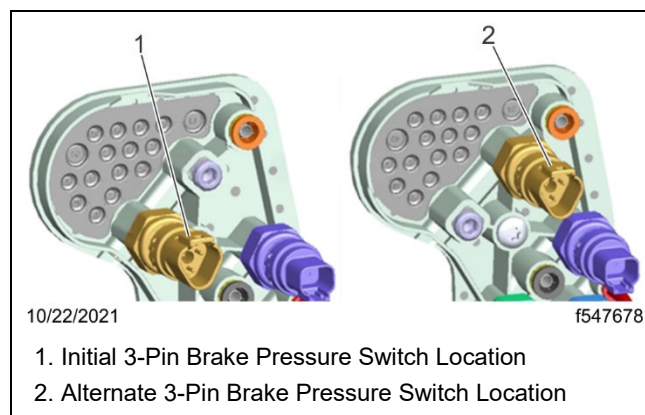
Fig. 1, Possible 3-Pin Brake Light Pressure Switch Locations

NOTE: Depending on the vehicle build date, the 3-pin brake light pressure switch may be in one of the two locations on the pass-through switch manifold. See [Fig. 1](#).

4. Disconnect and remove the 3-pin brake light pressure switch.

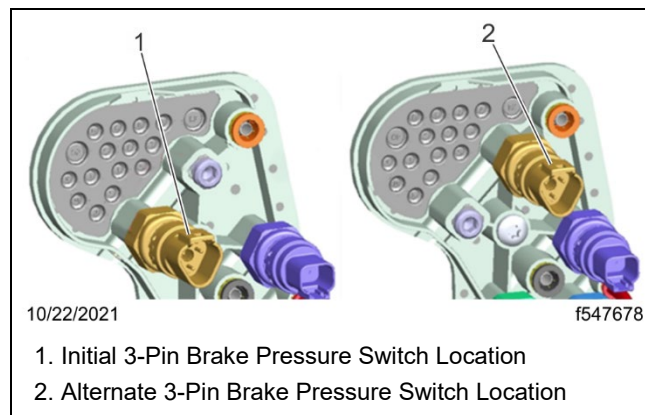
Fig. 8, Possible 3-Pin Brake Light Pressure Switch Locations

NOTE: Depending on the vehicle build date, the 3-pin brake light pressure switch may be in one of the two locations on the pass-through manifold switch. See [Fig. 8](#).

4. Disconnect and remove the 3-pin brake light pressure switch.
