November 2021
FL863A (Final)
INT FL863-01 (Interim)
NHTSA #20V-567
Transport Canada #2020-444

Subject: Freightliner Cascadia Brake Light Illumination

Models Affected: Specific model year 2017-2021 Freightliner Cascadia vehicles manufactured March 8, 2016, through January 3, 2020, and equipped with a certain brake light pressure switch.

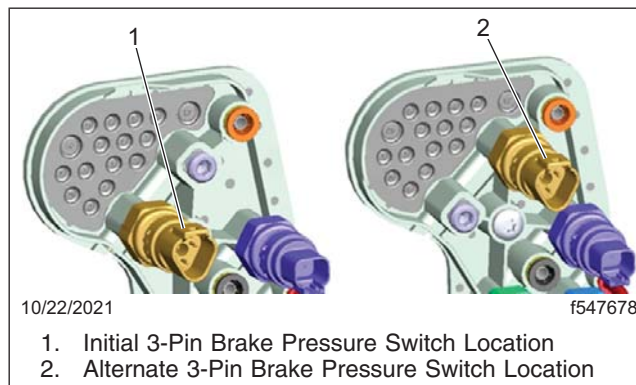
Fig. 1, Possible 3-Pin Brake Light Pressure Switch Locations

NOTE: Depending on the vehicle build date, the 3-pin brake light pressure switch may be in one of two locations on the pass-through switch manifold. See [Fig. 1](#).

4. Disconnect and remove the 3-pin brake light pressure switch.
