November 2021
FL863A (Final)
INT FL863-01 (Interim)
NHTSA #20V-567
Transport Canada #2020-444
REVISED NOTICE

Subject: Freightliner Cascadia Brake Light Illumination

Models Affected: Specific model year 2017-2021 Freightliner Cascadia vehicles manufactured March 8, 2016, through January 3, 2020, and equipped with a certain brake light pressure switch.

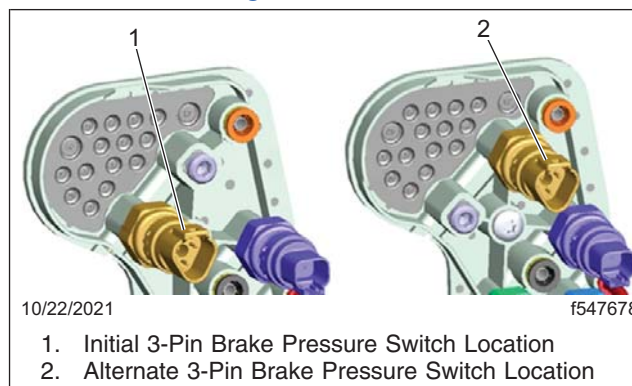
Fig. 1, Possible 3-Pin Brake Light Pressure Switch Locations

NOTE: Depending on the vehicle build date, the 3-pin brake light pressure switch may be in one of two locations on the pass-through manifold switch. See [Fig. 1](#).

IMPORTANT: Excess side loading or side twisting of brake light pressure switch during removal can result in damage to the pass-through manifold switch. Select a tool that will minimize side loading or side twisting such as sensor socket P/N DDE DSN012T20007 (preferred), or "crows foot" wrench, or "stubby" wrench.
