RE: **Recall Campaign Launch Notification**
Relocate Grounding for the Illuminated Star
MY20 167 (GLE-Class, GLS-Class)

Campaign No. 2020100016, November 2020
Revision A

SUBJECT: **Model GLE-Class and GLS-Class vehicles (167 platform)**
Model Year 2020
Installation of the Illuminate Star

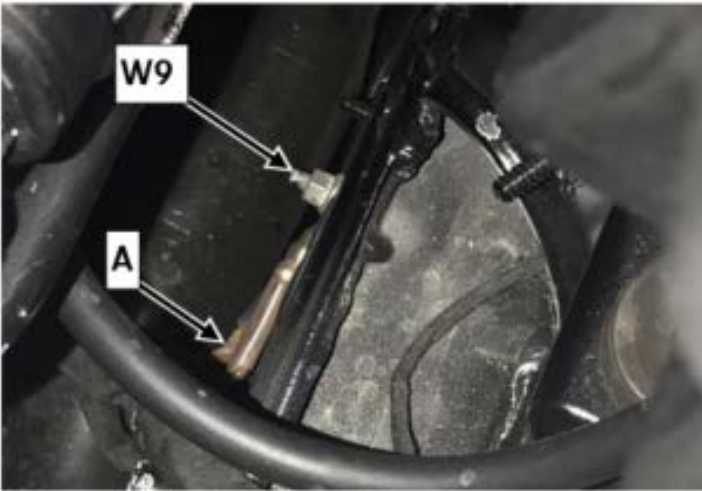
Figure 1

1. Open hood.
2. Switch off ignition and store transmitter key outside the transmitter range (at least 2 meters).
3. Unscrew ground **point W9**.
i For basic data, see **GF00.19-P-2001-17NCA**.
4. Remove illuminated star ground line (**A**, figure 1).

- Check ground line clearance.
- Ground line may be zip tied to shorten original length.
- Check behind the illuminated star for any possible zip ties around the ground wire.
- Zip ties may be removed for extra length if needed.

6. Route illuminated star ground line (**A, figure 1**) to jump-start connection point and attach to threaded pin of jump-start connection point.
7. Screw on brass sleeve (**B, figure 2**).
Hm Brass sleeve 16 Nm.
8. Secure illuminated star ground line (**A, figure 1**) up to jump-start connection point.
i Ensure a chafe-free routing and attachment of the illuminated star ground line. See **AZ88.40-P-0011-01ME**
9. Check anti-twist protection (**C, figure 3**) of cable lug of ground **point W9** for damage.

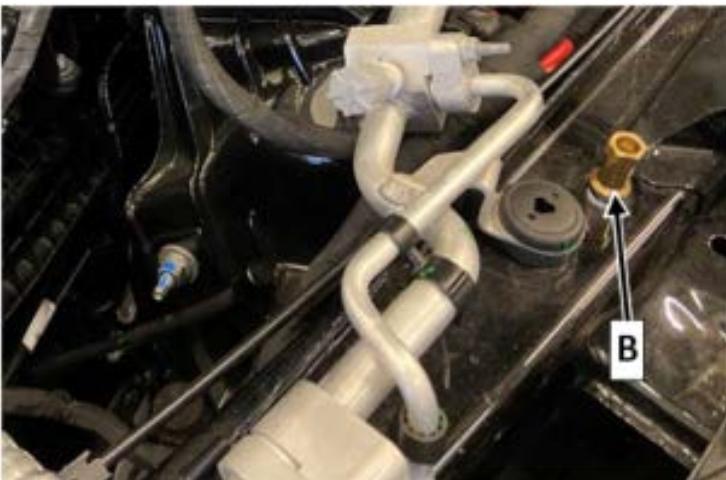
Figure 2

5. Unscrew brass sleeve (**B**, figure 2) at jump-start connection point.

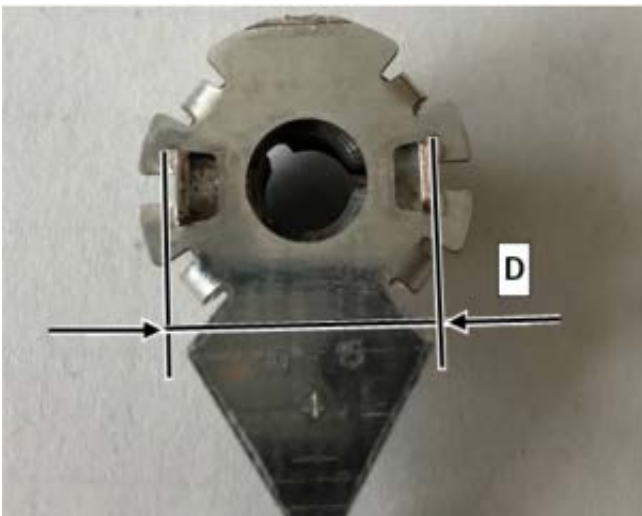
Figure 4

10. Measure outside dimension between anti-twist protection lugs (**D, figure 4**).
i Outside dimension between anti-twist protection lugs (**D, figure 4**) min. 13.6 mm.

- a. Anti-twist protection (**C, figure 3**) **straight** or **bent outwards**, i.e. outside dimension between anti-twist protection lugs (**D, figure 4**) **equal to or greater than 13.6 mm**: Perform operation step 11, then **end measure**.
- b. Anti-twist protection (**C, figure 3**) **bent inwards**, i.e. outside dimension between anti-twist protection lugs (**D, figure 4**) **less than 13.6 mm**: Create **PTSS case**.
