RE: **Recall Campaign Launch Notification**  
**Relocate Grounding for the Illuminated Star**  
**MY20 167 (GLE-Class, GLS-Class)**

<b>Campaign No. :</b>	<b>NHTSA ID</b>	<b>Campaign Desc. :</b>	<b>Relocate Grounding for the Illuminated Star</b>
2020100015	20V626	20P8292801	
2020100016		20P8292802

Campaign No. 2020100016, November 2020

SUBJECT: **Model GLE-Class and GLS-Class vehicles (167 platform)**  
**Model Year 2020**  
**Installation of the Illuminate Star**

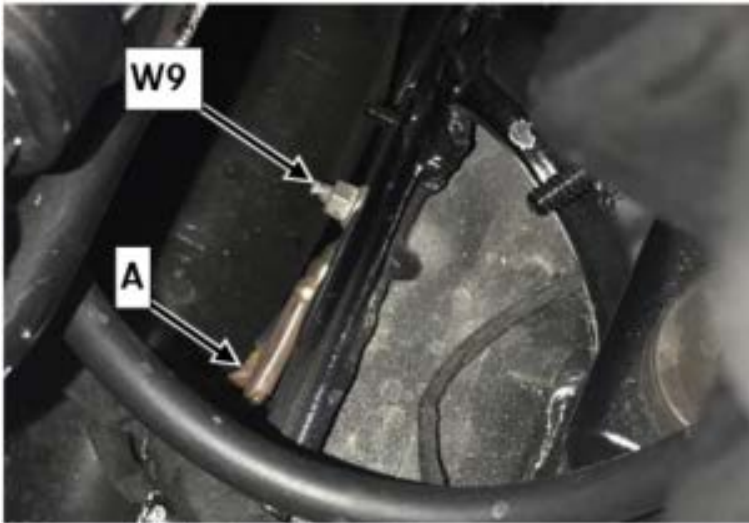
**Figure 1**

Mercedes-Benz AG ("MBAG"), the manufacturer of Mercedes-Benz vehicles, has determined that certain Model Year ("MY") 2020 GLE-Class and GLS-Class vehicles (167 platform) that are fitted with the optional illuminated Mercedes-Benz star in the front grill may have the electrical grounding installed outside specifications. In this case, the function of other components that share the same ground connection might be impaired. Depending on the individual ground point used for the illuminated star logo, either the power steering control unit, or the left headlamp, and/or the wiper motor might malfunction. This could increase the risk of a crash. A deactivation of the power steering assist as well as the deactivation of the left headlamp and the wiper motor would be indicated by an acoustic warning, as well as by a visual warning message in the instrument cluster.

1. Open hood.
2. Switch off ignition and store transmitter key outside the transmitter range (at least 2 meters).
3. Unscrew ground **point W9**.  
**i** For basic data, see **GF00.19-P-2001-17NCA**.
4. Remove illuminated star ground line (**A, figure 1**).

6. Route illuminated star ground line (**A, figure 1**) to jump-start connection point and attach to threaded pin of jump-start connection point.
7. Screw on brass sleeve (**B, figure 2**).  
Nm Brass sleeve **16 Nm**.
8. Secure illuminated star ground line (**A, figure 1**) up to jump-start connection point.  
i Ensure a chafe-free routing and attachment of the illuminated star ground line. See **AZ88.40-P-0011-01ME**
9. Check anti-twist protection (**C, figure 3**) of cable lug of ground **point W9** for damage.

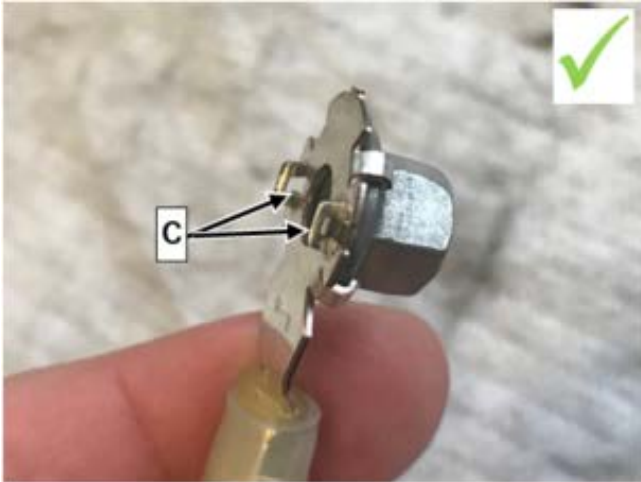
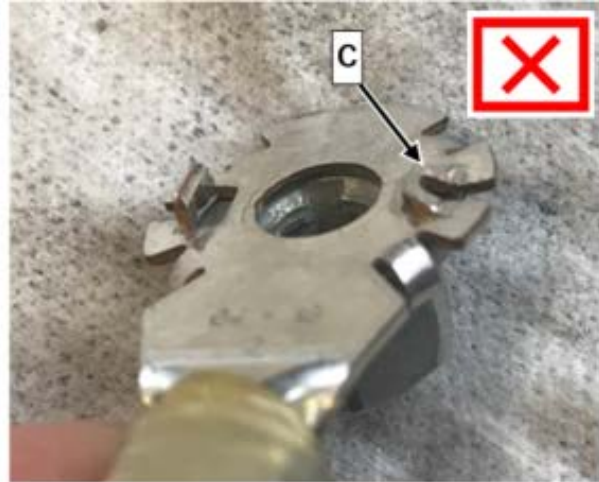
Figure 3 (OK)

(not OK)

- a. Anti-twist protection (**C, figure 3**) **straight** or **bent outwards**, i.e. outside dimension between anti-twist protection lugs (**D, figure 4**) **equal to or greater than 13.6 mm**: Perform operation step 11, then **end measure**.
- b. Anti-twist protection (**C, figure 3**) **bent inwards**, i.e. outside dimension between anti-twist protection lugs (**D, figure 4**) **less than 13.6 mm**: Create **PTSS case**.

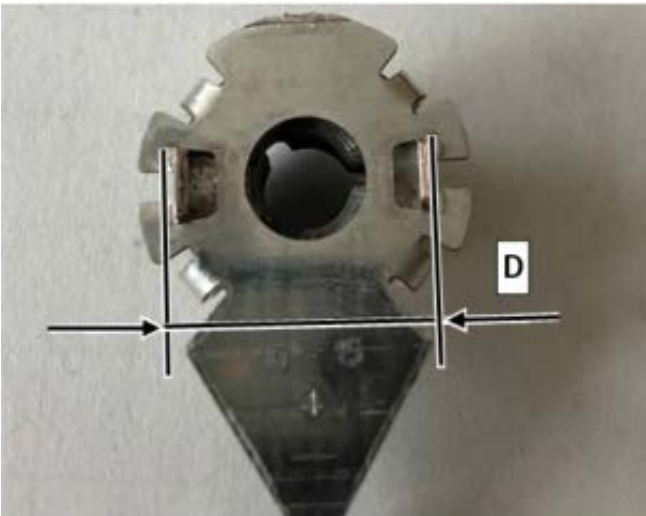
Figure 4

**i** Only if anti-twist protection of cable lug is **bent inwards** , i.e. outside dimension between anti-twist protection lugs (**D, figure 4**) is **less than 13.6 mm**.

10. Measure outside dimension between anti-twist protection lugs (**D, figure 4**).  
i Outside dimension between anti-twist protection lugs (**D, figure 4**) **min. 13.6 mm**.

Make detailed photos of anti-twist protection of ground line, ground point W9 in removed condition. Clarify the further repair procedure via a **PTSS case**. Keep faulty part.
