December 2020
FL867A
NHTSA #20V-686

Subject: Freightliner Econic SD Battery Cables and Ground Ring Terminal

Models Affected: Specific Model Year 2019-2021 Freightliner Econic SD model vehicles, manufactured June 24, 2019, through October 29, 2020.

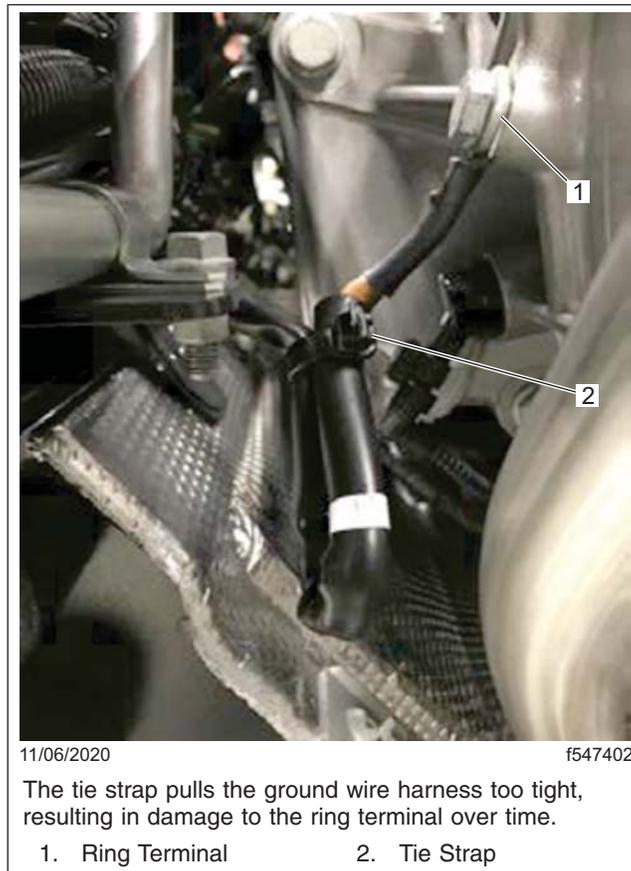
Fig. 1, Ground Harness, Incorrect Installation

The tie strap may pull the ground wire harness too tight, resulting in damage to the ring terminal over time. See [Fig. 1](#).

2. Park the vehicle on a level surface, shut down the engine, and set the parking brake. Chock the tires.
3. Remove the ring terminal from the negative post and the ground wires.

4. Remove any rubber sleeves from the ground wires, even if undamaged.
5. Clean the ground wires and components, as needed, to remove any dust or debris.

6. Slide a new piece of heat shrink tubing (sleeve) on the ground wires (to be heat shrunk in place after the new ring terminal is soldered).
7. Install a new ring terminal on the ground wires.

8. Solder the two ground wires to the ring terminal.
9. Apply heat to the shrink tubing, sealing it around the ground wires to prevent corrosion.
10. Install the ring terminal on the negative post; torque the M10 nuts to 13.28 lbf-ft (18 N·m).

IMPORTANT: Ensure that the ground wires have enough slack to compensate for engine movement and vibration.

11. Use a tie strap to attach the ground wires to the wiring harness convoluted tubing. See [Fig. 6](#).

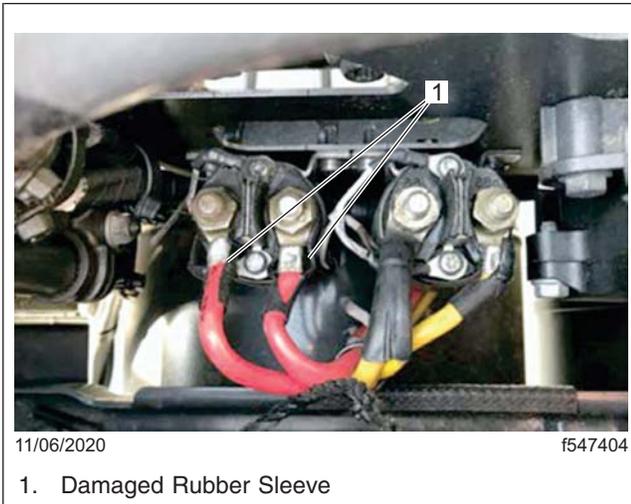
Fig. 2, Damaged Sleeve at the Relays

Rubber sleeves on the two relays behind the battery box and at the main battery switch may be damaged due to a combination of the coated corrosion protection wax and high temperatures required during the paint finishing process. See [Fig. 2](#) and [Fig. 3](#).

1. Remove the left battery from the battery box.
2. Remove the red and yellow cables from the relays in the back of the battery box.
3. Remove any rubber sleeves from the cables, even if undamaged.
4. Clean the cables and components, as needed, to remove any dust or debris.
5. Apply heat shrink tubing (sleeve) around the cables and terminals and heat-seal them.
6. Install the cables on the relays. Align all ring terminals so that the positive and negative cables do not cross and are not tied together. See [Fig. 7](#).

Torque the M8 nuts on the red and yellow cables to 8.12 lbf-ft (11 N·m).

If loosened to reposition the brown ground wires, torque the M6 screws to 3.1 lbf-ft (4.2 N·m).

7. Apply corrosion protection wax to the relay threaded studs.

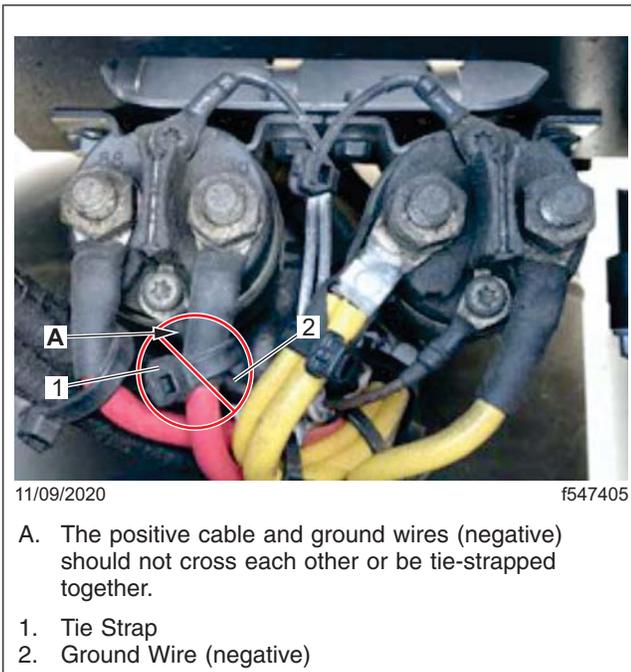
Fig. 4, Positive and Negative Cables Incorrectly Tie-Strapped Together

The positive cables may be tie-strapped to the thin negative ground wires of the relays. See [Fig. 4](#).

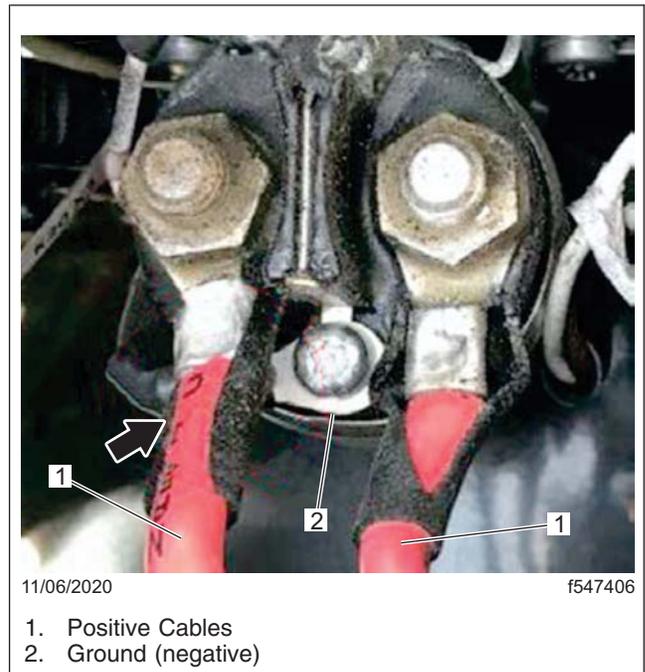
Fig. 5, Positive and Negative Cables Cross

The positive and negative cables may cross. See [Fig. 5](#).
