**SUBJECT: Safety Recall 20S63 – Supplement #1**  
 Certain Front Wheel Drive 2014-2015 Model Year Taurus, 2014-2016 Model Year Explorer, and 2014 Model Year Edge Vehicles Equipped with a 2.0L or 2.3L Engine Front Halfshaft Bracket Replacement

**Safety Recall 20S63 – Supplement #1**

## CERTAIN FRONT WHEEL DRIVE 2014-2015 MODEL YEAR TAURUS, 2014-2016 MODEL YEAR EXPLORER, AND 2014 MODEL YEAR EDGE VEHICLES EQUIPPED WITH A 2.0L OR 2.3L ENGINE — FRONT HALF SHAFT BRACKET REPLACEMENT

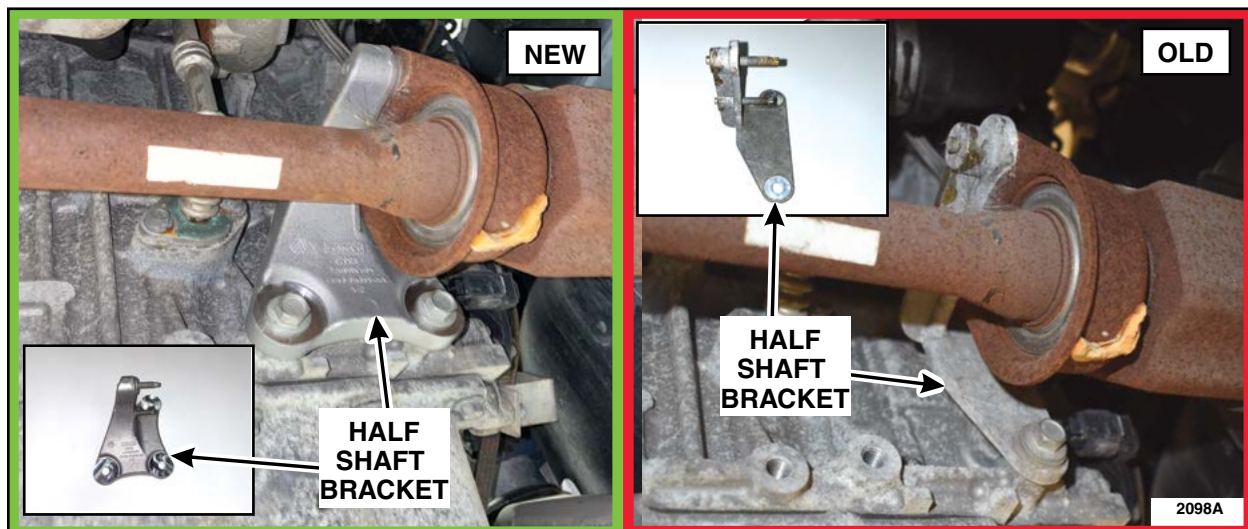
FIGURE 1

**NEW !** 2. *Inspect the Right Hand (RH) side half shaft bracket. Is the new style bracket already installed? The new bracket will have three mounting bolts, the old style bracket will have two. See Figure 1.*

**NOTE:** To see the old and *new* half shaft bracket. See Figure 1.

8. Install two (2) *new* half shaft bearing studs into the *new* bracket.

9. Install the *new* RH half shaft bearing bracket and three (3) bolts.
