Vehicle Report

NHTSA ID: 20V696 Transaction ID: 20-0010369-25253-10 (Original Report)

SAFETY NOTICE

SUBJECT: Rotation Bearing Bolts

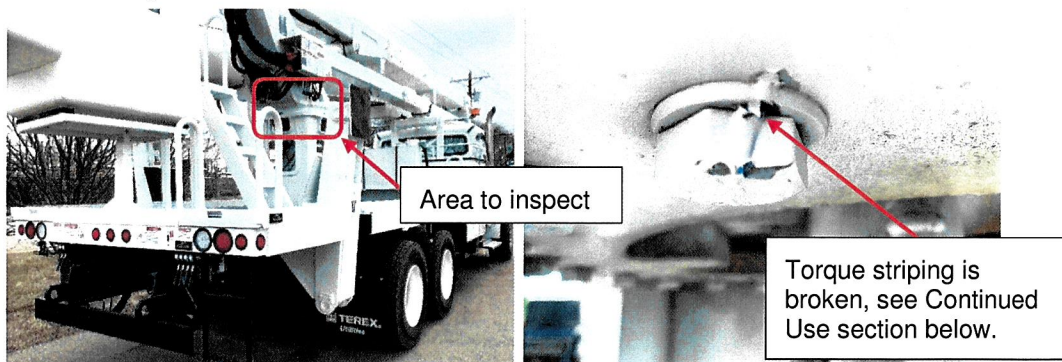
Figure 1. Area of unit to inspect rotation bearing bolts

Terex Transmission TL models TL80 & TL100 aerial devices, produced from April 2019 through August 2020, may have rotation bearing bolts that will loosen. The loosening of the bearing bolts may cause the bearing bolts to fail. **Failure of the rotation bearing bolts could cause the boom to fall which could result in injury or death.**

1. Immediately inform all users, operators, and supervisors that the rotation bearing bolts must be inspected daily before use.
2. Inspect to determine if it has loose rotation bearing bolts using the following figures as reference. All rotation bearing bolts must be inspected; both the rotation bearing bolts connecting the rotation bearing to the pedestal and the rotation bearing bolts connecting the rotation bearing to the turntable need to be inspected. The rotation bearing bolt inspection only applies to units without a hydraulic lift.

- a. The inspection involves a torque check on all rotation bearing bolts using a calibrated torque wrench. The torque required for the rotation bearing bolts on the TL80 & TL100 is 350 ft-lbs.
- b. Any loose bearing bolts are to be retorqued to 350 ft-lbs using a calibrated torque wrench. For this issue, any loose bolts can be retorqued without replacement. Any

- missing bearing bolts and/or washers are to be replaced with new hardware using the parts section of the manual to determine the correct bolt and/or washer part numbers.
- c. After the rotation bearing bolts are retorqued, apply torque striping across the bolt head and washer to the bolting plate to aid in daily visual inspections.
3. After retorquing all rotation bearing bolts, the unit can be used following the instructions in the continued use section below as well as all operator, maintenance, and inspection requirements as specified in the manuals.

1. Inspect the rotation bearing bolt torque stripe daily before use until Field Service Kit Z1604 is installed, using the above picture as reference.
 - a. If the torque stripe is intact and/or the washers do not move on all rotation bearing bolts machine use can continue until Field Service Kit Z1604 is installed, following all operator, maintenance, and inspection requirements as specified in the manuals and this bulletin.

- b. If the torque stripe is broken or the washer is loose on any of the rotation bearing bolts, retorque the bolt to 350 ft-lbs with a calibrated torque wrench. After retorquing any required bolts, machine use can continue following the daily visual inspection and retorquing as needed until Field Service Kit Z1604 is installed.
