Subject: TM2020 LuK Clutch Disc Replacement

Models Affected: TM 2020 C Model Transmissions equipped with LuK Brand Clutch

Daimler Trucks North America LLC, on behalf of its DETROIT™ Powertrain Division, is initiating Recall Campaign D21R3 to replace the LuK Clutch Disk in certain TM2020 models.

February 2021
FL869 (D21R3)
NHTSA #20V-742

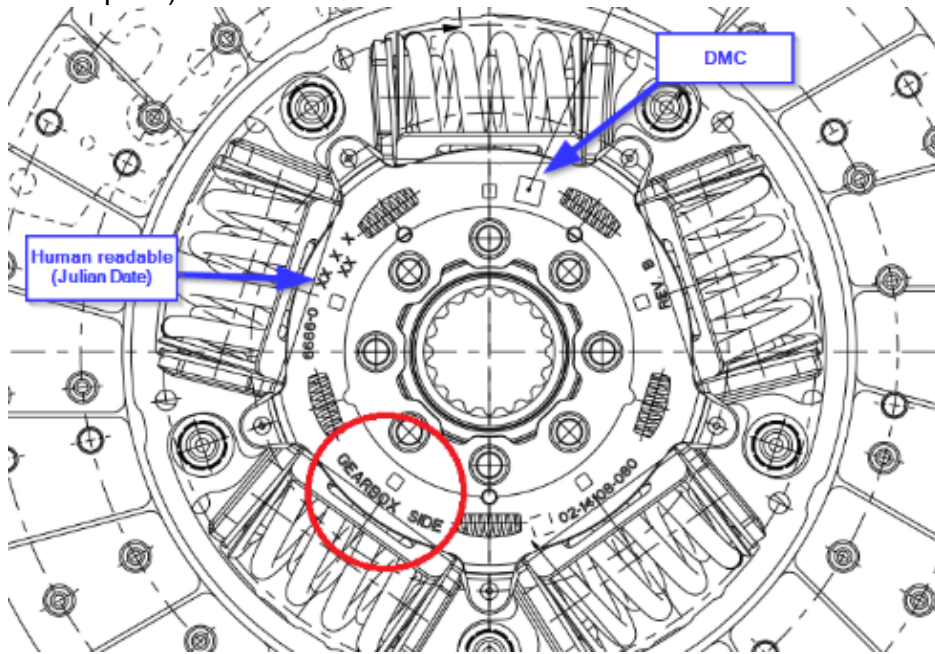
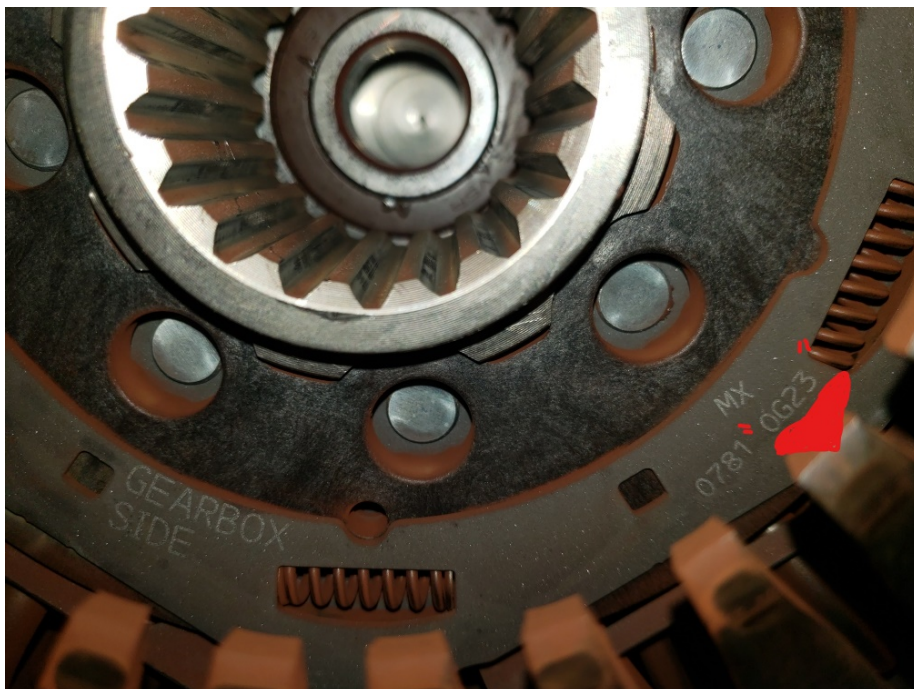
18. With the pressure plate installed, find the date code etched in the hub of the disk, in the location shown below (between the "GEARBOX SIDE" text, and Data Matrix Code (DMC), on the center plate).

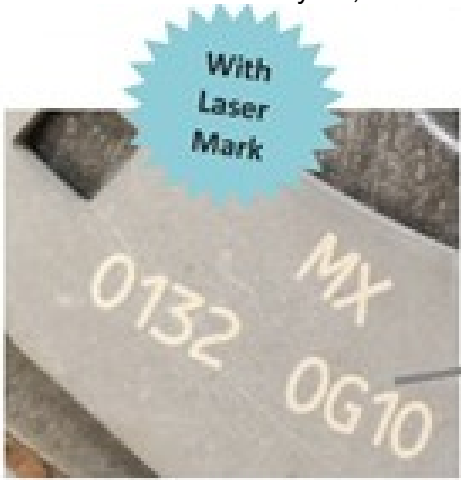
19. Determine if clutch is in, or out of the affected population, by comparing the code elements in the table below to the date code on the disk.

Element	Character	Range	Example
Year Code	1 st	0 (2020)	0G10 – Build date is July 10, 2020
Month Code	2 nd	G (Jul) and H (Aug)

Day of the Month	3 rd and 4 th	08 through 31 and 01 through 15

20. If the clutch has a build date between and including 0G08 through 0H15, continue with the Clutch Removal steps. If the build date is before, or after the affected range, continue with the Transmission Installation steps.
