FL869 (D21R3) REV1

NHTSA #20V-742

Subject: LuK Clutch Disc Replacement

Models Affected: DT12 Transmissions equipped with LuK Brand Clutch

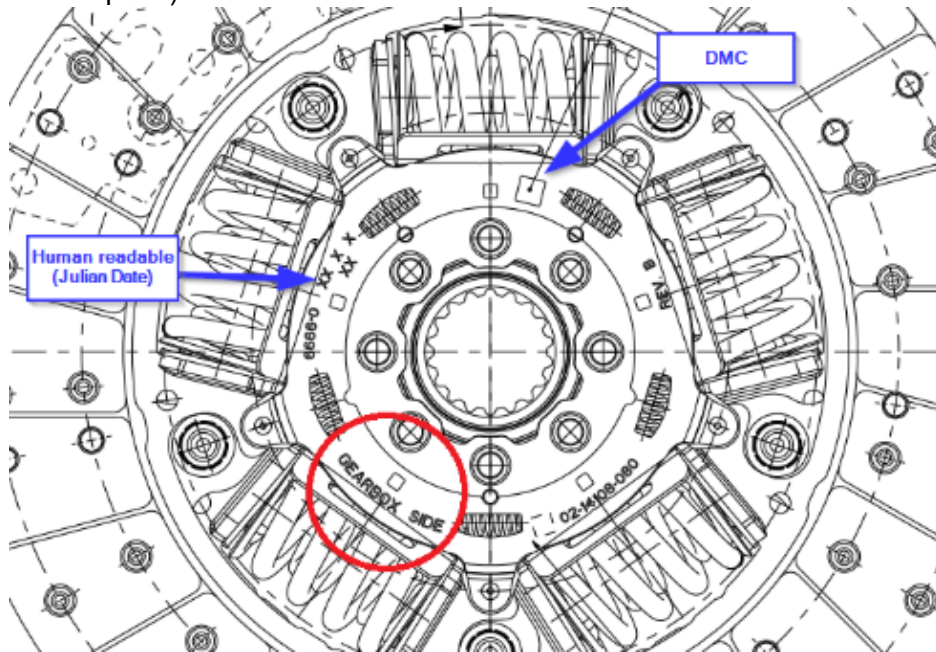
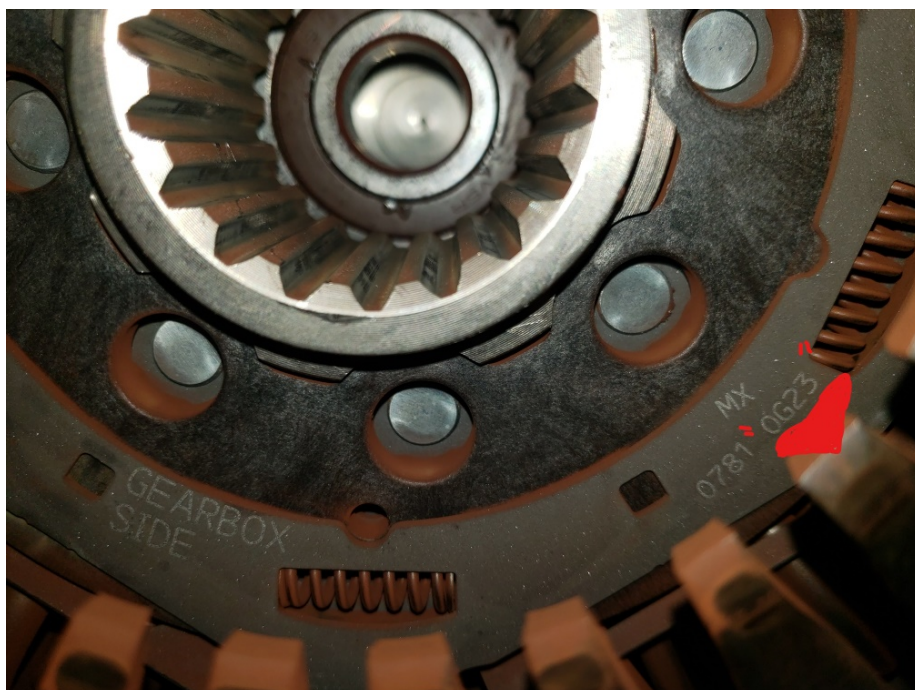
18. With the pressure plate installed, find the date code etched in the hub of the disk, in the location shown below (between the "GEARBOX SIDE" text, and Data Matrix Code (DMC), on the center plate).

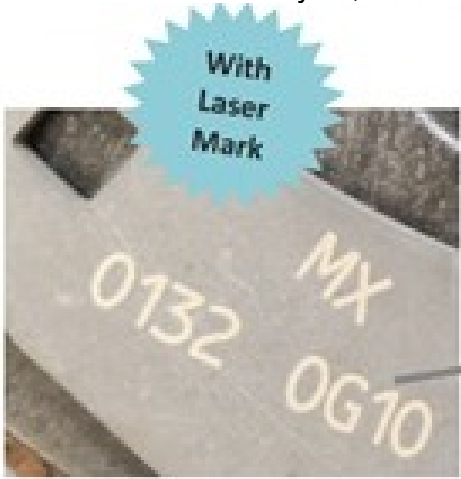
Element	Character	Range	Example
Year Code	1 st	0 (2020)	0G10 – Build date is July 10, 2020
Month Code	2 nd	G (Jul) and H (Aug)

Day of the Month	3 rd and 4 th	08 through 31 and 01 through 15

20. If the clutch has a build date between and including 0G08 through 0H15, continue with the Clutch Removal steps. If the build date is before, or after the affected range, continue with the Transmission Installation steps.
