Volvo Trucks **Uptime**

То:	Dealer Principals Service Managers Warranty Managers Parts Managers	Region:	⊠U.S. ⊠CAN	Bulletin: SRA-V20-06 Date: December 17, 2020 Valid to: N/A Action Required? ⊠Yes ⊟No
From: Subject:	Gerard Hones, Regulatory Specialist Government Reporting Safety Recall RVXX2006, Norgren Collet Inspection/Replacement

Subject: Safety Recall RVXX2006, Norgren Collet Inspection/Replacement

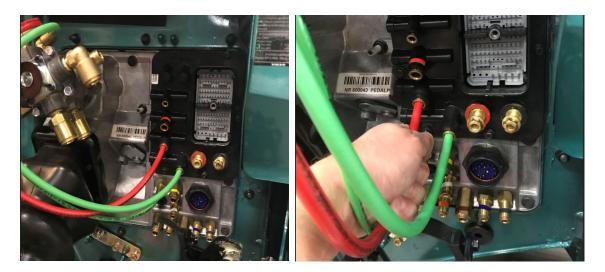
- 2. Open hood.
- 3. On each air hose at the pass through connection, one at a time, push in twice, and then pull out firmly.

- 4. If no fault found, exterior inspection is complete. If any hose comes free or is loose, proceed with replacement of affected collet(s) on page 9.
- 5. Close hood, and proceed to next step.
