SUBJECT: NEW VEHICLE DEMONSTRATION / DELIVERY HOLD – *Supplement #2*
Safety Recall 20S73

Certain 2021 Model Year Econoline Equipped with 7.3L Engine
Engine Cover Thermal Management

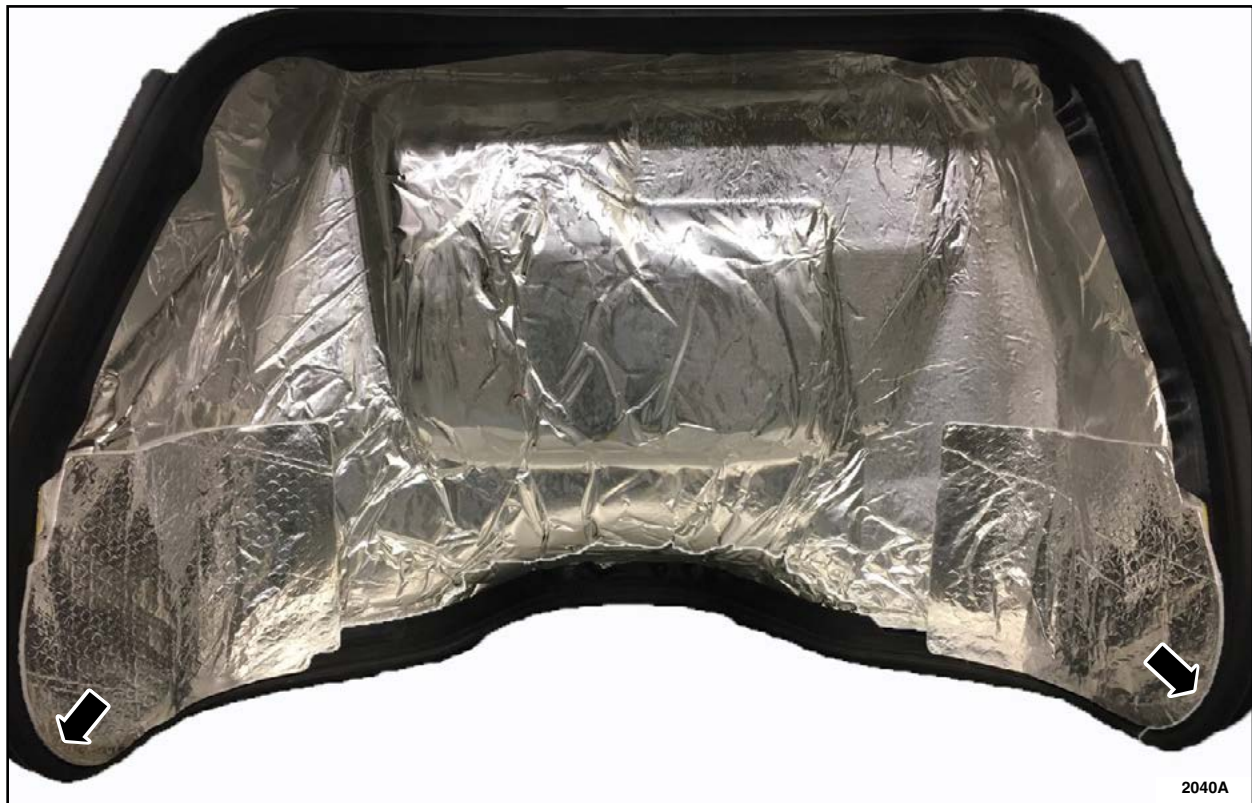
FIGURE 1

1. Reprogram the Powertrain Control Module (PCM) with the latest calibration. Please follow the Module Reprogramming on Page 5. Then, proceed to Step 2, if a Cutaway Chassis.
2. Remove the engine cover. Please follow the Workshop Manual (WSM) procedures in Section 501-05.
3. Inspect the thermal cover positioning on the interior of the engine cover, on the right and left side lower corners, as shown in Figure 1.

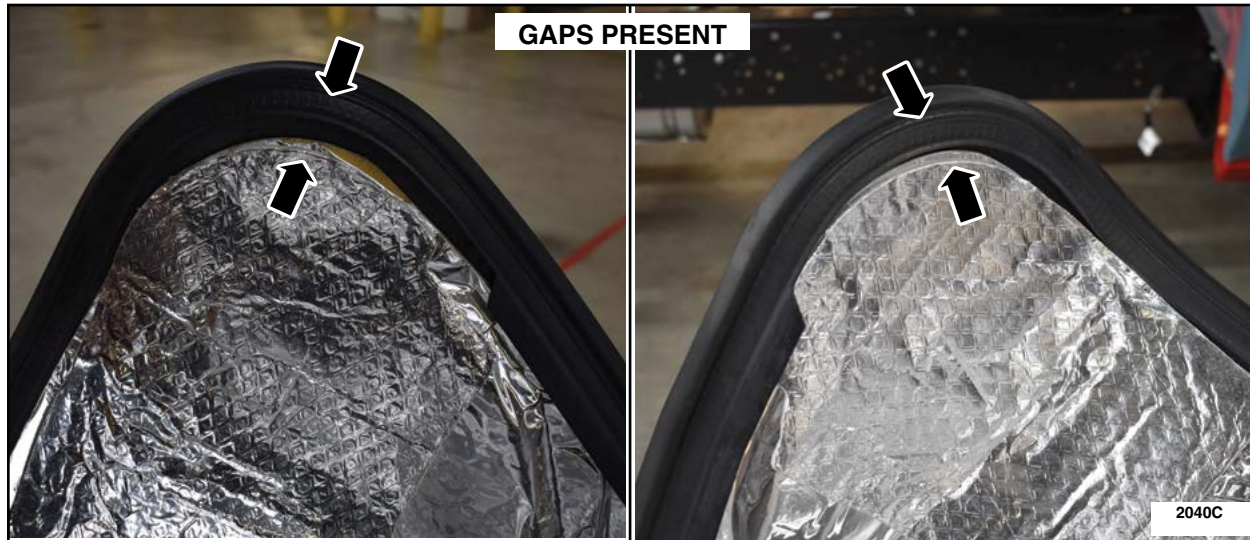
FIGURE 2

4. Are there any gaps present between the thermal shield and the engine covers weatherstrip on either side of the engine cover as shown in Figure 2?

YES - Proceed to the Thermal Patch Kit Installation Procedure.
NO - No further action is required.

NEW ! **NOTE:** *Thermal patch only needs to be installed on the side that has a gap present.* The shorter thermal patch is installed on the driver side of the engine cover and the larger thermal patch is installed on the passenger side of the engine cover. The patches will match what is currently in place on the engine cover but will be placed on top to cover gaps present.
