February 11, 2021

**SUBJECT: NEW VEHICLE DEMONSTRATION / DELIVERY HOLD – *Supplement #1***  
**Safety Recall 20S73**

Certain 2021 Model Year Econoline Equipped with 7.3L Engine  
 Engine Cover Thermal Management

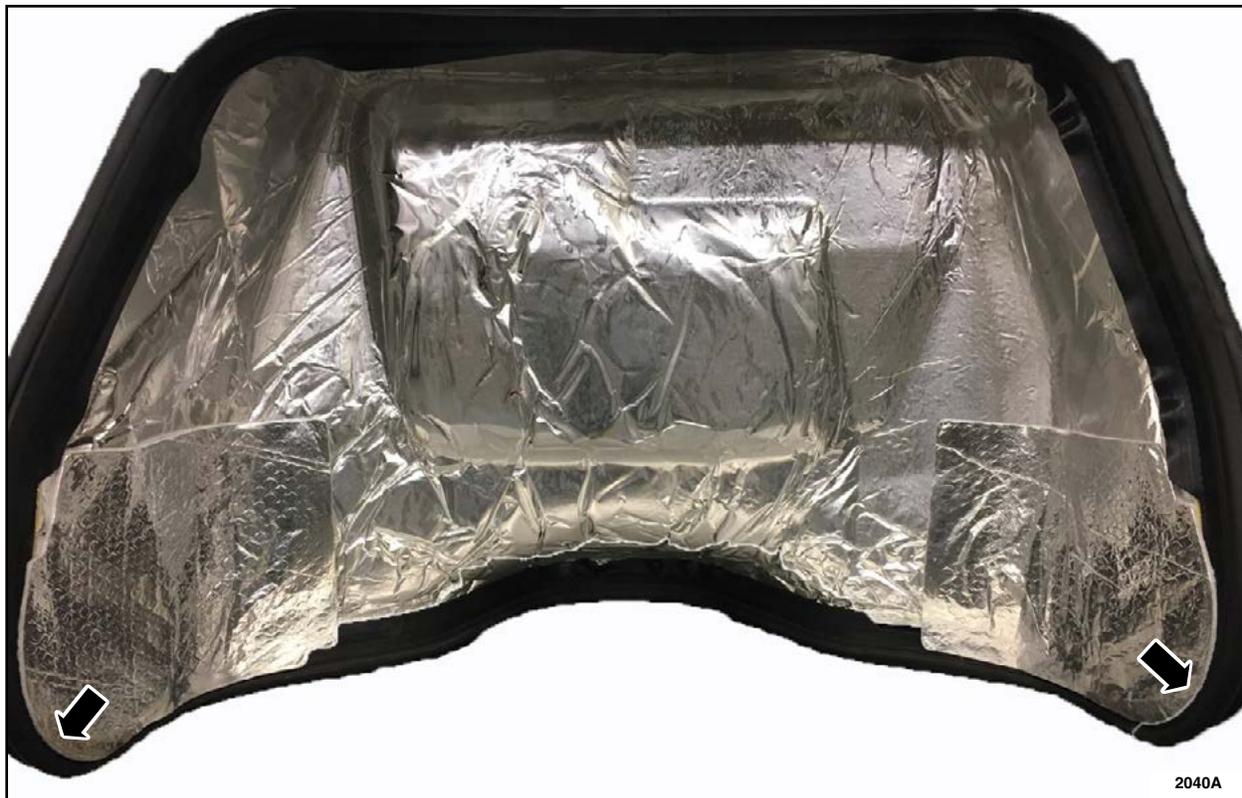
**FIGURE 1**

1. Reprogram the Powertrain Control Module (PCM) with the latest calibration. *Please follow the Module Reprogramming on Page 5. Then, proceed to Step 2, if a Cutaway Chassis.*
2. Remove the engine cover. Please follow the Workshop Manual (WSM) procedures in Section 501-05.
3. Inspect the thermal cover positioning on the interior of the engine cover, on the right and left side lower corners, as shown in Figure 1.

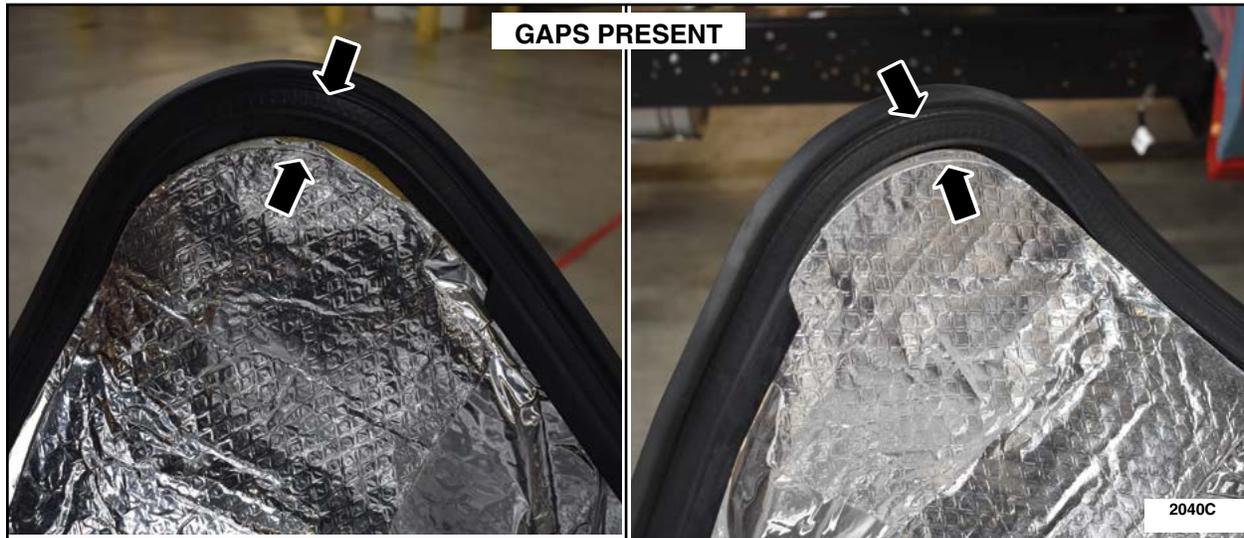
**FIGURE 2**

4. Are there any gaps present between the thermal shield and the engine covers weatherstrip on either side of the engine cover as shown in Figure 2?

YES - Proceed to the Thermal Patch Kit Installation Procedure.  
NO - No further action is required.
