# News Channel Update | Vans Customer Service and Parts

TO: Freightliner Principals, General Managers, Sales Managers, Service Managers, Parts Managers	FROM: Anthony Washington, Department Manager, Regulations and Certifications
Re: Recall Campaign Launch Notification Model 907 (Sprinter) Model Years 2020 Replace Rear Axle Brake Calipers	DATE: April 12, 2020

Campaign No. 2021030006, April 2021

**Electric Parking Brake Rear Brake Calipers**

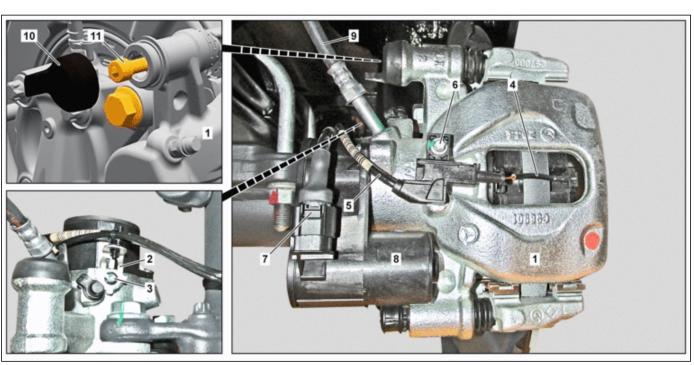
D42.10-A004-79

Mercedes-Benz AG ("MBAG"), the manufacturer of Freightliner vans, has determined that on certain Sprinter vehicles from platform 907 (VS30) equipped with an electrical parking brake(EPB), if the EPB is used frequently, then over time, the brake caliper of the rear axle may leak brake fluid into the housing of the electric parking brake that is connected to the rear axle service brake system. This could allow air to enter the hydraulic brake system which could lead to extended brake pedal travel and a changed brake pedal feel. If the condition is not addressed, the risk of a crash could increase. DVUSA is conducting a voluntary recall. An authorized Freightliner dealer will replace the rear brake calipers.

Replace both rear-axle brake calipers, along with actuator motors of electric parking brake.
