## **IMPORTANT SAFETY RECALL 20V-103**

**SN681**

**MODELS AFFECTED:** TM End Mount Aerial Devices

**SUBJECT:** Leveling Sensor Installation

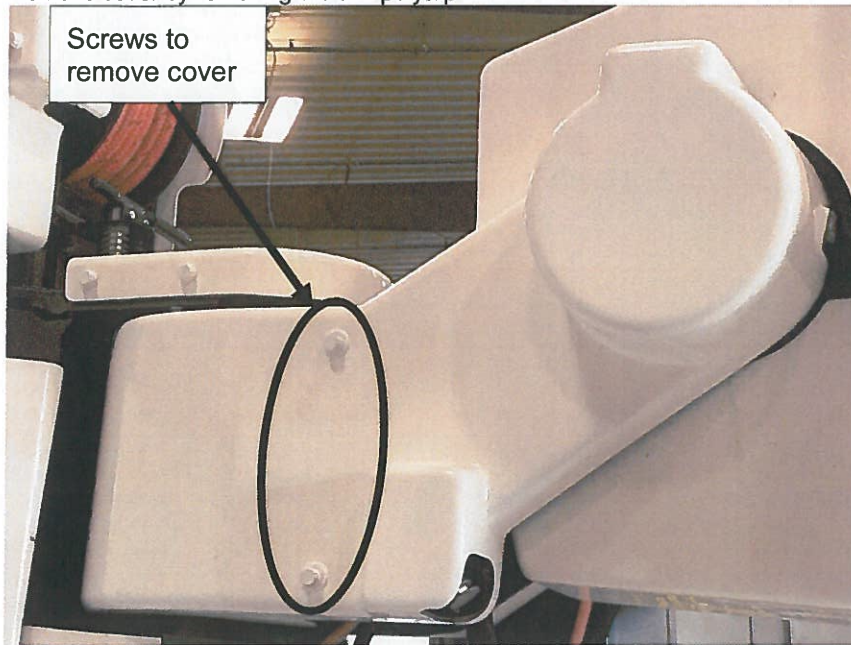
- a. Remove cover by removing the two polytop screws to access the basket level sensor.

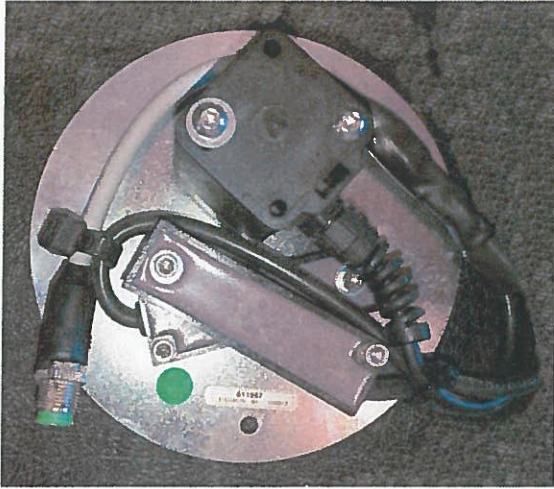
On Terex TM end mount aerial devices, manufactured from April 2014 through July 2019, one of the two basket level limit sensors at the boom tip may have been assembled upside down. The limit sensors prevent the platform from going more than 15 degrees from level if the electrical system malfunctions. The incorrect mounting of the level sensor may cause an out of level basket to continue moving more than 15 degrees out of level. **If the leveling system malfunctions it may cause the occupants to fall from the platform.**

This bulletin applies if the Light colored potting visible on both sensors

3. If your unit has both sensors mounted with the light colored potting visible, this bulletin applies. Correct following the instructions in Field Service Kit Z1562. Take a picture before correcting the issue and another picture after correcting the issue. Send both pictures with the completion form including the serial number and date of correction to [utilities.warranty@terex.com](mailto:utilities.warranty@terex.com).
4. If your unit has the light colored potting visible only on the top sensor, and the wires coming out of the sensors below the mounting screw this bulleting does not apply and use can continue without restriction.

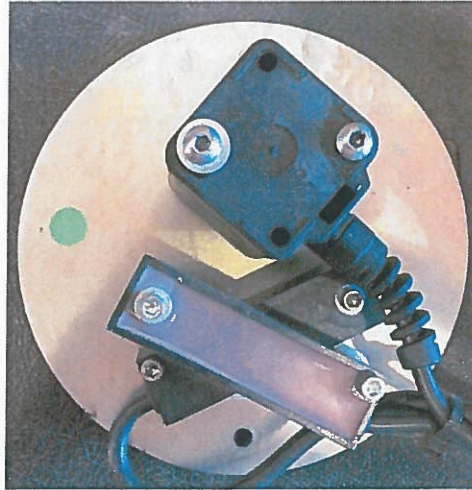
This bulletin does **NOT** apply if the Light colored potting visible on top sensor only
