Terex Utilities

SAFETY NOTICE

SN681A

SUBJECT: Leveling Sensor Installation

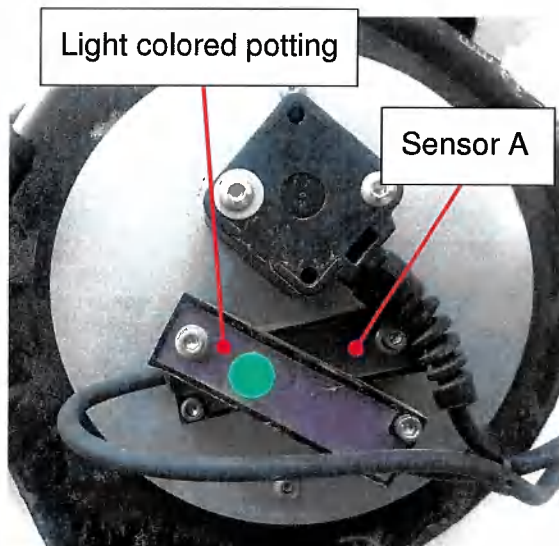
Figure 3A
This bulletin applies if the light colored potting visible on the top sensor, or sensor labeled A on the bottom

The unit noted above had the leveling sensors incorrectly mounted as shown in either Fig. 3A or 4A of the SN681A bulletin. The sensor position has been corrected by following the instructions provided in Field Service Kit Z1562.

3. If your unit has the light colored potting visible on the top sensor, or the sensor labeled A on the bottom; this bulletin applies. Correct following the instructions in Field Service Kit Z1562. Take a picture before correcting the issue and another picture after correcting the issue. Send both pictures with the completion form including the serial number and date of correction to utilities.warranty@terex.com.
4. If your unit has the light colored potting visible only on the bottom sensor with the wires coming out of the sensors above the mounting screw and with sensor labeled A on top this bulletin does not apply and use can continue without restriction.

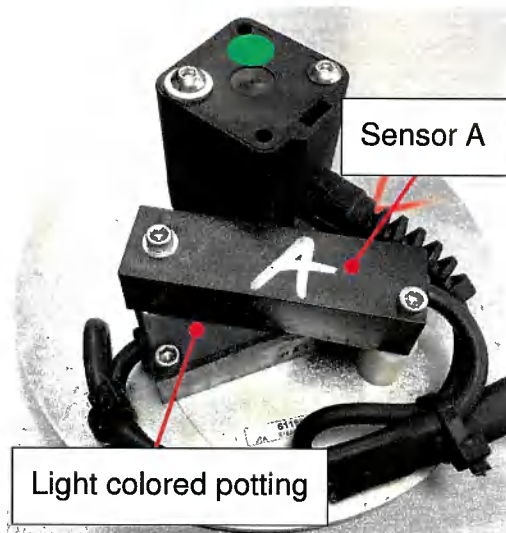
Figure 3B
This bulletin does **NOT** apply if the light colored potting only visible on bottom sensor and sensor labeled A on top

The leveling sensors have been inspected on this unit and are positioned correctly when compared with either Fig. 3B or 4B on the Safety Notice 681A bulletin and **no repair is required**. Please submit a photo of the mounted sensors with this completion form. ***No reimbursement for only completing this inspection.***

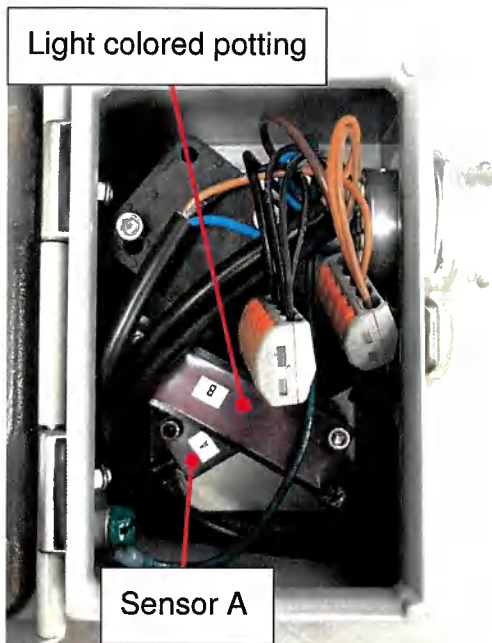
Figure 4A

This bulletin applies if the light colored potting visible on the top sensor, or sensor labeled A on the bottom

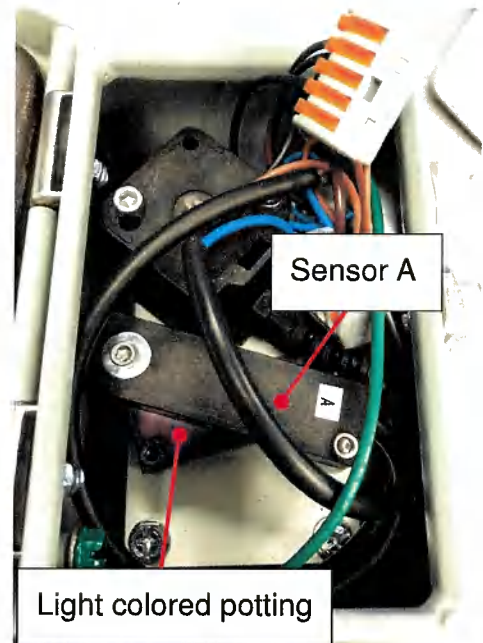
Figure 4B

This bulletin does **NOT** apply if the light colored potting only visible on bottom sensor and sensor labeled A on top
