PRODUCT CAMPAIGN BULLETIN

<p>APPLICABILITY: 2003-14 MY Legacy 2003-14 MY Outback 2003-06 MY Baja 2009-13 MY Forester 2004-11 MY Impreza 2004-14 MY WRX and STI</p> <p>SUBJECT: Takata Front Passenger Airbag Module / Inflator “Like for Like” Recall</p>	<p>NUMBERS: TKA-20 TKB-20 TKC-20</p> <p>DATE: 01/06/20</p> <p>NHTSA ID: 20V001 20V002 20V003</p>
---	---

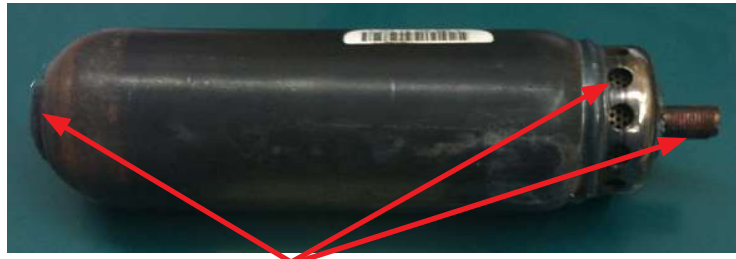
The shape, holes, and copper-colored stud indicate this is not a Genuine Subaru inflator.

- **Do not proceed with this repair if your inspection reveals a non-Genuine Subaru airbag module has been installed in the vehicle.** Follow the instructions described in the “Counterfeit Airbag Information” Dealer Advisory Bulletin.

- Document the presence of the aftermarket or counterfeit device on the repair order and with photos. Report this information immediately on a Quality Monitoring Report (QMR). **IMPORTANT:** When entering a related QMR, use failure code **ULF** and **NOT** the campaign fail code.

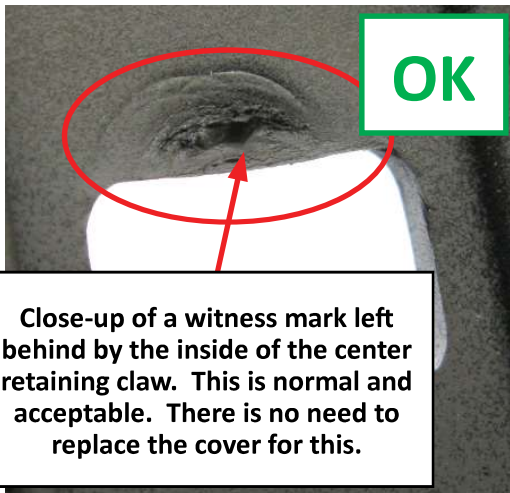
Close-up of a witness mark left behind by the inside of the center retaining claw. This is normal and acceptable. There is no need to replace the cover for this.

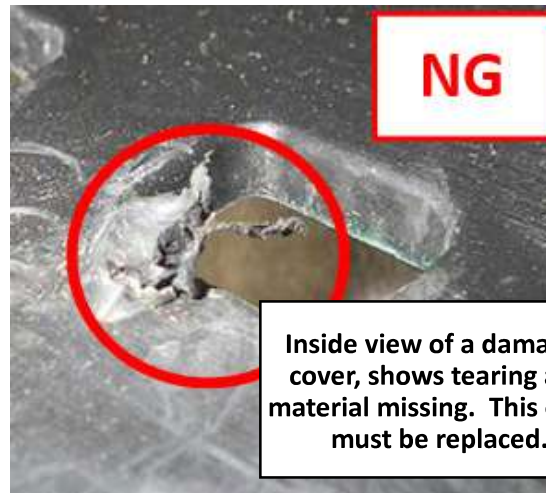
Inside view of a damaged cover, shows tearing and material missing. This cover must be replaced.

Step 3- Confirm the orientation is correct as outlined earlier in this bulletin. Refit the original cover, if reusable, onto the replacement module assembly. Make sure all the claws are fully engaged (see Figure 1 above). When properly installed, the cover should feel loose with a small amount of freeplay. If the cover is tight (no freeplay or looseness), it most likely is not fully engaged onto the claws.

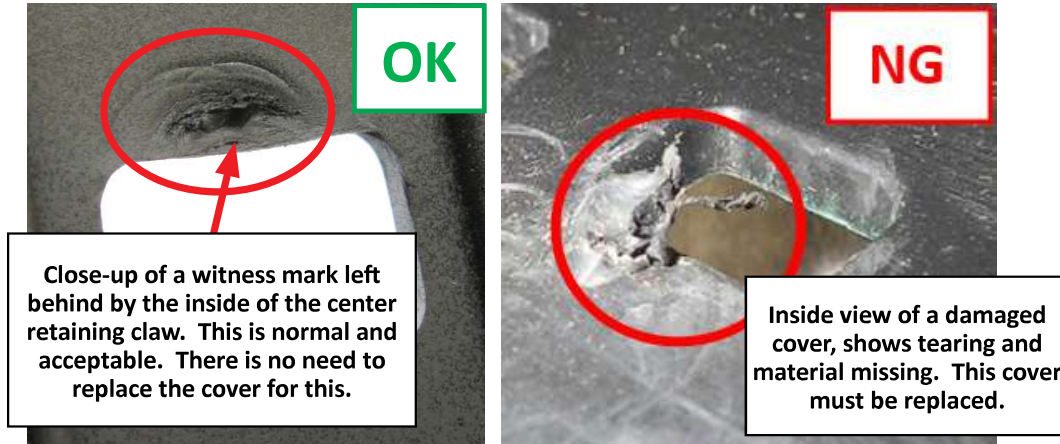
- Inspect the claw openings on the outside and inside of the cover for damage. If any found to look like the NG example photo below, the cover must be replaced.

Step 3- Refit the cover onto the replacement module assembly, making sure all the claws are fully engaged (see **Figure 1** above). For this application, the cover will only fit on the module one way. When properly installed, the cover should feel loose with a small amount of freeplay. If the cover is tight (no freeplay or looseness), it most likely is not fully engaged onto the claws.
