PRODUCT CAMPAIGN BULLETIN

<p>APPLICABILITY: 2003-14 MY Legacy 2003-14 MY Outback 2003-06 MY Baja 2009-13 MY Forester 2004-11 MY Impreza 2004-14 MY WRX and STI</p> <p>SUBJECT: Takata Front Passenger Airbag Module / Inflator “Like for Like” Recall</p>	<p>NUMBERS: TKA-20R TKB-20R TKC-20R</p> <p>DATE: 01/06/20</p> <p>REVISED: 10/30/23</p> <p>NHTSA ID: 20V001 20V002 20V003</p>
--	--

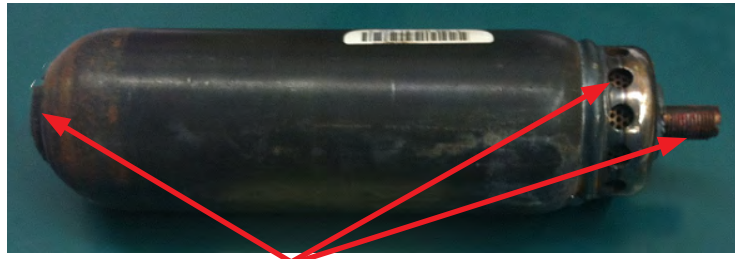
The shape, holes, and copper-colored stud indicate this is not a Genuine Subaru inflator.

- **Do not proceed with this repair if your inspection reveals a non-Genuine Subaru airbag module has been installed in the vehicle.** Follow the instructions described in the “Counterfeit Airbag Information” Dealer Advisory Bulletin.

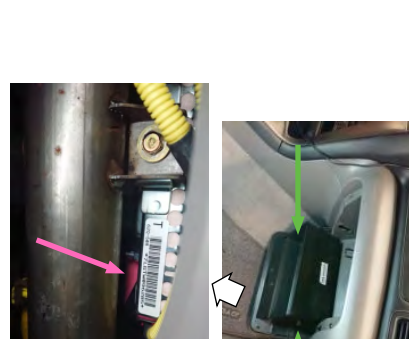
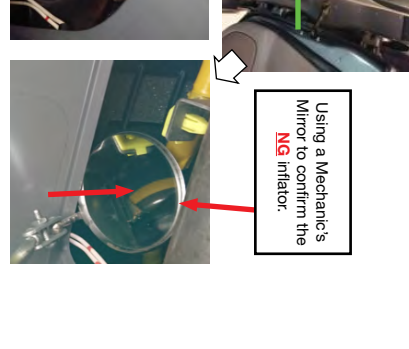
<div style="border: 1px solid black; padding: 5px; width: fit-content; margin: 5px auto;"> Using a Mechanic's Mirror to confirm the NG inflator. </div>

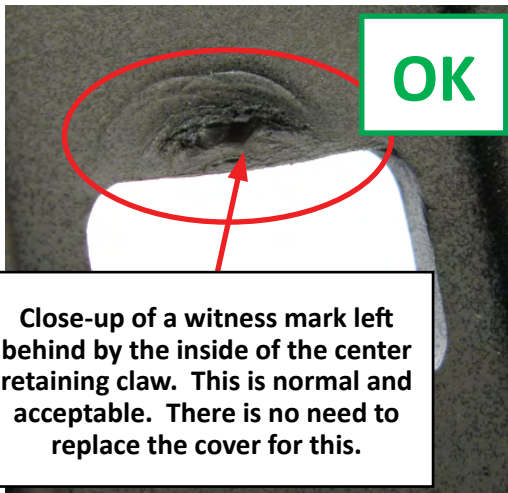
Close-up of a witness mark left behind by the inside of the center retaining claw. This is normal and acceptable. There is no need to replace the cover for this.

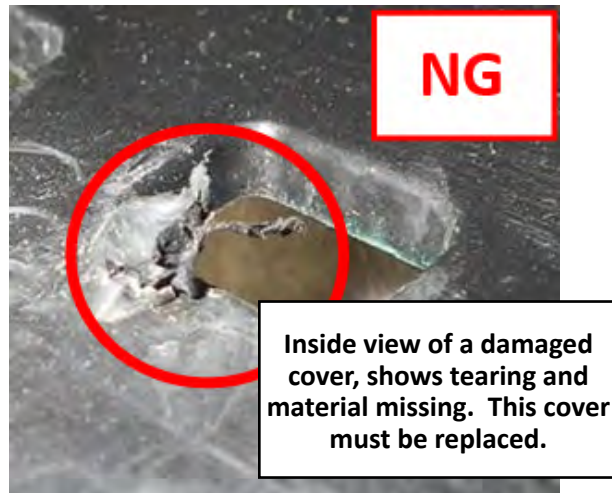
Inside view of a damaged cover, shows tearing and material missing. This cover must be replaced.

Step 3- Confirm the orientation is correct as outlined earlier in this bulletin. Refit the original cover, if reusable, onto the replacement module assembly. Make sure all the claws are fully engaged (see Figure 1 above). When properly installed, the cover should feel loose with a small amount of freeplay. If the cover is tight (no freeplay or looseness), it most likely is not fully engaged onto the claws.

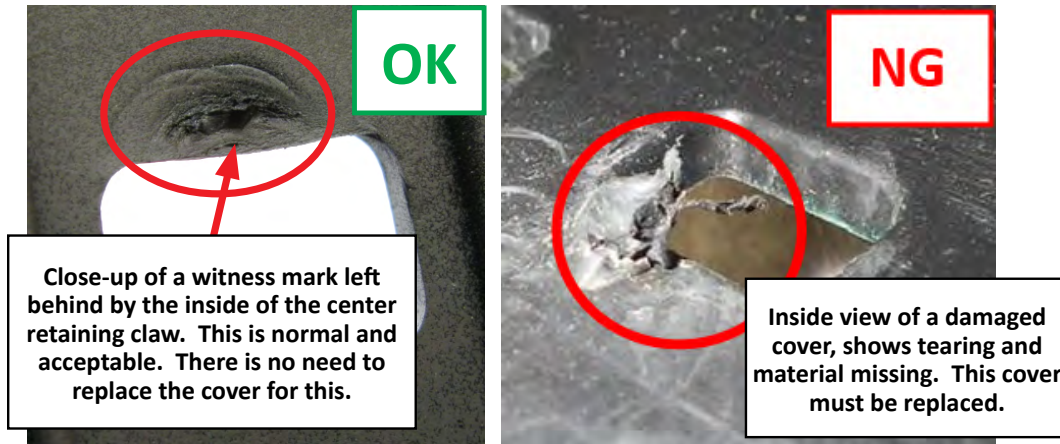
- Inspect the claw openings on the outside and inside of the cover for damage. If any found to look like the NG example photo below, the cover must be replaced.

Step 3- Refit the cover onto the replacement module assembly, making sure all the claws are fully engaged (see **Figure 1** above). For this application, the cover will only fit on the module one way. When properly installed, the cover should feel loose with a small amount of freeplay. If the cover is tight (no freeplay or looseness), it most likely is not fully engaged onto the claws.
