**PRODUCT CAMPAIGN BULLETIN**

**APPLICABILITY:** 2003-14 MY Legacy  
 2003-14 MY Outback  
 2003-06 MY Baja  
 2009-13 MY Forester  
 2004-11 MY Impreza  
 2004-14 MY WRX and STI

**NUMBERS:** TKA-20R  
 TKB-20R  
 TKC-20R

**SUBJECT:** Takata Front Passenger Airbag Module / Inflator “Like for Like” Recall

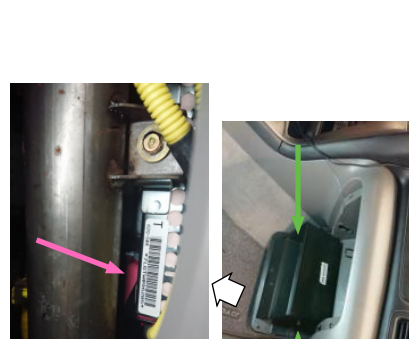
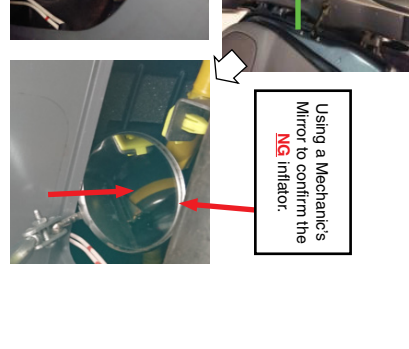
<div style="border: 1px solid black; padding: 5px; width: fit-content; margin: 5px auto;">             Using a Mechanic's Mirror to confirm the <b>NG</b> inflator.         </div>

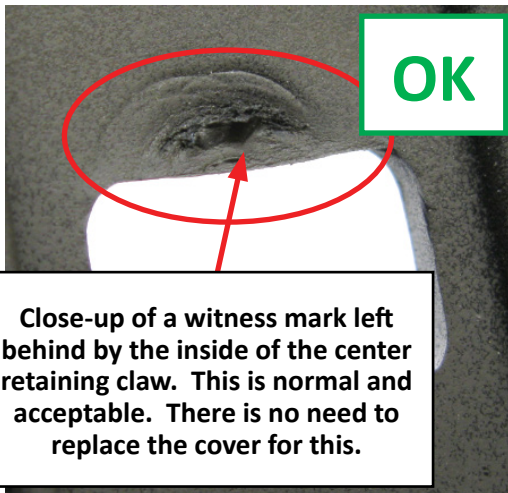
Close-up of a witness mark left behind by the inside of the center retaining claw. This is normal and acceptable. There is no need to replace the cover for this.

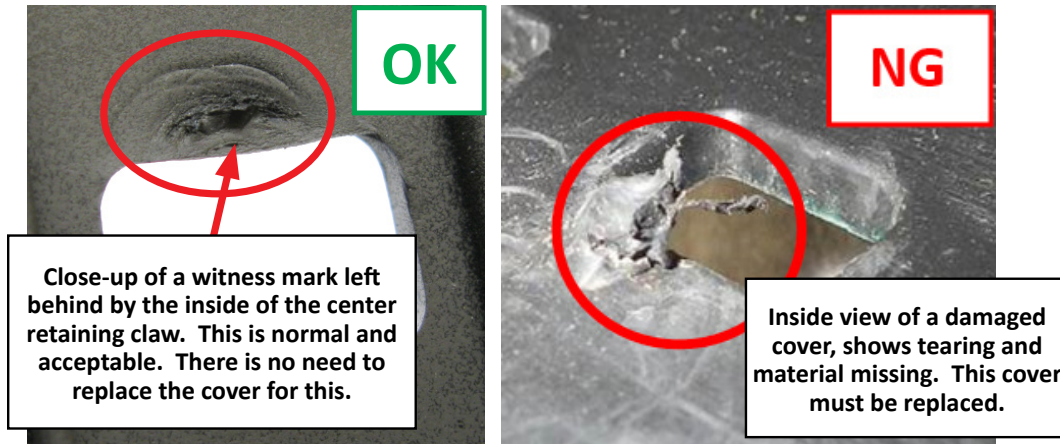
- Inspect the claw openings on the outside and inside of the cover for damage. If any found to look like the NG example photo below, the cover must be replaced.
