## PRODUCT CAMPAIGN BULLETIN

**APPLICABILITY:** 2003-14 MY Legacy  
 2003-14 MY Outback  
 2003-06 MY Baja  
 2009-13 MY Forester  
 2004-11 MY Impreza  
 2004-14 MY WRX and STI

**SUBJECT:** Takata Front Passenger Airbag Module /  
 Inflator “Like for Like” Recall

**NUMBERS:** TKA-20R  
 TKB-20R  
 TKC-20R

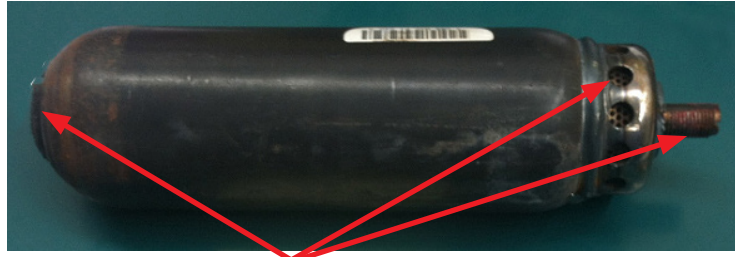
**The shape, holes, and copper-colored stud indicate this is not a Genuine Subaru inflator.**

- **Do not proceed with this repair if your inspection reveals a non-Genuine Subaru airbag module has been installed in the vehicle.** Follow the instructions described in the “Counterfeit Airbag Information” Dealer Advisory Bulletin.

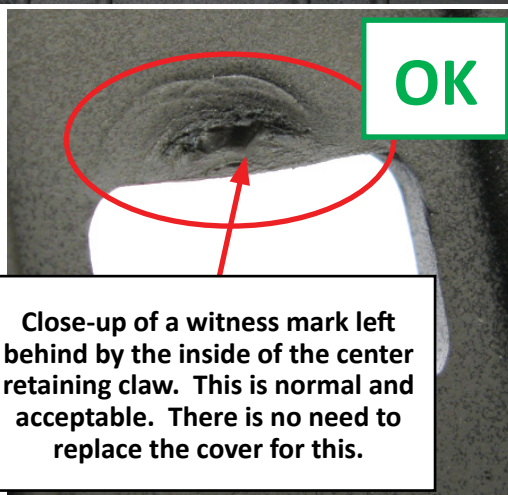
Close-up of a witness mark left  
behind by the inside of the center  
retaining claw. This is normal and  
acceptable. There is no need to  
replace the cover for this.

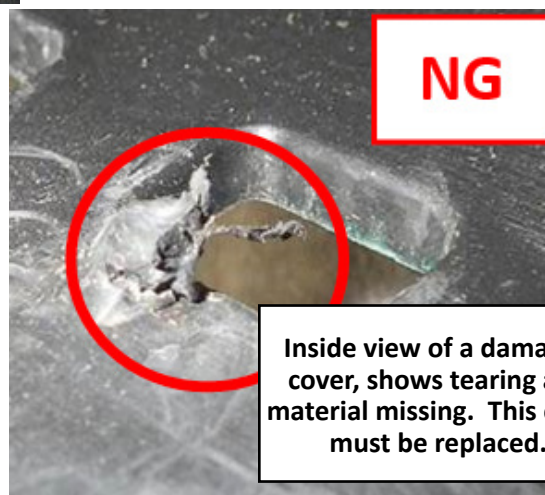
Inside view of a damaged  
cover, shows tearing and  
material missing. This cover  
must be replaced.
