Product Safety Recall

15052 Front Passenger Air Bag Inflator

Release Date: February 2020

Condition	This recall affects certain 2006 model year Saab 9-2X vehicles which may have had an interim "like-for-like" repair performed under a previous air bag recall using Takata Non-Desiccated Frontal Passenger-side Air Bag Inflators containing Phase Stabilized Ammonium Nitrate for Zone B. Zone B includes states with moderate temperature cycling and absolute humidity. It includes: Arizona, Arkansas, Delaware, District of Columbia, Illinois, Indiana, Kansas, Kentucky, Maryland, Missouri, Nebraska, Nevada, New Jersey, New Mexico, North Carolina, Ohio, Oklahoma, Pennsylvania, Tennessee, Virginia, and West Virginia. The propellant wafers in some of the subject inflators may degrade over time, which could lead to overaggressive combustion in the event the air bag is activated. Overly aggressive combustion creates excessive internal pressure when the inflator is activated, which may cause the inflator body to rupture. Activation of a non-desiccated ammonium nitrate inflator with degraded propellant may result in an inflator rupture. An inflator rupture may cause metal fragments to pass through

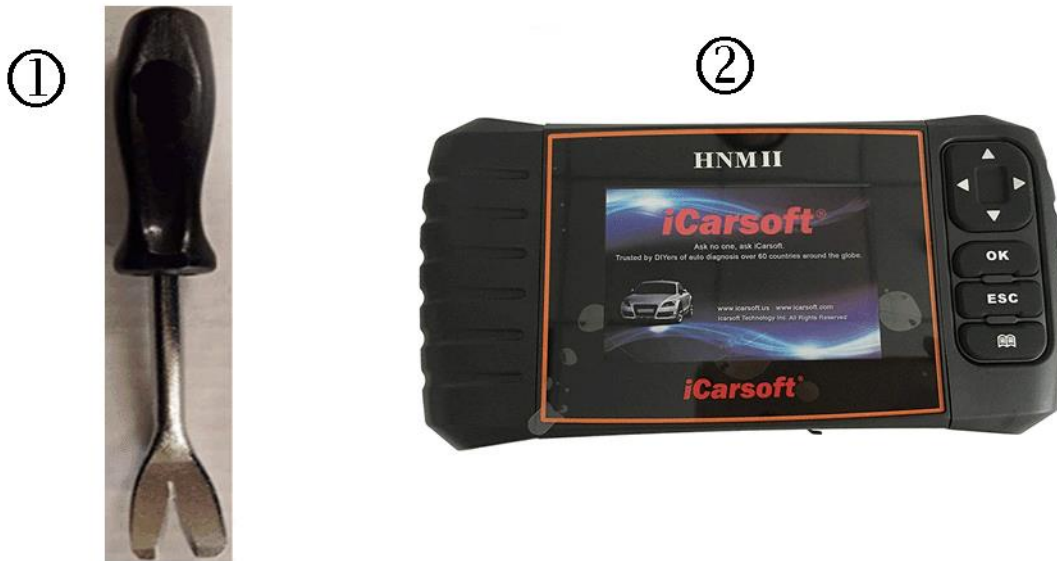
5145880

(1) Trim Clip Removal Tool (2) iCarsoft HNM II Diagnostic tool

This trim clip removal tool (1) must be used to properly perform the front passenger air bag module replacement procedure described in this bulletin. GM dealers should already have at least one of these trim clip removal tools in their special tool inventory.

This scan tool (2) must be used to properly perform the front passenger air bag module replacement procedure described in this bulletin. Dealers should purchase this scan tool either online or locally. **GM will reimburse for only one scan tool per dealer.** Tool description: iCarsoft HNM II Diagnostic tool with all systems diagnoses, OBDII full functions and reset services.
