PRODUCT CAMPAIGN BULLETIN

| <p>APPLICABILITY: 2003-14 MY Legacy 2003-14 MY Outback 2003-06 MY Baja 2009-13 MY Forester 2004-11 MY Impreza 2004-14 MY WRX and STI</p> <p>SUBJECT: Takata Front Passenger Airbag Module / Inflator “Like for Like” Recall</p> | <p>NUMBERS: TKA-20R TKB-20R TKC-20R</p> <p>DATE: 01/06/20</p> <p>REVISED: 12/28/22</p> <p>NHTSA ID: 20V001 20V002 20V003</p> |

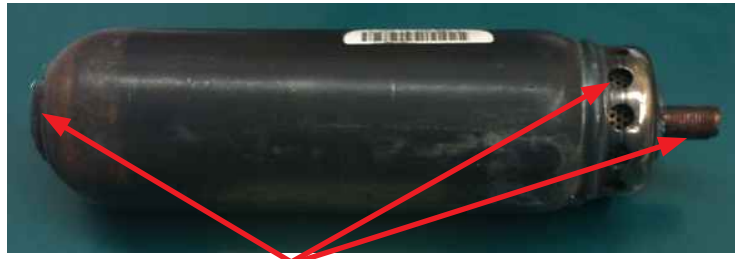
The shape, holes, and copper-colored stud indicate this is not a Genuine Subaru inflator.

- **Vehicles that do not contain Genuine Subaru airbags are not eligible for this recall repair.** For more information on identifying counterfeit airbags and how to address related customer situations, please refer to STIS for the “Counterfeit Airbag Information” Dealer Advisory Bulletin dated October 25, 2012 by going to Subaru.net>Service>STIS>Online Reference - choose Publication Type: ‘Other/Miscellaneous’ and search keywords: ‘Airbag’).

- **Do not proceed with this repair if your inspection reveals a non-Genuine Subaru airbag module has been installed in the vehicle.** Follow the instructions described in the “Counterfeit Airbag Information” Dealer Advisory Bulletin.

- Document the presence of the aftermarket or counterfeit device on the repair order and with photos. Report this information immediately on a Quality Monitoring Report (QMR). **IMPORTANT:** When entering a related QMR, use failure code **ULF** and **NOT** the campaign fail code.

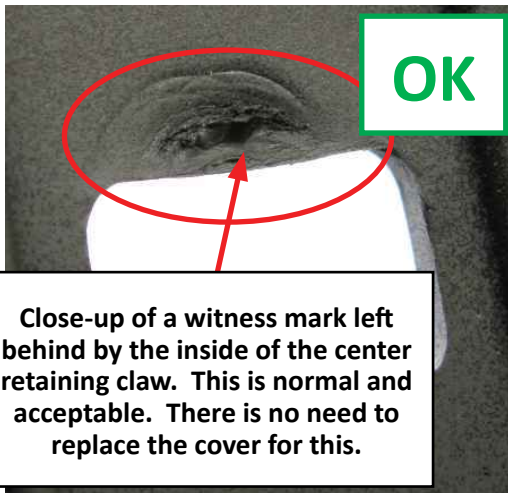
Close-up of a witness mark left behind by the inside of the center retaining claw. This is normal and acceptable. There is no need to replace the cover for this.

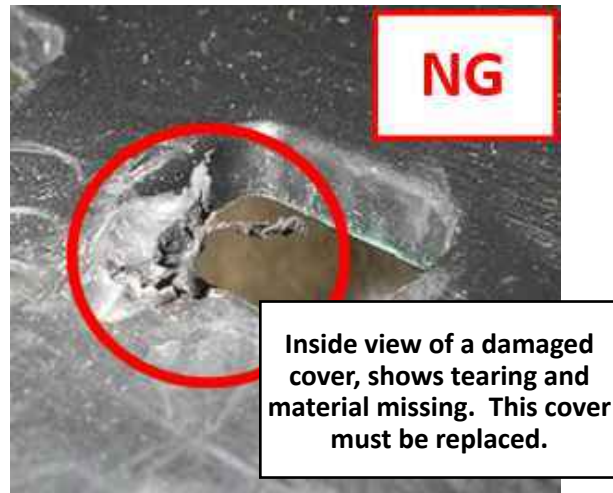
Inside view of a damaged cover, shows tearing and material missing. This cover must be replaced.

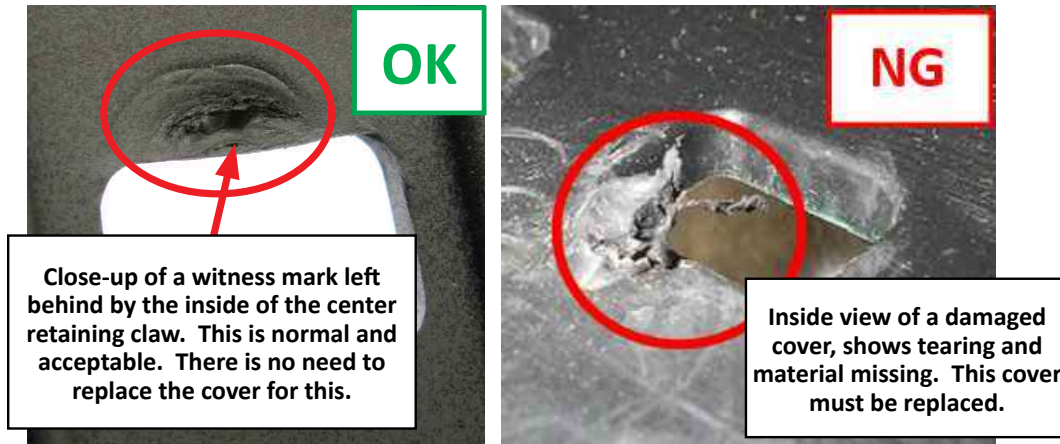
- Inspect the claw openings on the outside and inside of the cover for damage. If any found to look like the NG example photo below, the cover must be replaced.
