# Product Safety Recall

## 15052 Front Passenger Air Bag Inflator

Release Date: January 2020

<b>Condition</b>	This recall affects certain 2006 model year Saab 9-2X vehicles which may have had an interim "like-for-like" repair performed under a previous air bag recall using Takata Non-Desiccated Frontal Passenger-side Air Bag Inflators containing Phase Stabilized Ammonium Nitrate for Zone B. Zone B includes states with moderate temperature cycling and absolute humidity. It includes: Arizona, Arkansas, Delaware, District of Columbia, Illinois, Indiana, Kansas, Kentucky, Maryland, Missouri, Nebraska, Nevada, New Jersey, New Mexico, North Carolina, Ohio, Oklahoma, Pennsylvania, Tennessee, Virginia, and West Virginia. The propellant wafers in some of the subject inflators may degrade over time, which could lead to overaggressive combustion in the event the air bag is activated. Overly aggressive combustion creates excessive internal pressure when the inflator is activated, which may cause the inflator body to rupture. Activation of a non-desiccated ammonium nitrate inflator with degraded propellant may result in an inflator rupture. An inflator rupture may cause metal fragments to pa

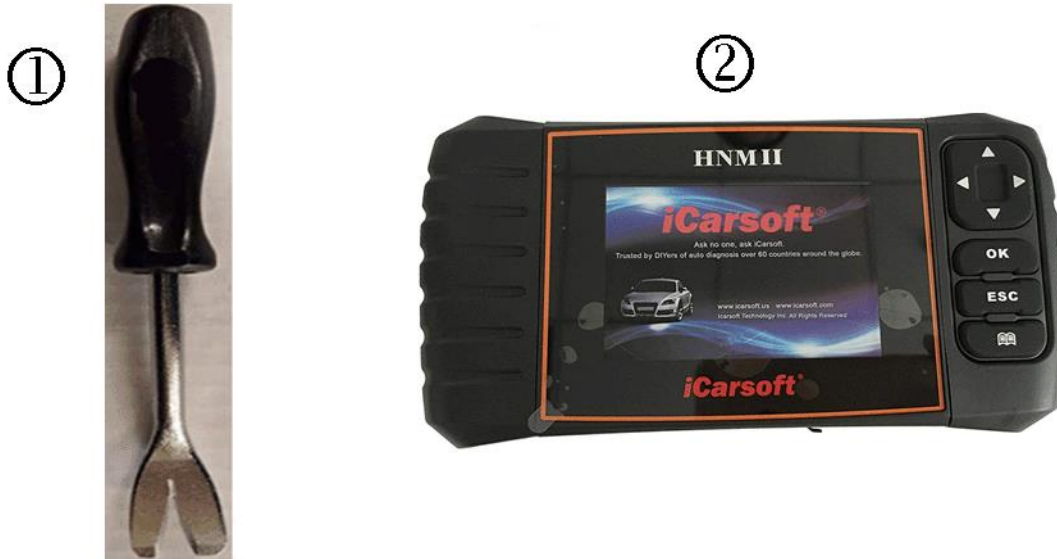
5145880

(1) Trim Clip Removal Tool (2) iCarsoft HNM II Diagnostic tool

This trim clip removal tool (1) must be used to properly perform the front passenger air bag module replacement procedure described in this bulletin. GM dealers should already have at least one of these trim clip removal tools in their special tool inventory.

This scan tool (2) must be used to properly perform the front passenger air bag module replacement procedure described in this bulletin. Dealers should purchase this scan tool either online or locally. **GM will reimburse for only one scan tool per dealer.** Tool description: iCarsoft HNM II Diagnostic tool with all systems diagnoses, OBDII full functions and reset services.

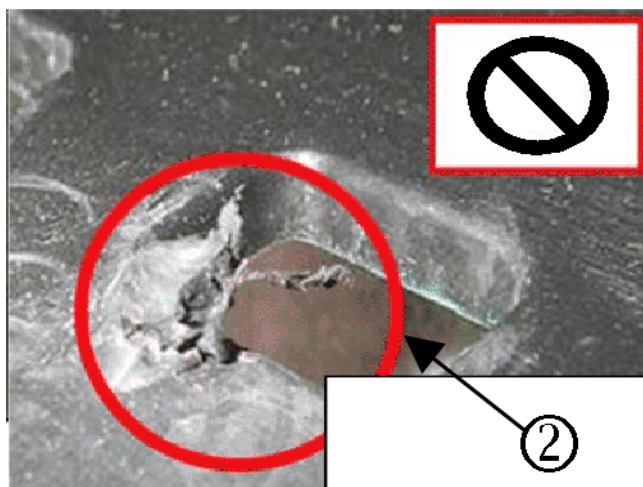
5145910

14. Inspect the claw openings on the outside and inside of the cover for damage. If any found to look like the (2) the cover must be replaced.
