Product Safety Recall

15053 Front Passenger Air Bag Inflator

Release Date: February 2020

Condition	This recall affects 2006 model year Saab 9-2X vehicles which may have had an interim "like-for-like" repair performed under a previous air bag recall using Takata Non-Desiccated Frontal Passenger-side Air Bag Inflators containing Phase Stabilized Ammonium Nitrate for Zone C. Zone C includes states with lower temperature cycling and absolute humidity. It includes: Alaska, Colorado, Connecticut, Idaho, Iowa, Maine, Massachusetts, Michigan, Minnesota, Montana, New Hampshire, New York, North Dakota, Oregon, Rhode Island, South Dakota, Utah, Vermont, Washington, Wisconsin, and Wyoming. the propellant wafers in some of the subject inflators may degrade over time, which could lead to overaggressive combustion in the event the air bag is activated. Overly aggressive combustion creates excessive internal pressure when the inflator is activated, which may cause the inflator body to rupture. Activation of a non-desiccated ammonium nitrate inflator with degraded propellant may result in an inflator rupture. An inflator rupture may cause metal fragments to pass through the air bag and into the

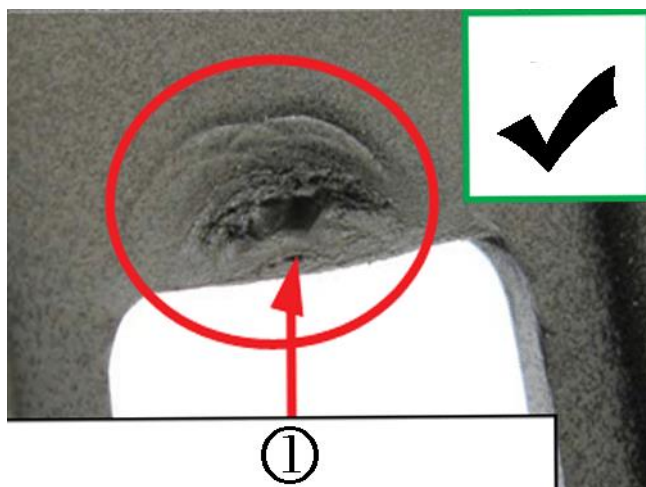
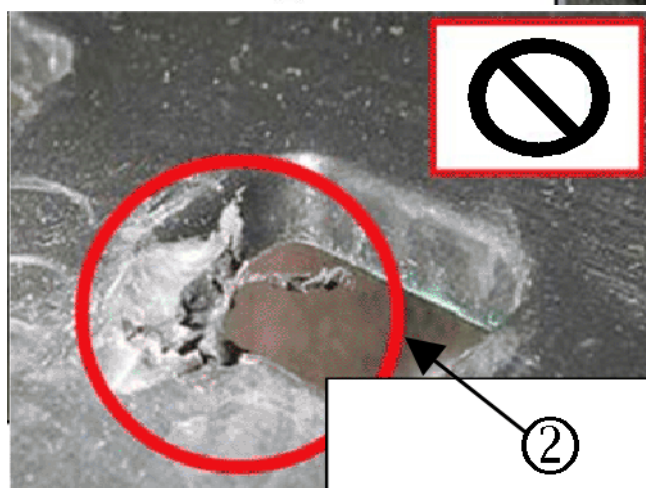
14. Inspect the claw openings on the outside and inside of the cover for damage. If any found to look like the (2) the cover must be replaced.
