PRODUCT CAMPAIGN BULLETIN

<p>APPLICABILITY: 2003-14 MY Legacy 2003-14 MY Outback 2003-06 MY Baja 2009-13 MY Forester 2004-11 MY Impreza 2004-14 MY WRX and STI</p> <p>SUBJECT: Takata Front Passenger Airbag Module / Inflator “Like for Like” Recall</p>	<p>NUMBERS: TKA-20R TKB-20R TKC-20R</p> <p>DATE: 01/06/20</p> <p>REVISED: 12/28/23</p> <p>NHTSA ID: 20V001 20V002 20V003</p>
--	--

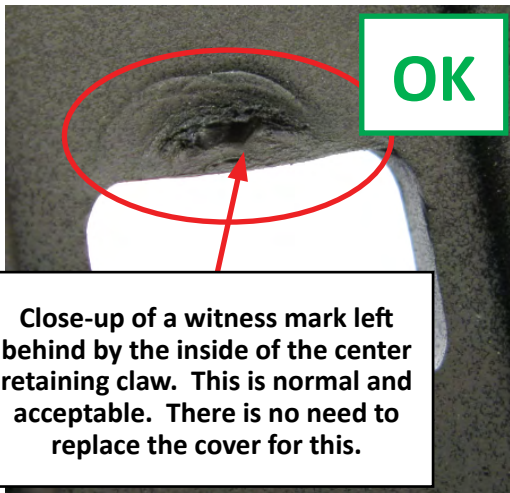
Close-up of a witness mark left behind by the inside of the center retaining claw. This is normal and acceptable. There is no need to replace the cover for this.

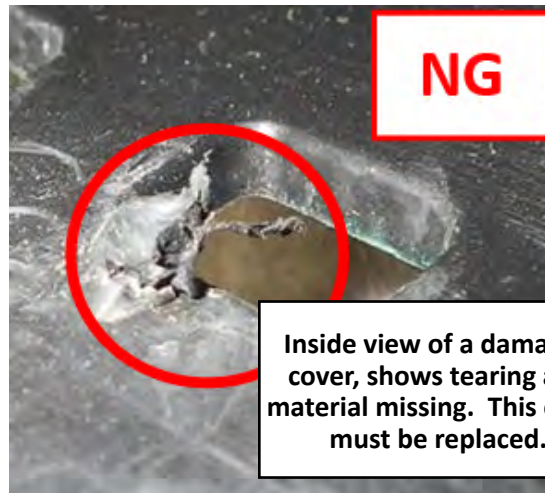
Inside view of a damaged cover, shows tearing and material missing. This cover must be replaced.

Step 3- Confirm the orientation is correct as outlined earlier in this bulletin. Refit the original cover, if reusable, onto the replacement module assembly. Make sure all the claws are fully engaged (see Figure 1 above). When properly installed, the cover should feel loose with a small amount of freeplay. If the cover is tight (no freeplay or looseness), it most likely is not fully engaged onto the claws.
