## PRODUCT CAMPAIGN BULLETIN

**SUBJECT:** Takata Front Passenger Airbag Module /  
 Inflator “Like for Like” Recall

**NUMBERS:** TKA-20R  
 TKB-20R  
 TKC-20R

**NHTSA ID:** 20V001  
 20V002  
 20V003

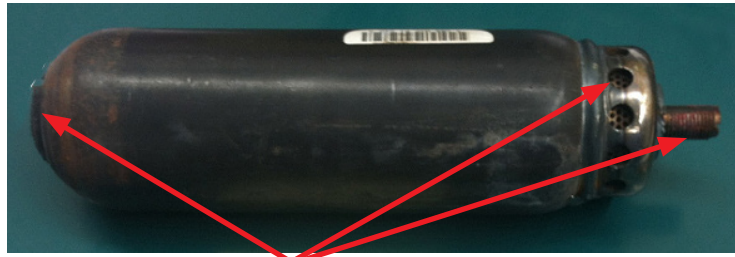
**The shape, holes, and copper-colored stud indicate this is not a Genuine Subaru inflator.**

- **Do not proceed with this repair if your inspection reveals a non-Genuine Subaru airbag module has been installed in the vehicle.** Follow the instructions described in the “Counterfeit Airbag Information” Dealer Advisory Bulletin.

- Document the presence of the aftermarket or counterfeit device on the repair order and with photos. Report this information immediately on a Quality Monitoring Report (QMR). **IMPORTANT:** When entering a related QMR, use failure code **ULF** and **NOT** the campaign fail code.

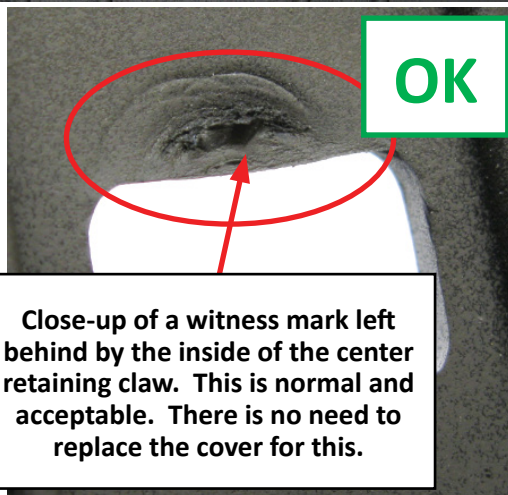
Close-up of a witness mark left  
behind by the inside of the center  
retaining claw. This is normal and  
acceptable. There is no need to  
replace the cover for this.

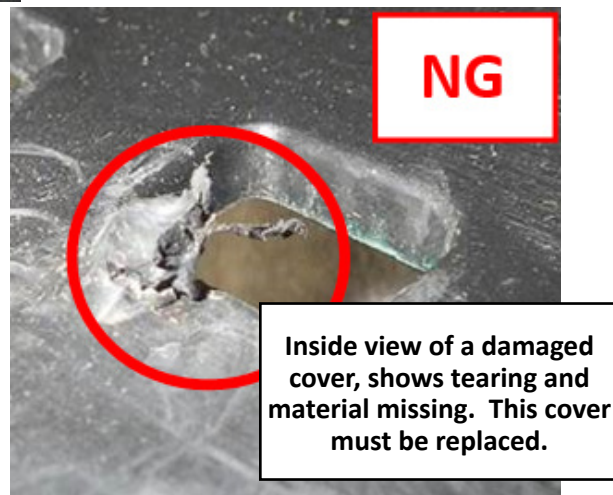
Inside view of a damaged  
cover, shows tearing and  
material missing. This cover  
must be replaced.
