Product Safety Recall

15053 Front Passenger Air Bag Inflator

Release Date: January 2020

Condition	This recall affects 2006 model year Saab 9-2X vehicles which may have had an interim "like-for-like" repair performed under a previous air bag recall using Takata Non-Desiccated Frontal Passenger-side Air Bag Inflators containing Phase Stabilized Ammonium Nitrate for Zone C. Zone C includes states with lower temperature cycling and absolute humidity. It includes: Alaska, Colorado, Connecticut, Idaho, Iowa, Maine, Massachusetts, Michigan, Minnesota, Montana, New Hampshire, New York, North Dakota, Oregon, Rhode Island, South Dakota, Utah, Vermont, Washington, Wisconsin, and Wyoming. the propellant wafers in some of the subject inflators may degrade over time, which could lead to overaggressive combustion in the event the air bag is activated. Overly aggressive combustion creates excessive internal pressure when the inflator is activated, which may cause the inflator body to rupture. Activation of a non-desiccated ammonium nitrate inflator with degraded propellant may result in an inflator rupture. An inflator rupture may cause metal fragments to pass through the air bag and into the v

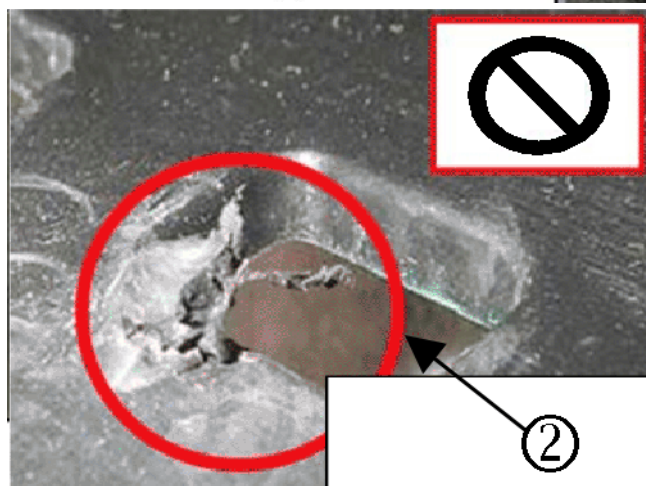
5145910

14. Inspect the claw openings on the outside and inside of the cover for damage. If any found to look like the (2) the cover must be replaced.

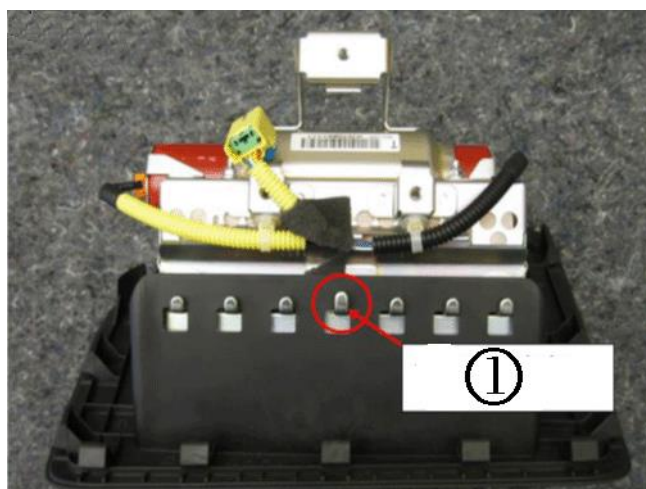
5145881

15. Refit the cover onto the replacement module assembly, making sure all the claws are fully engaged (picture above). For this application, the cover will only fit on the module one way. When properly installed, the cover should feel loose with a small amount of free play. If the cover is tight (no free play or looseness), it most likely is not fully engaged onto the claws.
16. **VERY IMPORTANT:** Record the alpha-numeric serial numbers for BOTH the original and the replacement module assemblies on the hard copy of the Repair Order.
