Product Safety Recall

15049 Front Passenger Air Bag Inflator

Release Date: January 2020

Condition	This recall affects 2005 model year Saab 9-2X vehicles which may have had an interim "like-for-like" repair performed under a previous air bag recall using Takata Non-Desiccated Frontal Passenger-side Air Bag Inflators containing Phase Stabilized Ammonium Nitrate for Zone C. Zone C includes states with lower temperature cycling and absolute humidity. It includes: Alaska, Colorado, Connecticut, Idaho, Iowa, Maine, Massachusetts, Michigan, Minnesota, Montana, New Hampshire, New York, North Dakota, Oregon, Rhode Island, South Dakota, Utah, Vermont, Washington, Wisconsin, and Wyoming. the propellant wafers in some of the subject inflators may degrade over time, which could lead to overaggressive combustion in the event the air bag is activated. Overly aggressive combustion creates excessive internal pressure when the inflator is activated, which may cause the inflator body to rupture. Activation of a non-desiccated ammonium nitrate inflator with degraded propellant may result in an inflator rupture. An inflator rupture may cause metal fragments to pass through the air bag and into the v

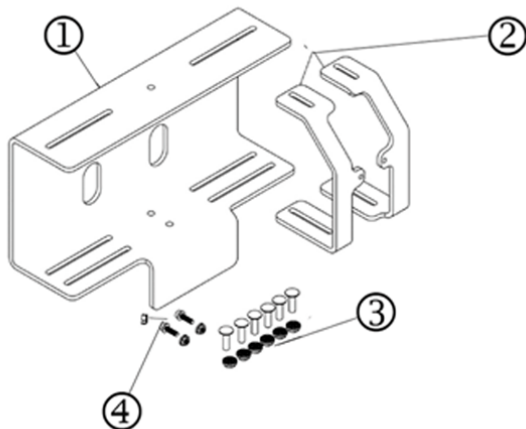
4006668

(1) Mounting Bracket (2) Support Bars (3) Support Bar Hardware (4) Air Bag Mounting Hardware.

The air bag mounting bracket, shown below, must be used to safely perform the front passenger air bag inflator replacement procedure described in this bulletin. All GM dealers should already have at least one of these mounting brackets in their special tool inventory. They were provided by GM through Bosch Automotive Service Solutions in late 2015 to address previous Takata air bag safety recalls. The Bosch special tool number is EL-51377. If your dealership does not have the air bag mounting bracket, do not attempt to perform this service procedure and immediately contact Bosch at 1-800-GM-TOOLS for assistance. Attempting to replace the front passenger air bag inflator without using the bracket poses a safety risk for the technician and anyone else in the area.
