2020 Royal Alloy Grand Tourer 150 Recall Instructions - EDITED

All 2020 Royal Alloy Grand Tourer 150 models produced in calendar year 2019. Check the manufacture date on the DOT Certification label located on the upper left portion of the leg-shield to verify the production date if you are unsure.

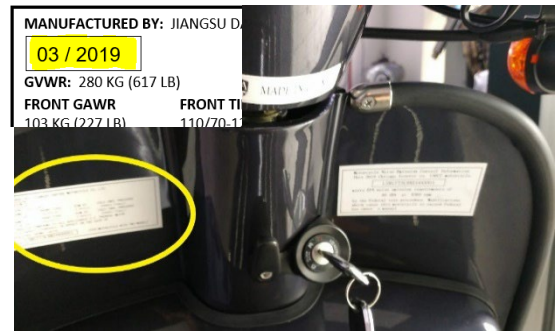
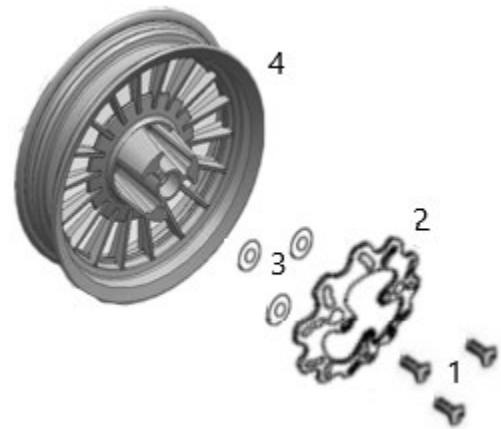
During operation, the front brake rotor can become uncentered within the front brake caliper causing the innermost brake pad to dislodge from the top of the brake caliper. This could result in reduced or a complete loss of braking ability in both the front and rear brake systems as they are linked.

- 1) Place a large metal punch tool over the head of the brake rotor bolt (1).
- 2) Strike the punch a few times with a hammer prior to extraction. Video: <https://youtu.be/UPZp9kqcnnY>

- 3) Remove brake rotor mounting bolt and discard.
- 4) Repeat steps 1-3 until all brake rotor bolts have been removed from the wheel.
- 5) Install Spacer (3) supplied between the Wheel (4) and brake Rotor (2) at the mounting point.
