SIB 65 04 20

2020-01-16

RECALL CAMPAIGN 20V-017: REPLACE DRIVER'S FRONT AIR BAG MODULE

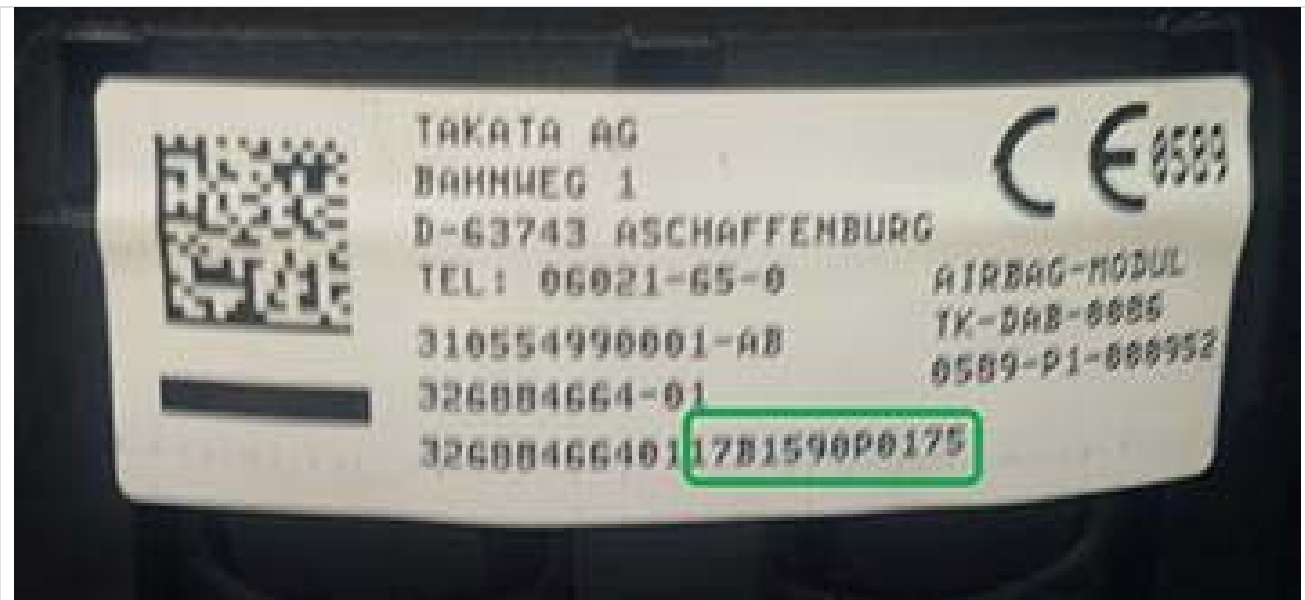
This is the last half of the number (after the part number) as shown below:

Note: It is necessary to document which air bag goes into which vehicle. Therefore, the technician is required to note on the repair order the serial number of the new air bag. The serial number should also be entered into the warranty claims comment section.

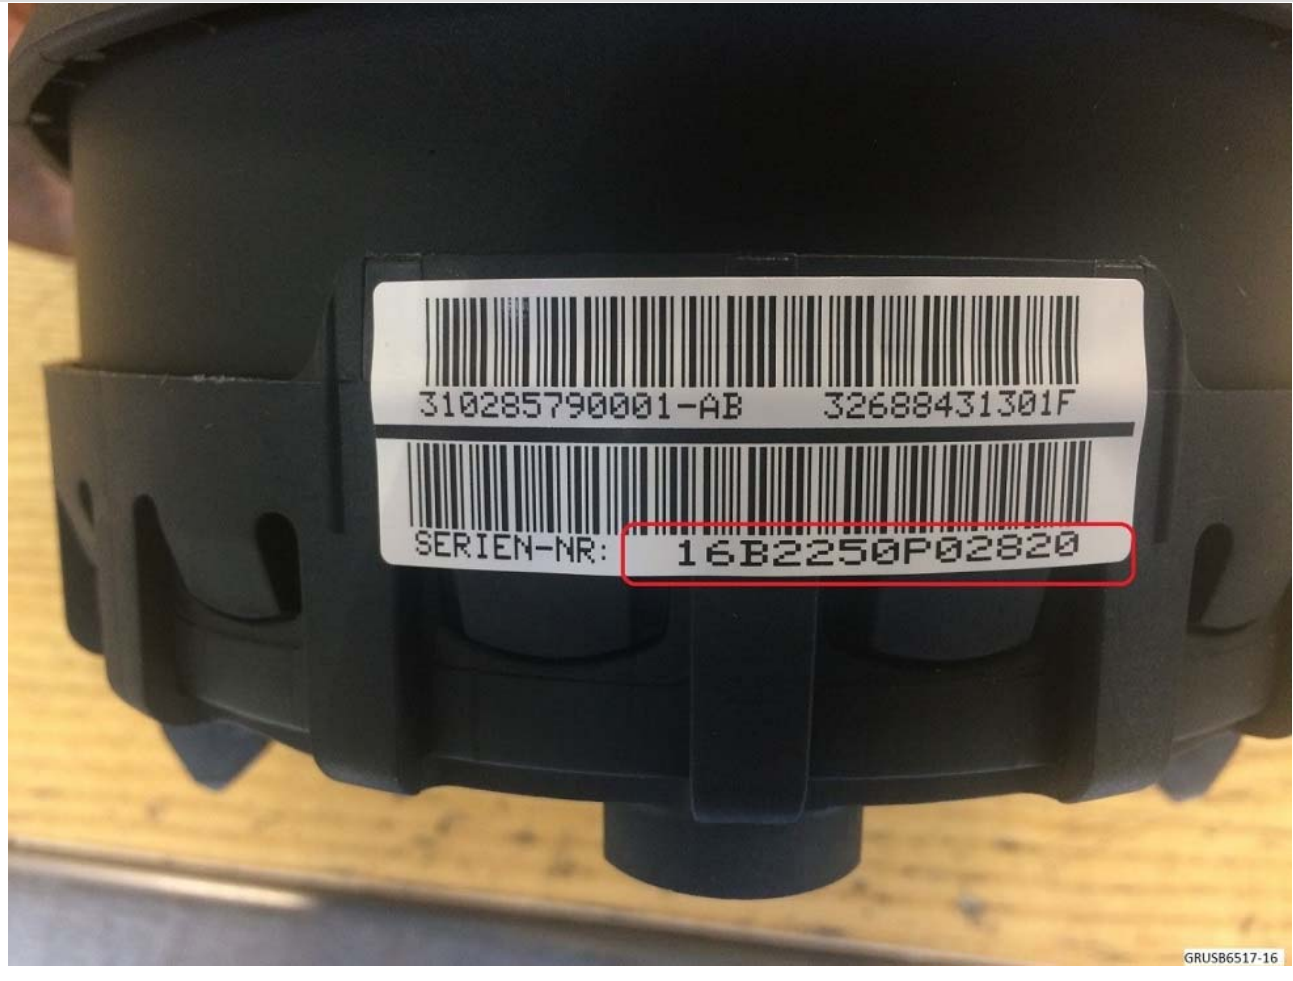
OR this number can also be found on the bottom of the label.

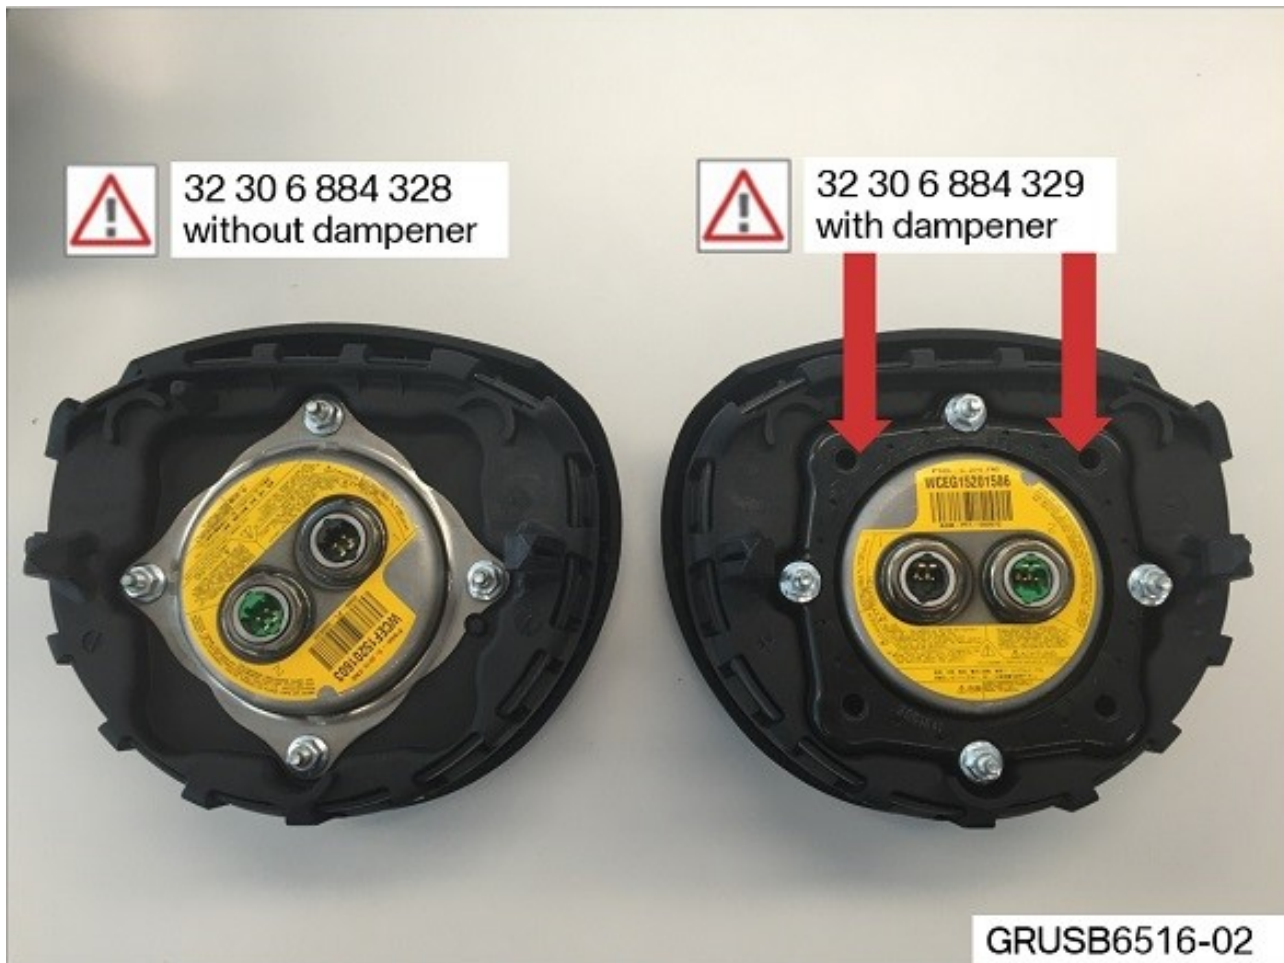
Note: **Original part coming out of the vehicle may not match the replacement part. This applies to vehicles originally equipped with or without a dampener. Refer to the photos below:**
