SIB 65 04 20

**RECALL CAMPAIGN 20V-017: REPLACE DRIVER'S FRONT AIR BAG MODULE**

This Service Information Bulletin (Revision 3) replaces SI B65 04 20 **dated December 2022**.

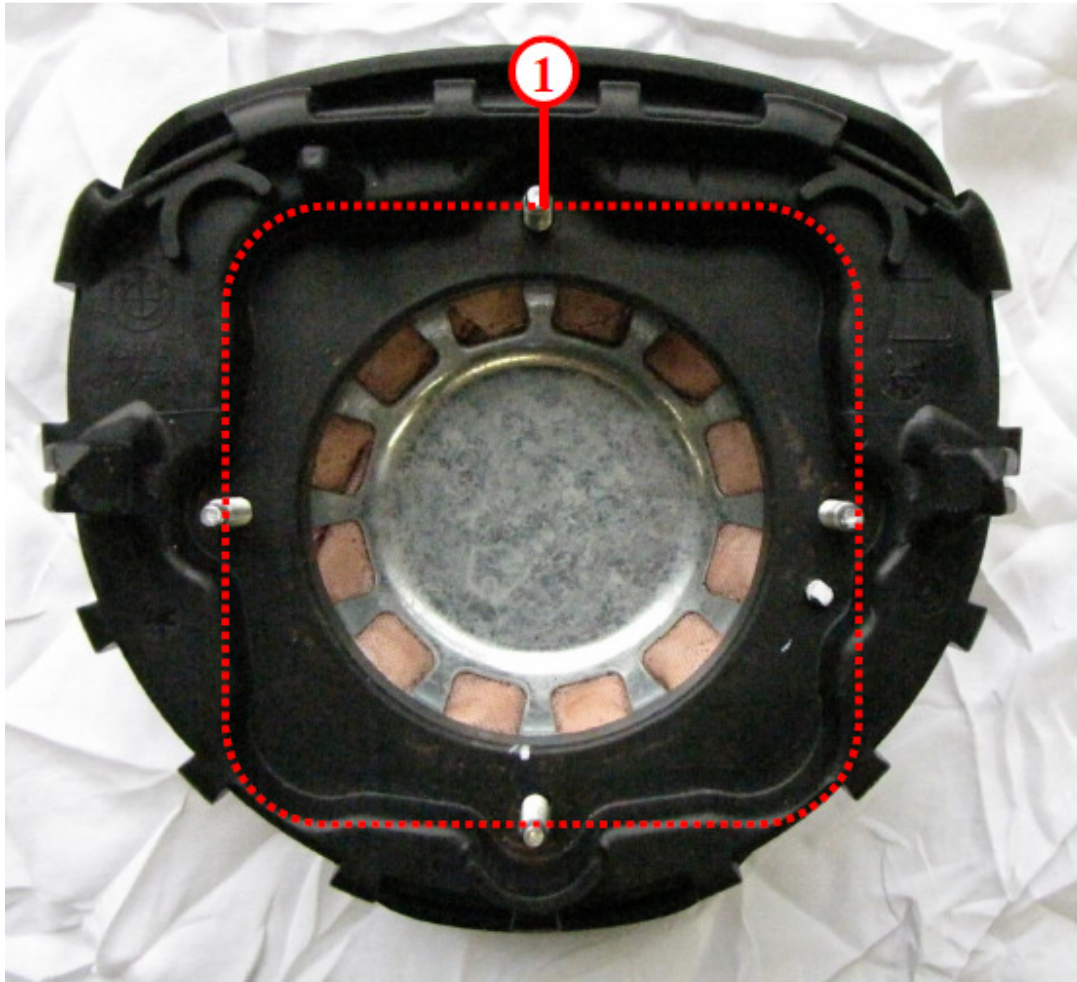
If the original Generator cannot be removed without excess force then cancel this procedure and replace the entire Air Bag assembly.
