**SIB 65 04 20**

RECALL CAMPAIGN 20V-017: REPLACE DRIVER'S FRONT AIR BAG MODULE

This Service Information Bulletin (Revision 1) replaces SI B65 04 20 **dated January 2020**.

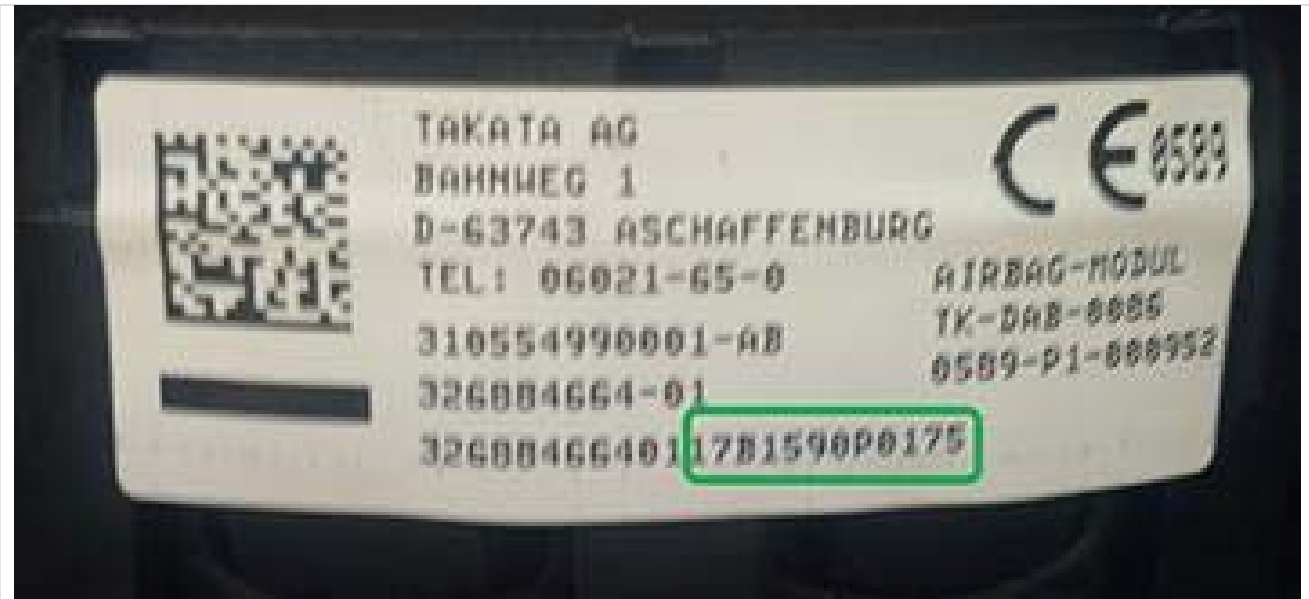
There are two different serial numbers that can be found. For this recall we only need the serial number on the label on the side of the air bag. . The serial number is identified below by the red box (1).

This is the last half of the number (after the part number) as shown below. The part number is identified below by the green box (2).

Note: It is necessary to document which air bag goes into which vehicle. Therefore, the technician is required to note on the repair order the serial number of the new air bag. The serial number should also be entered into the warranty claims comment section.

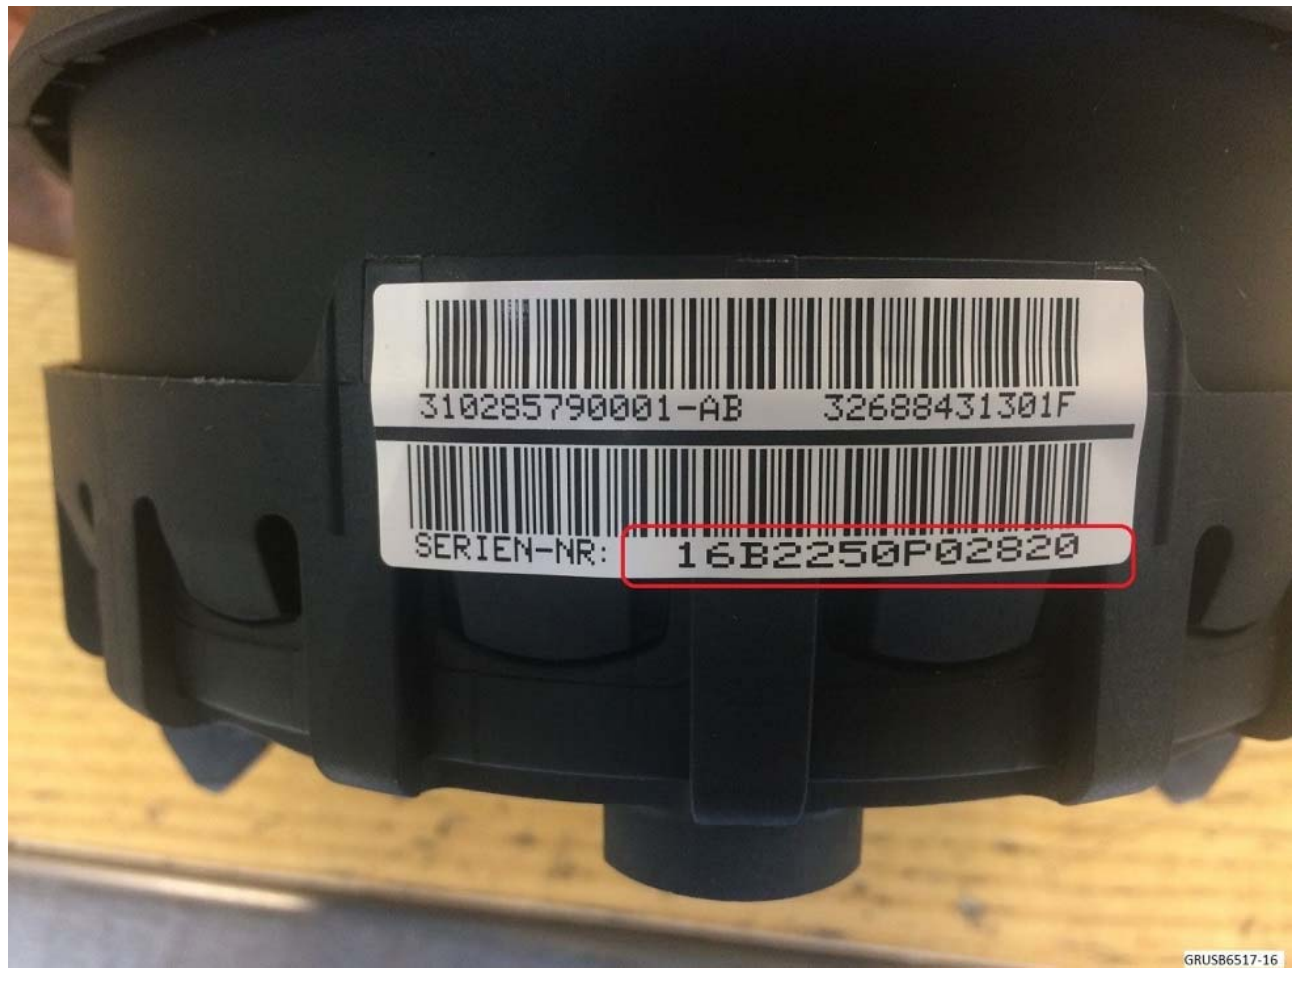
OR the serial number can also be found on the bottom of the label.

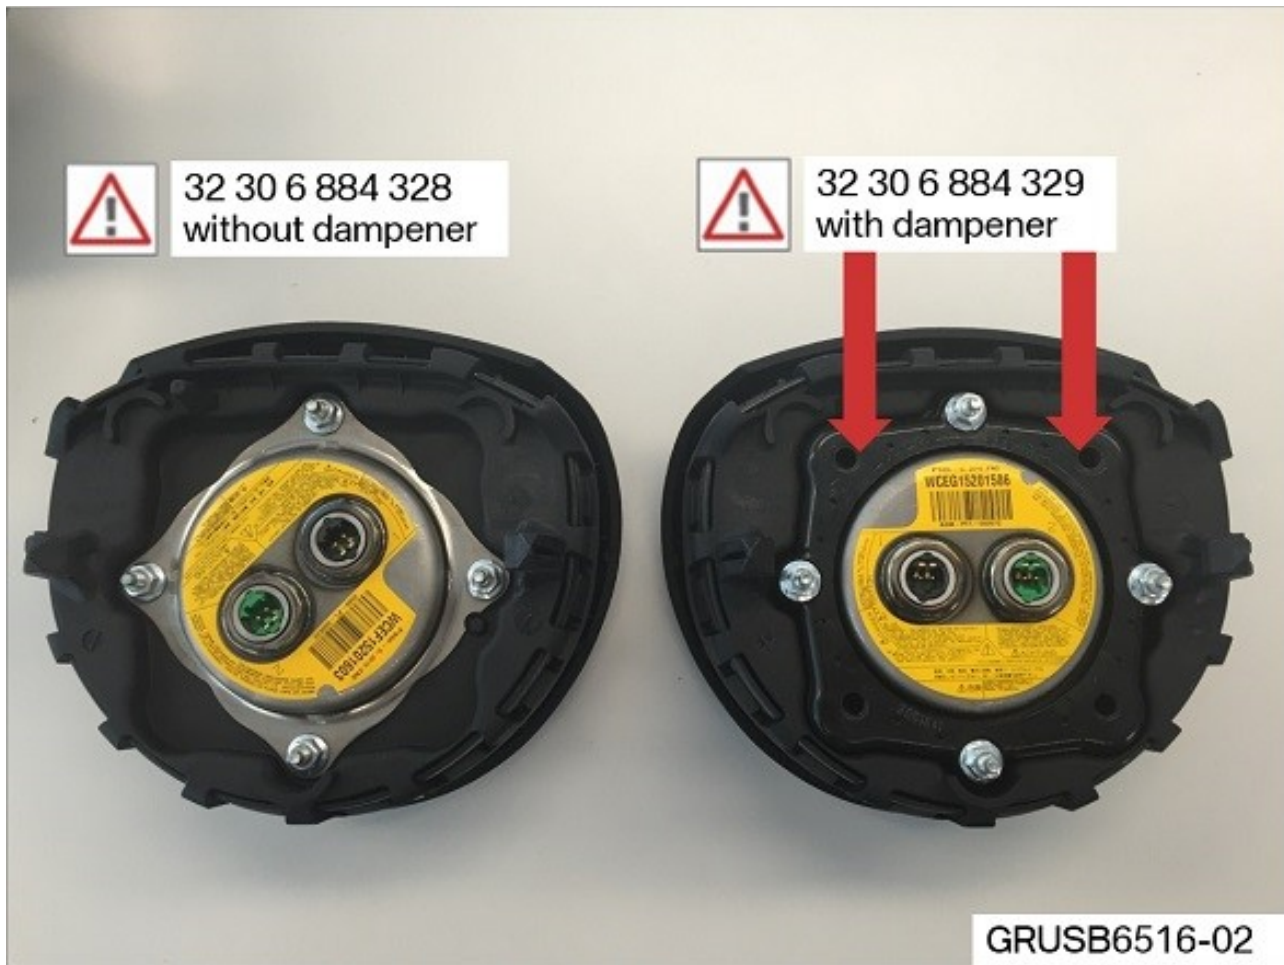
Note: **Original part coming out of the vehicle may not match the replacement part. This applies to vehicles originally equipped with or without a dampener. Refer to the photos below:**
