SIB 65 01 20

**RECALL CAMPAIGN 20V-018: REPLACE PASSENGER'S FRONT AIR BAG MODULE**  
2026-07-16This Service Information Bulletin (Revision 4) replaces SI B65 01 20 **dated October 2025**.**What's New:**

RE: Recall 20V-018: Replace Passenger's Front Air Bag Module – B65 01 20

**Passenger Front Air Bag Module  
Safety Recall 20V-018  
BMW 3 Series  
Model Year 2000-2006  
Initial: 1/14/2020**

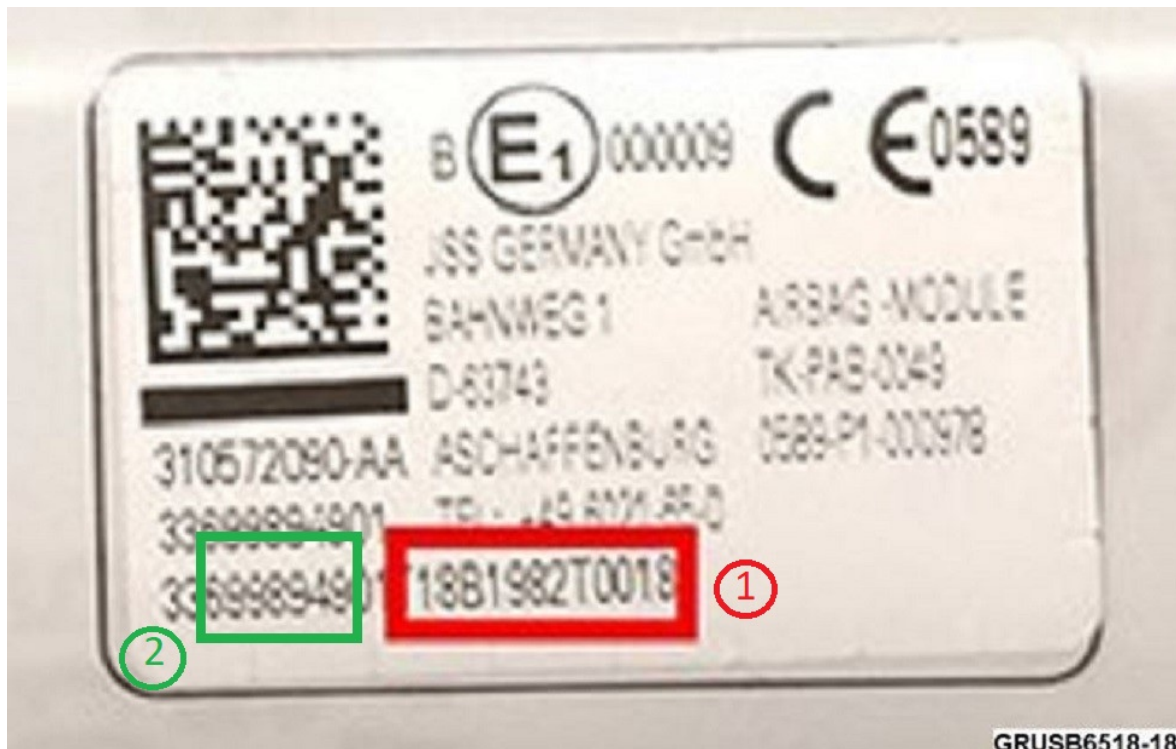
- The serial number is identified below by the red box (1).
- The last 7 digits of the part number is identified below by the green box (2).

**The replacement air bag module's serial number must be documented on the repair order so it can also be entered into the claim's comment section.**
