Campaign Service

BULLETIN NUMBER:
CB20-C-001

IMPORTANT SAFETY RECALL

SEAT BELT INSPECTION AND REPLACEMENT – 20V-TBD (Transport Canada 2020-TBD)

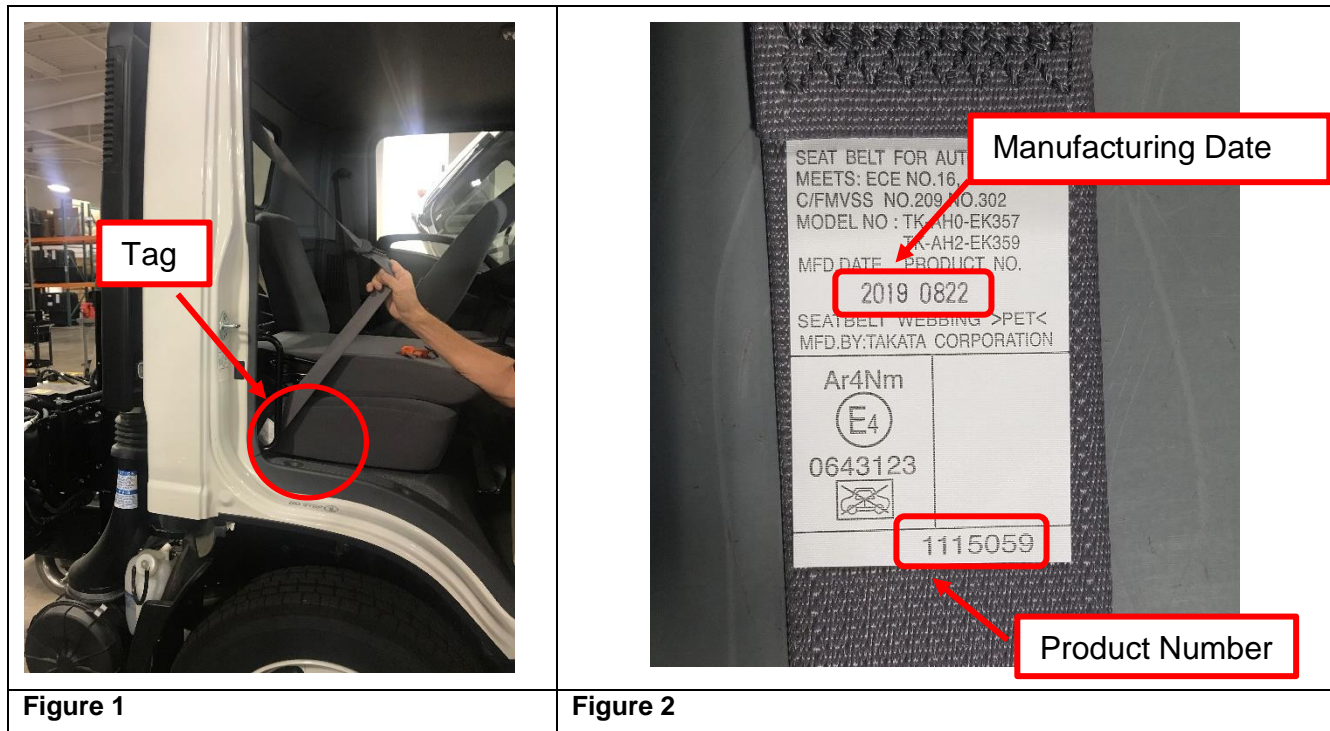
1. Place the vehicle in Park (P), apply the parking brake, and turn the engine off.
2. Inspect the driver and passenger side tongue seat belt assembly tags' product number and manufacturing date which are located near the seat belt's lower anchor point. (See Figures 1 and 2.) Record these numbers on the repair order for the vehicle.
