SAFETY RECALL BULLETIN

SUBJECT:		No: SR-20-001REV
DRIVER SIDE TAKATA NADI INFLATOR – SAFETY RECALL CAMPAIGN		DATE: June 2021
		MODEL: 1998–2000 Montero
CIRCULATE TO:	<input type="checkbox"/> GENERAL MANAGER	<input checked="" type="checkbox"/> PARTS MANAGER
	<input checked="" type="checkbox"/> SERVICE ADVISOR	<input checked="" type="checkbox"/> SERVICE MANAGER
	<input checked="" type="checkbox"/> WARRANTY PROCESSOR	<input checked="" type="checkbox"/> SALES MANAGER
		<input checked="" type="checkbox"/> TECHNICIAN

This bulletin supersedes SR-20-001 issued February 2021, to update the Squib Harness Modification section of the Installation Process. Revisions are italicized and indicated by: ◀

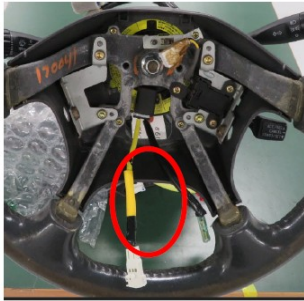
3. Condition after removal of airbag module as left figure

This Squib harness (left figure: red circle part) will be modified in next steps

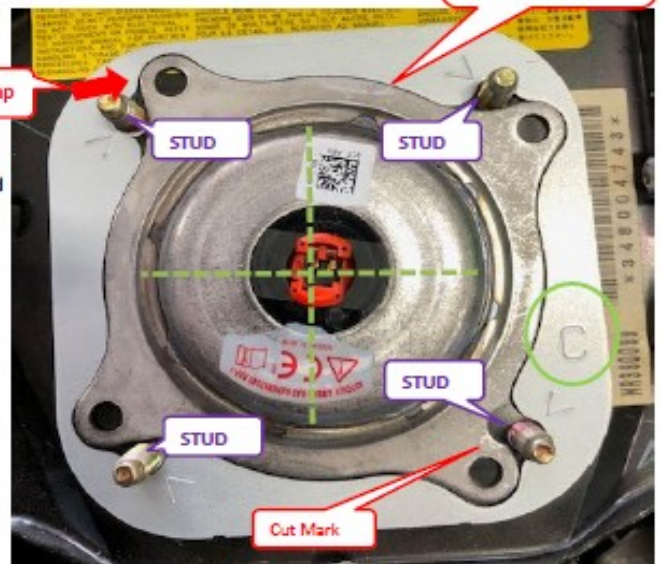
Correct

Inflator and Connector slightly angled and fitted into plate C:

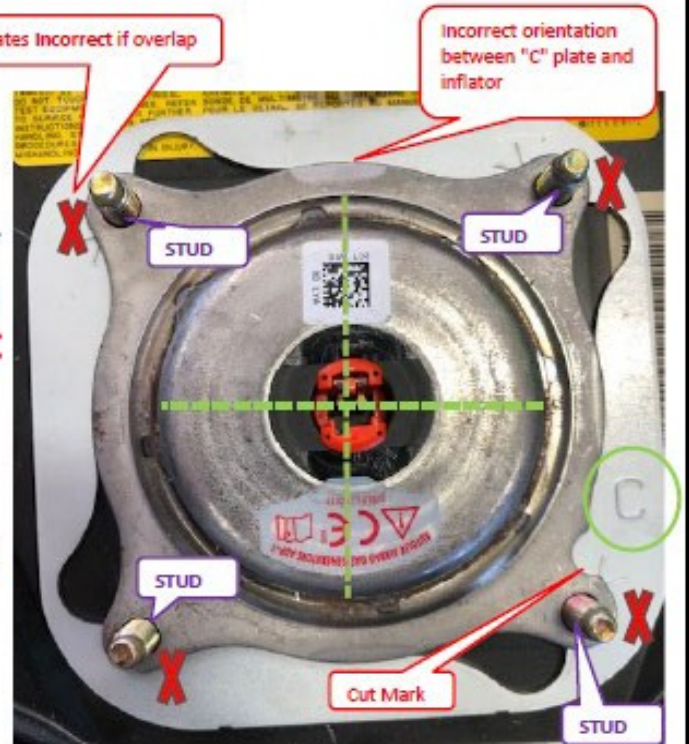
Inflator and Connector
straight up and
overlapping plate C:
Incorrect

NOTE:
4 studs **DO NOT** go
through 4 holes in the
inflator.
