May 2020

Dealer Service Instructions for:

# **Safety Recall W00 / NHTSA 20V-036 Shifter Cable**

**2014-2019 (VF) Ram ProMaster**

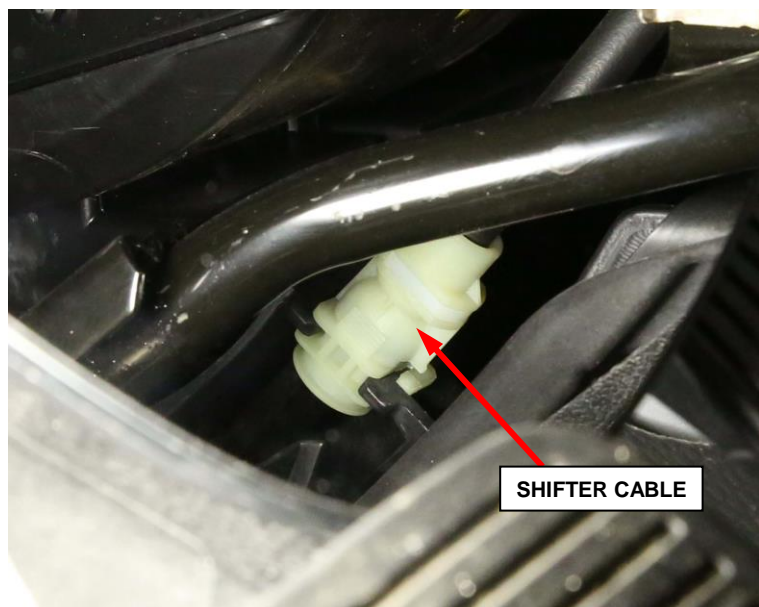
**Figure 17 – Install Shifter Cable Assembly to Shifter Housing**

**NOTE: Double check the connection in Install Step 7. Sometimes the cable does not embed correctly into the bracket. An audible click should be heard when the cable locks into the bracket.**

7. From inside the vehicle, attach the shifter cable assembly to the shifter housing. An audible “click” should be heard when the locking tab engages the housing (Figure 17).
