Technical Service Bulletin 19 002

Subject: Upper Shock Mounting Hardware

Applies To: Fire Truck IFS 20k and 24k Models

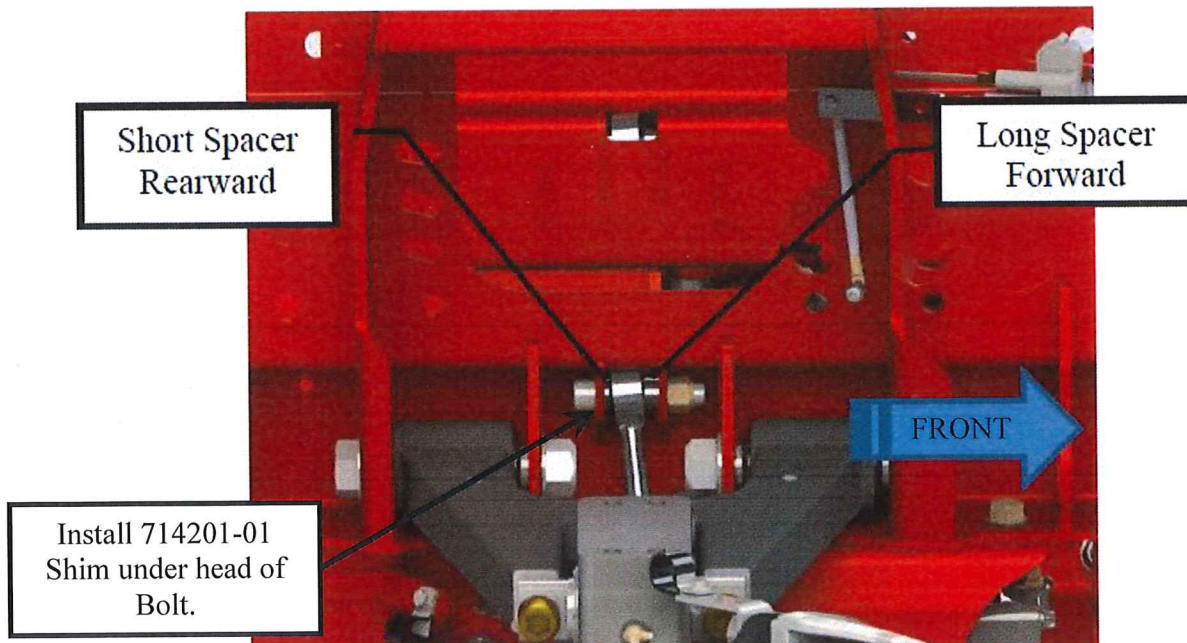
Right side assembly shown

Condition: The upper shock mounting hardware may come loose over time due improper joint clamp load.

3. Install new hardware including spacers and shims from kit #K715180 as shown below.
 - a. **Note:** One 714201-01 shims must be installed under the head of each 715176-01 Bolt.

- b. **Assembly tip:** Insert bolt through the rear tab enough to hang needed shims and short spacer, place shock in position, advance bolt to engage shock, position long spacer, push bolt through front tab, and install nut.

4. Using a socket extension thru the access holes in the cradle, torque the head of the bolt to between 245 and 260 ft-lbs while holding the nut with a wrench.
5. Repeat Steps 1 through 4 on the opposite side.
