Safety Recall W03 / NHTSA 20V-043

Transmission Valve Body

**2019 - 2020 (DJ) Ram 2500 Pickup
(D2) Ram 3500 Pickup**

NOTE: This recall applies only to the above vehicles equipped with a 6-Speed Automatic 68RFE Transmission (sales code DG7).

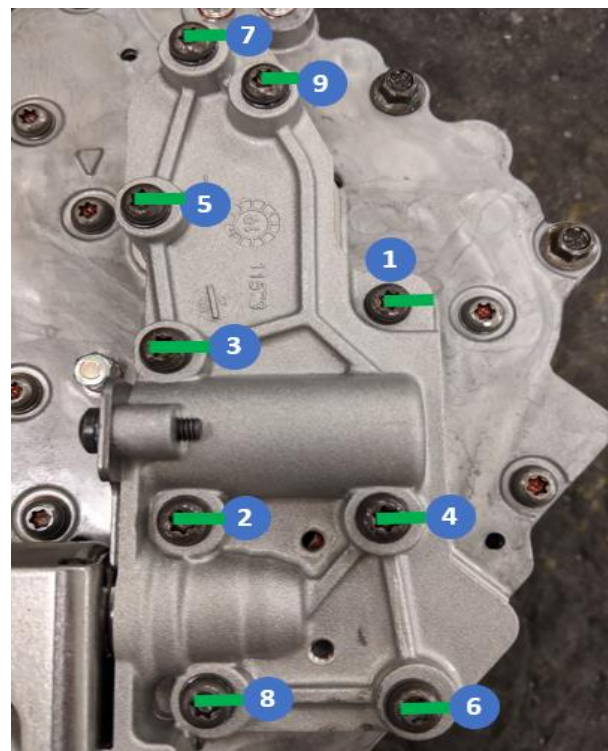
Figure 10 – Tightening Sequence

IMPORTANT: Tightening sequence procedure **MUST** be followed to assure correct lower valve body mounting, failure to follow the tightening sequence may result in transmission malfunction.

19. Re-install Lower Valve Body to main Transmission Valve Body, hand starting and seating all of the fasteners then tighten to 7.3 N·m (64.6 in. lbs.) according to specified pattern illustrated in (Figure 10).

21. **Important:** Repeat tightening the 9 Lower Valve Body fasteners to 7.3 N·m (64.6 in. lbs.) using the sequence illustrated in (Figure 10).
