Campaign No. 2020020016, March 2020

SUBJECT: **Model GT-Class vehicles (290 platform)**
Model Year 2019
Automatic transmission wiring harness

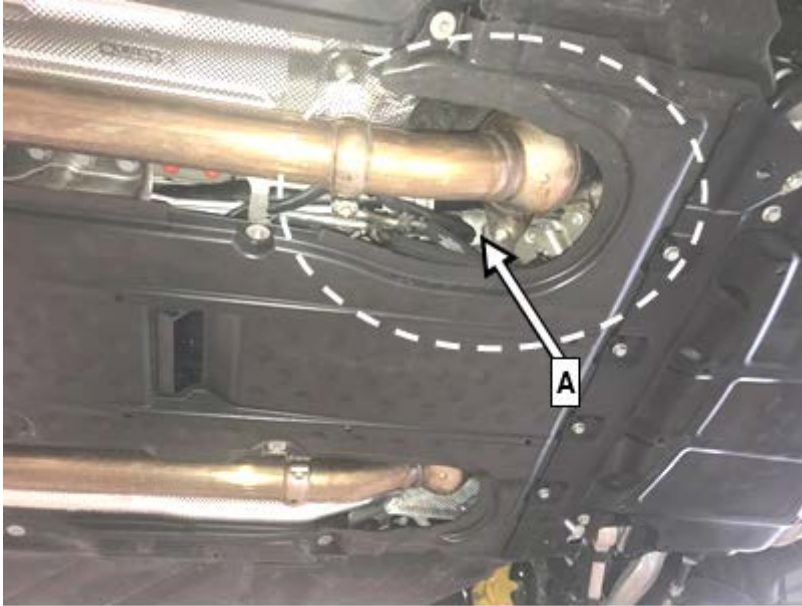
Figure 1

i The area of the automatic transmission wiring harness to be checked (**A, Figure 1**) is located on the right-hand side below the drive shaft to the front axle differential.

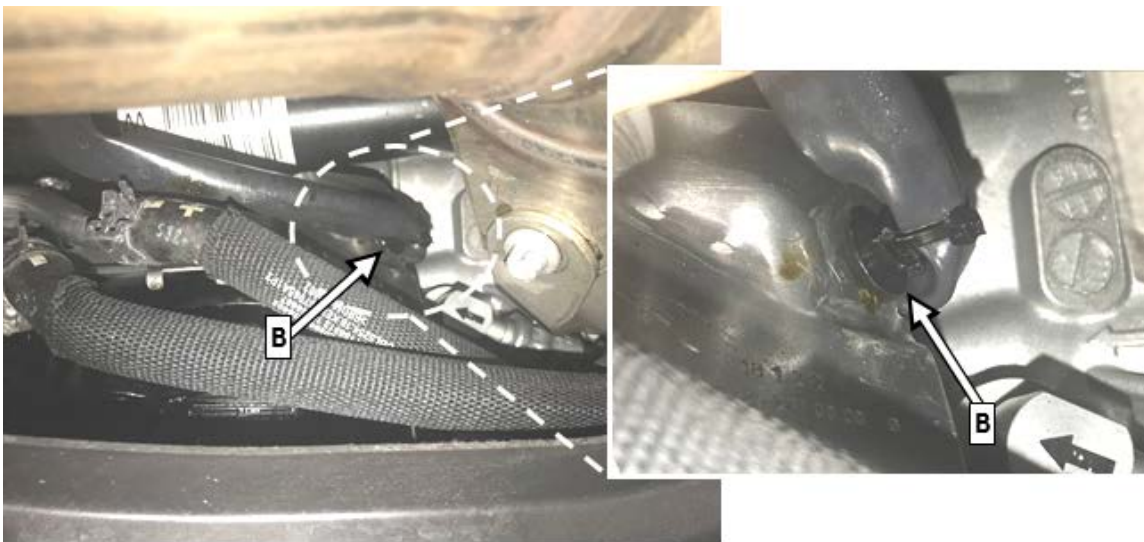
Figure 2 Correct installation

2. Check whether mounting clip (**B, Figure 2**) on automatic transmission wiring harness was installed correctly.

i It is possible that the mounting clip is not engaged in the blank holder.

- a. Mounting clip on wiring harness **not** installed correctly: Carry out **work procedure**.
- b. Mounting clip on wiring harness installed correctly: **End measure**.
