GROUP	NUMBER
RECALL	20-01-017H
DATE	MODEL(S)
March, 2020	ELANTRA (HD) ELANTRA TOURING (FD)

2007-2010 ELANTRA (HD) & 2009-2011 ELANTRA TOURING (FD) PCB RELAY KIT INSTALLATION (RECALL CAMPAIGN 188)

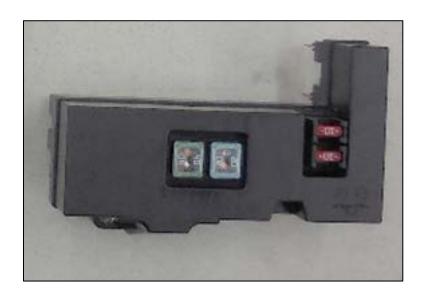
Description: Moisture may enter the ABS electrical system of certain Elantra (HD) and Elantra Touring (FD) vehicles. Over time, the moisture can cause a short circuit. If a short circuit occurs inside the ABS module, there could be an increased risk of an engine compartment fire. This bulletin describes the procedure to install a relay into the ABS module electrical circuit.
