February 26, 2020

Safety Recall: Third Row Accessory Power Outlet

Supersedes 20-012, dated February 11, 2020, to revise the information highlighted in **yellow**.

Year	Model	Trim	VIN Range
2018-20	Odyssey	EX-L, EX-L with Navigation and RES, Touring, and Elite	Check the iN VIN status for eligibility.

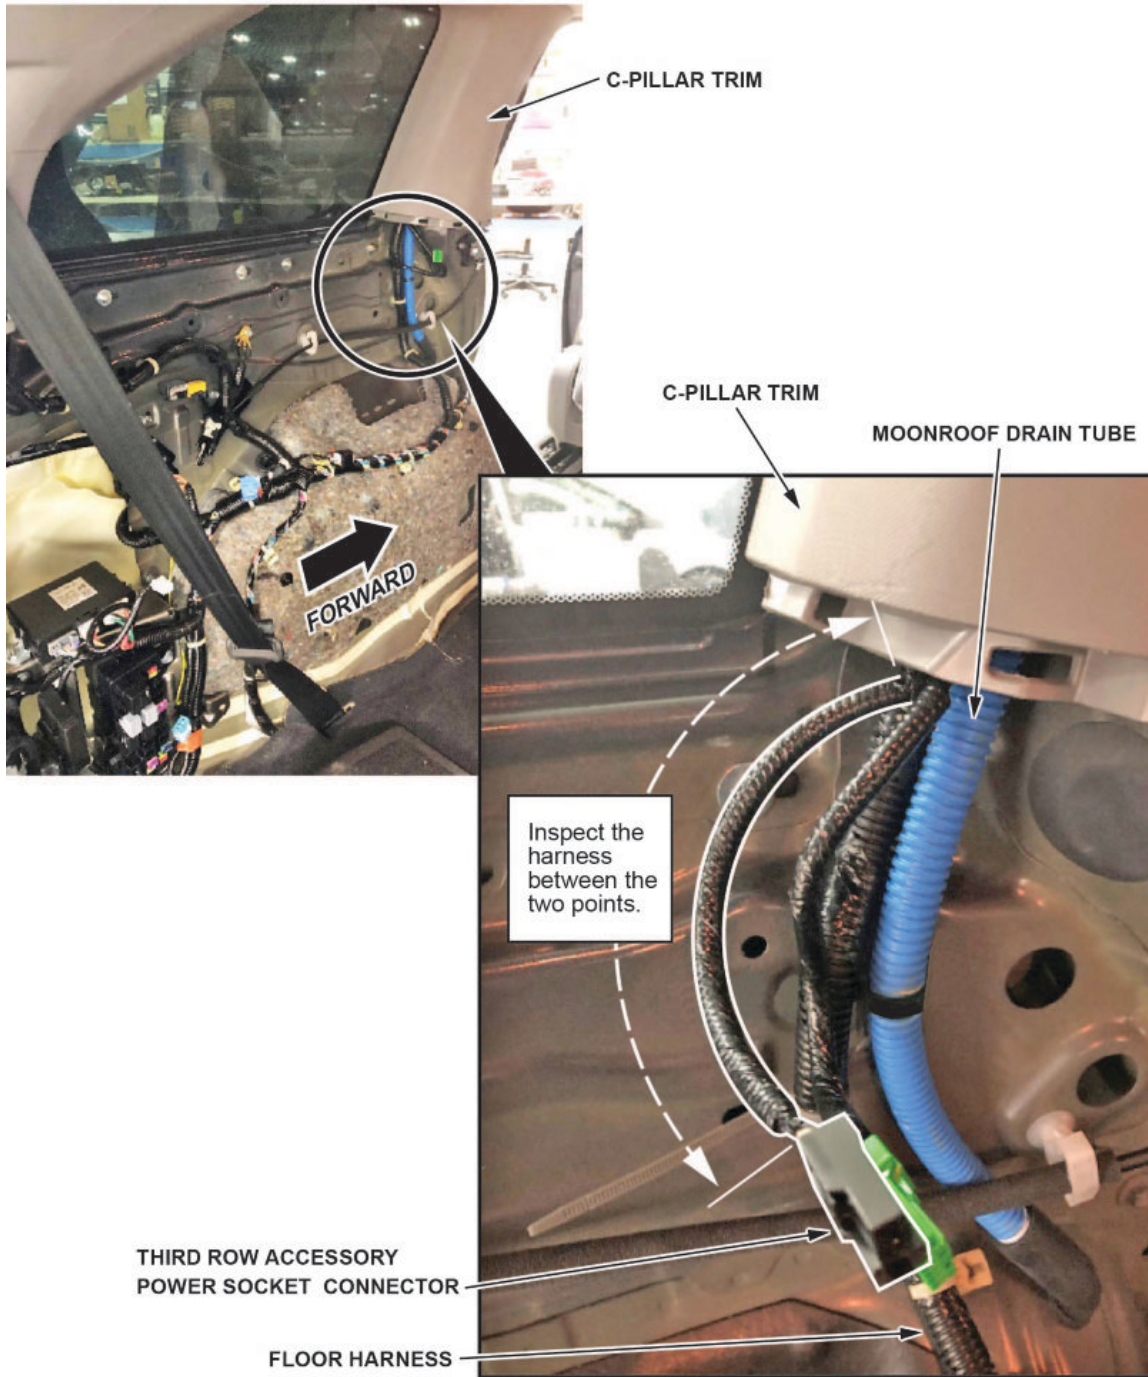
Revised Image

8. If the third row accessory power socket harness branch of the floor harness was improperly routed, the harness may be deformed. Inspect this part of the harness from the C-pillar trim to the third row accessory power socket connector for any exposed copper wiring. **Do not remove the electrical tape.**

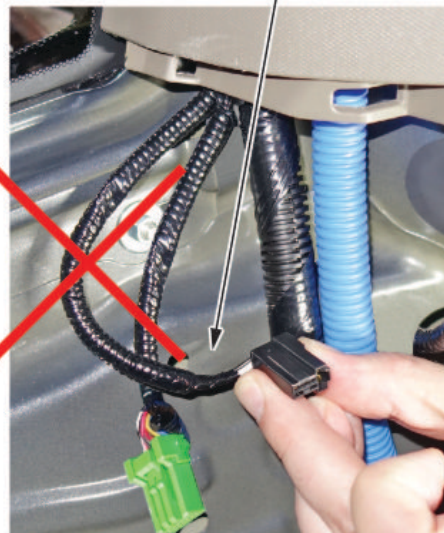
DO NOT route the third row accessory power socket harness and the rear entertainment harness (if equipped) as shown.

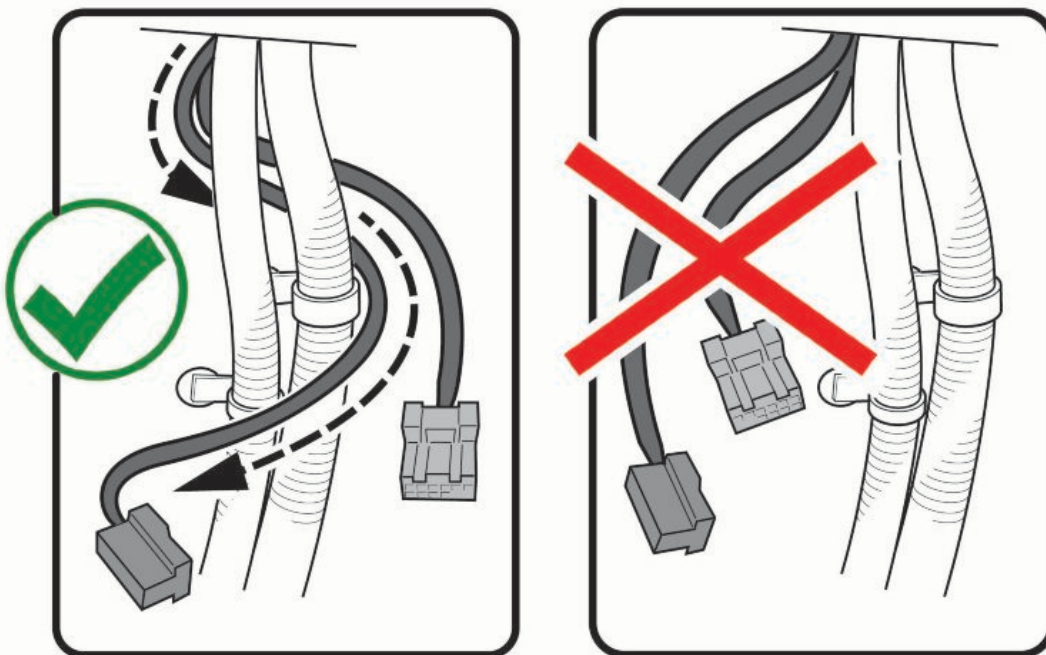
THIRD ROW ACCESSORY POWER SOCKET CONNECTOR
Be sure there is a gap between the connector and the floor harness.

15. Install the rear trim panel and, just before setting the trim panel to the c-pillar trim, check to confirm that the new clips were installed correctly, and the third row accessory power socket connector does not interfere with the floor harness when the panel is fully set.
